Project No.
7290.002.024

Subject: Ridgeview at Vista Glen
Santa Paula, California

SANTA PAULA GEOLOGIC HAZARD ABATEMENT DISTRICT MONITORING – FALL 2024

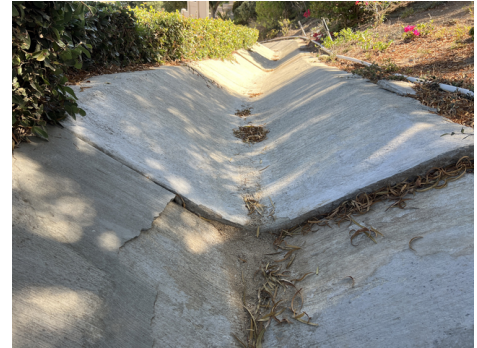
Concrete-lined surface drainage ditches were checked for accumulation of debris/sediment and for obvious distress, such as cracking or shifting of the concrete. As shown in Figure 1, there are approximately 4,000 linear feet of concrete-lined drainage ditches within the Santa Paula GHAD. Concrete-lined drainage ditches were generally clear of debris at the time of the site visit. As part of the scheduled routine site maintenance, the GHAD will remove vegetation and other unwanted material from the concrete-lined ditches prior to the winter rainy season. Additionally, there are minor cracks within the concrete-lined ditches throughout the development, which will be patched as needed. More significant cracks within the concrete-lined drainage ditches are noted in Site Condition A.1. A possible irrigation leak was observed in several locations on the slope above the concrete-lined drainage ditches (Site Conditions D.1 through D.3). These irrigation leaks should be addressed to reduce excess water and debris in the ditches and will continue to be monitored. Irrigation throughout the development is the Homeowner's Association's (HOA) responsibility; therefore, the GHAD will inform the HOA of the irrigation leaks.

Site Condition: A.1
Observation Date: 09/26/2024
Description: Crack in concrete-lined drainage ditch
Recommendation: Replace concrete-lined drainage ditch panel
Field Representative: MO

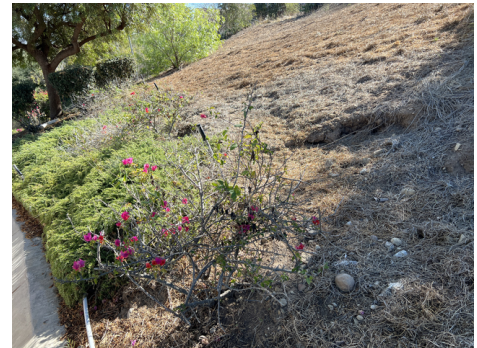
The slopes were observed for evidence of slope instability, including landslides, erosion, diverted drainage, or standing water. In general, slopes appeared to be performing well, with the exception of a minor area of soil erosion above the concrete-lined drainage ditches west of 936 Coronado Circle (Site Condition B.1, Figure 1). This area will continue to be monitored to determine if severity increases to the point of requiring mitigation.

Site Condition: B.1
Observation Date: 09/26/2024
Description: Soil sloughing on open space slope
Recommendation: Continue to monitor for evidence of global instability
Field Representative: MO

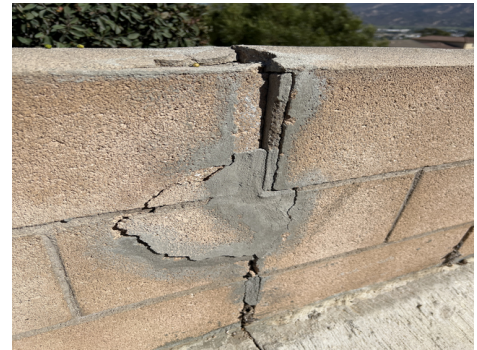
In general, the permanent retaining and splash walls throughout the GHAD are in good condition and appear to be performing well. The GHAD previously patched minor cracks in splash walls within Parcel "B" that had formed due to localized shifting along expansion joints in the adjacent concrete-lined drainage ditches. At the time of the visit, these patches appeared to be performing generally well, although we observed cracks in some areas of the splash walls along the concrete drainage ditches above Lots 1 through 14 and within Parcel "B" (Site Conditions C.1 through C.5, Figure 1). The cracks are approximately $\frac{1}{4}$ to $\frac{3}{4}$ inch wide, with some minor offset at certain locations. In part, the cracks appear to be related to localized shifting along the expansion joints in the adjacent concrete-lined drainage ditches and will continue to be monitored. In general, open cracks greater than $\frac{1}{2}$ inch wide should be sealed in a manner that will maintain the function of the splash walls.

Site Condition: C.1
Observation Date: 09/26/2024
Description: Localized offset splash wall
Recommendation: Replace offset piece
Field Representative: MO

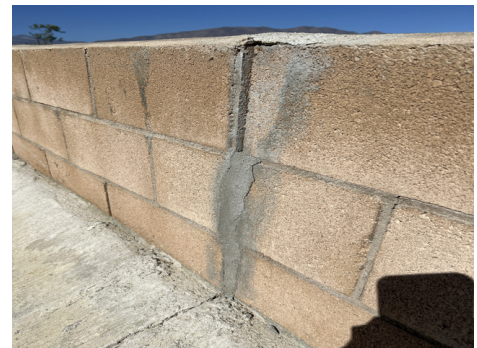
Site Condition: C.2
Observation Date: 09/26/2024
Description: Localized offset splash wall
Recommendation: Replace offset piece
Field Representative: MO

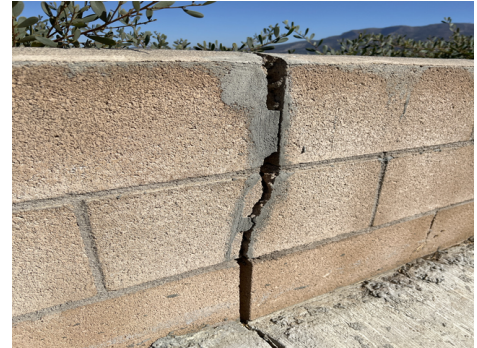
Site Condition: C.3
Observation Date: 09/26/2024
Description: Localized offset splash wall
Recommendation: Replace offset piece
Field Representative: MO

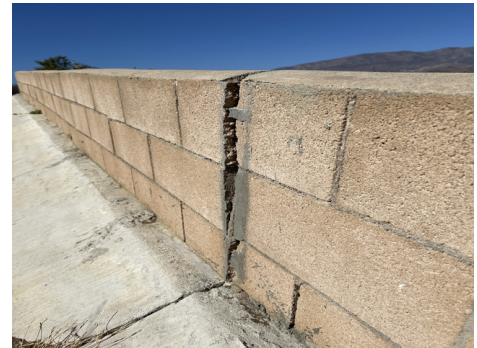
Site Condition: C.4
Observation Date: 09/26/2024
Description: Localized offset splash wall
Recommendation: Replace offset piece
Field Representative: MO

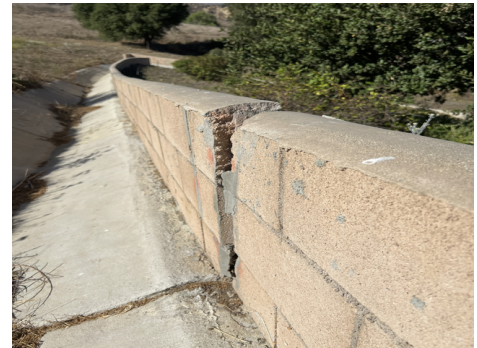
Site Condition: C.5
Observation Date: 09/26/2024
Description: Localized offset splash wall
Recommendation: Replace offset piece
Field Representative: MO

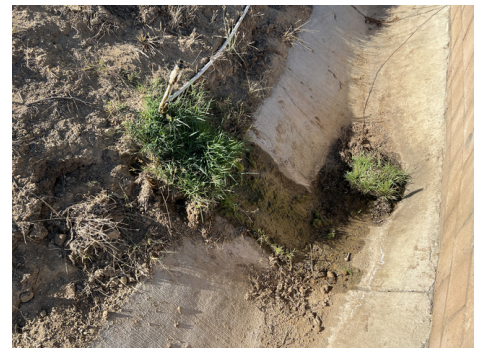
Site Condition: D.1
Observation Date: 09/26/2024
Description: Potential irrigation leak on slope above concrete-lined drainage ditch
Recommendation: Irrigation leaks should be addressed to reduce excess water and debris
Field Representative: MO

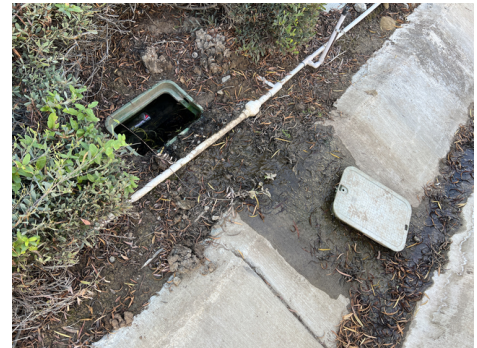
Site Condition: D.2
Observation Date: 09/26/2024
Description: Potential irrigation leak on slope above concrete-lined drainage ditch
Recommendation: Irrigation leaks should be addressed to avoid excess water and debris
Field Representative: MO

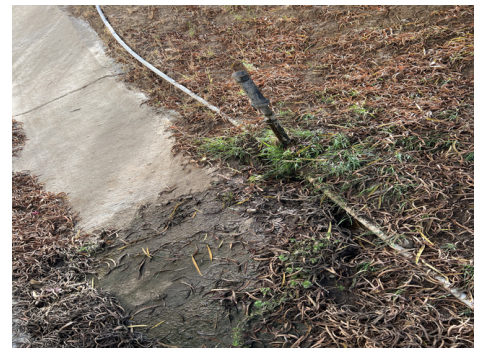
Site Condition: D.3
Observation Date: 09/26/2024
Description: Potential irrigation leak on slope above concrete-lined drainage ditch
Recommendation: Irrigation leaks should be addressed to avoid excess water and debris
Field Representative: MO

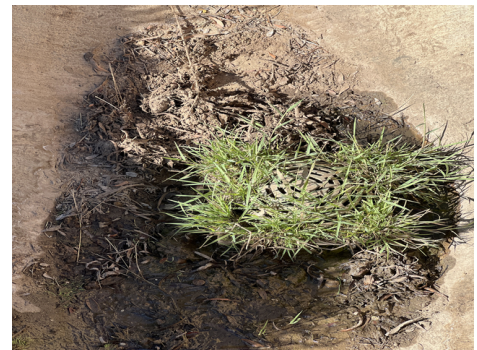
The inlets, outfalls, and trash racks located within the GHAD limits were generally in good condition, although we observed clogged drain inlets in some areas (Site Condition E.1). Storm drain inlets are cleaned as part of routine concrete-lined drainage ditch maintenance.

Site Condition: E.1
Observation Date: 09/26/2024
Description: Clogged drain inlet
Recommendation: Remove debris
Field Representative: MO

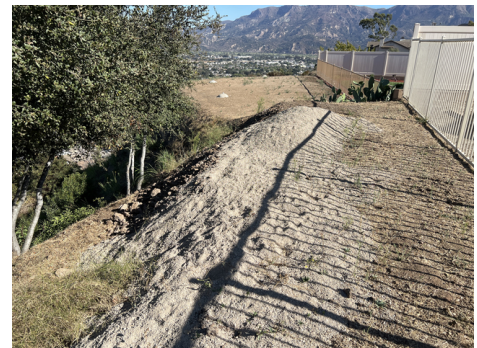
We noticed homeowner activity within the GHAD-owned open space on Parcel “C” east of 889 Coronado Circle (Lot 22) (Site Conditions F.1 and F.2). Homeowner improvements within GHAD-owned open space are not permitted, as they could contribute to slope instability. The GHAD will contact the homeowner(s) to have the materials and improvements removed.

Site Condition: F.1
Observation Date: 09/26/2024
Description: Resident materials placed on GHAD property
Recommendation: Remove all material from GHAD property
Field Representative: None

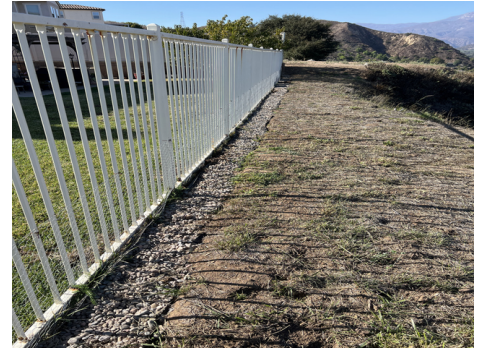
Site Condition: F.2
Observation Date: 09/26/2024
Description: Resident materials placed on GHAD property

Recommendation: Remove all material from GHAD property
