Project No.
7290.002.025

December 1, 2025

Subject: Ridgeview at Vista Glen
Santa Paula, California

SANTA PAULA GEOLOGIC HAZARD ABATEMENT DISTRICT MONITORING – FALL 2025

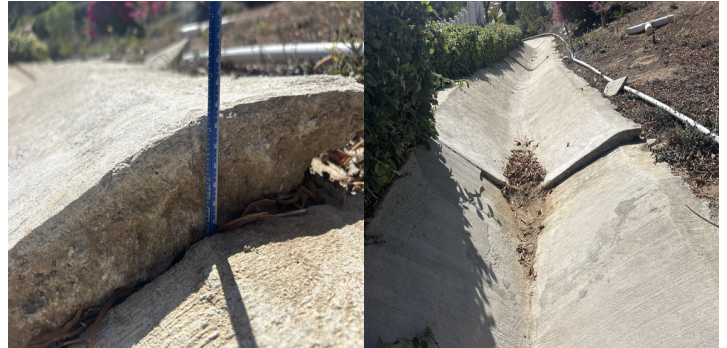
Minor cracks were observed within the concrete-lined ditches throughout the development, which will be patched as needed. More significant cracks within the concrete-lined drainage ditches are noted in Site Conditions A.1 and A.8. We also observed indications of irrigation leaks in several locations on the slope above the concrete-lined drainage ditches (Site Conditions D.1 through D.4). These irrigation leaks should be addressed to reduce excess water and debris in the ditches and will continue to be monitored. Irrigation throughout the development is the HOA's responsibility; therefore, the GHAD will inform the HOA of the irrigation leaks. The cracking is likely related in part to surrounding vegetative growth and increased moisture from irrigation. Proactive irrigation and landscape maintenance are recommended to support long-term stability.

Site Condition: A.1
Observation Date: 10/06/2025
Description: Crack in concrete-lined drainage ditch
Recommendation: Replace concrete-lined drainage ditch panel
Field Representative: EM, SD

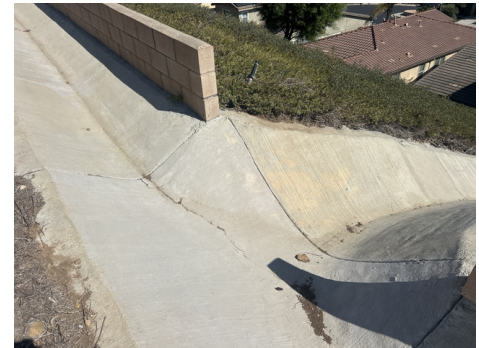
Site Condition: A.2
Observation Date: 10/06/2025
Description: Crack in concrete-lined drainage ditch
Recommendation: Continue to monitor
Field Representative: EM, SD

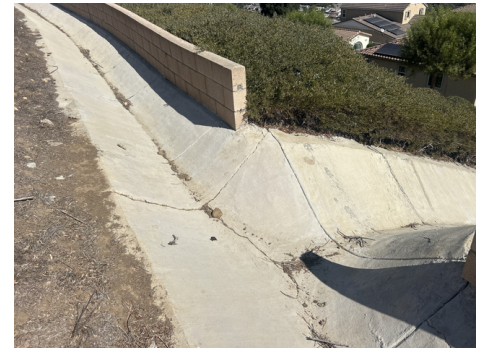
Site Condition: A.3
Observation Date: 10/06/2025
Description: Crack in concrete-lined drainage ditch
Recommendation: Continue to monitor
Field Representative: EM, SD

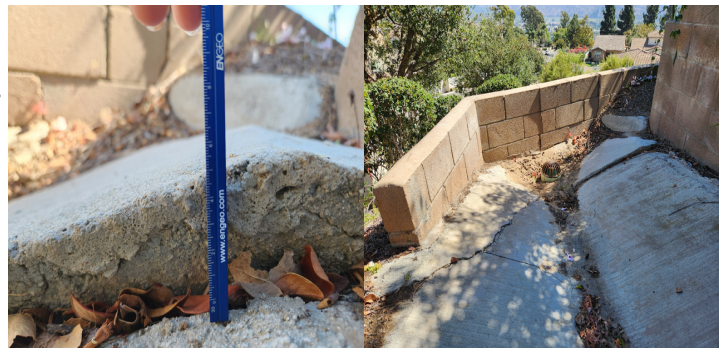
Site Condition: A.4
Observation Date: 10/06/2025
Description: Cracking and offset of concrete panel, debris surrounding panel
Recommendation: Replace panel and clear debris
Field Representative: EM, SD

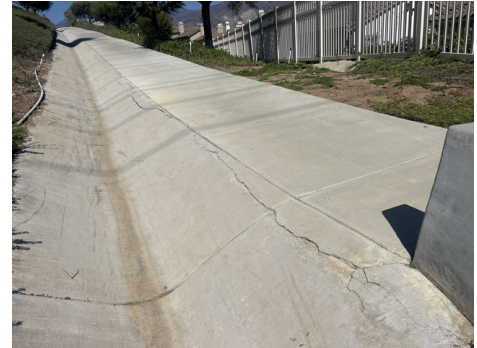
Site Condition: A.5
 Observation Date: 10/06/2025
 Description: Cracking on upper level of concrete ditch near pedestrian walkway
 Recommendation: Continue to monitor
 Field Representative: EM, SD

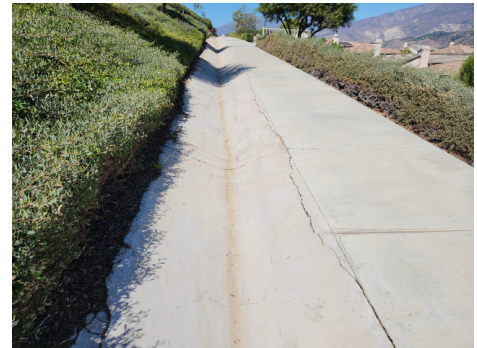
Site Condition: A.6
 Observation Date: 10/06/2025
 Description: Cracking on upper level of concrete ditch near pedestrian walkway
 Recommendation: Continue to monitor
 Field Representative: EM, SD

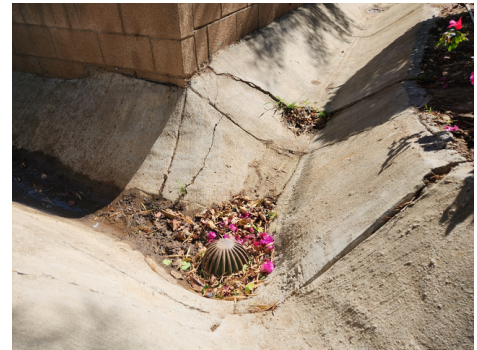
Site Condition: A.7
 Observation Date: 10/06/2025
 Description: Cracking and offset of concrete panel, debris surrounding panel
 Recommendation: Replace concrete panel and clear debris
 Field Representative: EM, SD

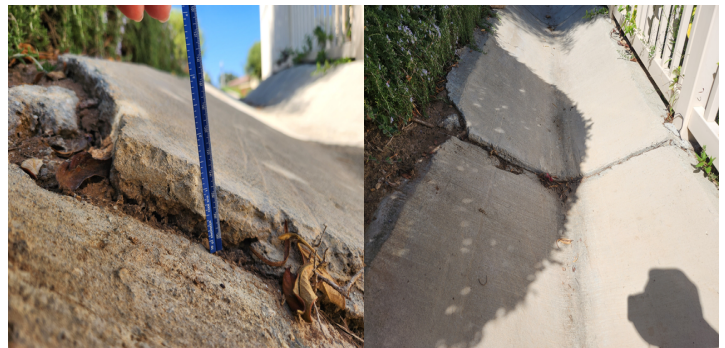
Site Condition: A.8
 Observation Date: 10/06/2025
 Description: Offset in concrete panel
 Recommendation: Patch where needed
 Field Representative: EM, SD

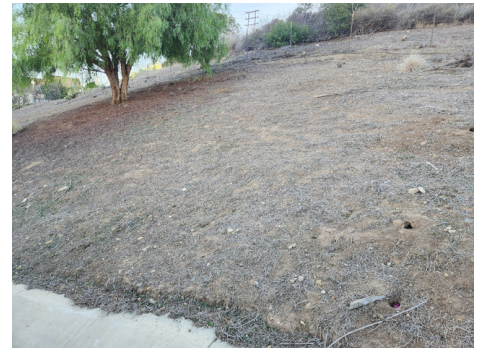
Site Condition: B.1
Observation Date: 10/06/2025
Description: Soil sloughing on open space slope

Recommendation: Continue to monitor for evidence of global instability

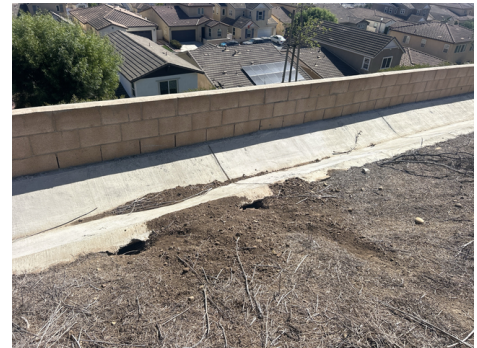
Slopes were observed for signs of instability such as erosion, landslides, standing water, or diverted drainage. In general, slopes appear to be performing well. However, localized soil erosion and potential animal burrowing were observed above the concrete-lined drainage ditches west of 968 Coronado Circle (Site Conditions B.2 and B.3). These areas require infilling with dirt and concrete slurry to prevent further scour. The GHAD will complete this repair as part of ongoing maintenance.

Site Condition: B.2
Observation Date: 10/06/2025
Description: Undermining of the concrete ditch, potential ground squirrel burrowing activity

Recommendation: Fill in burrowed areas with concrete

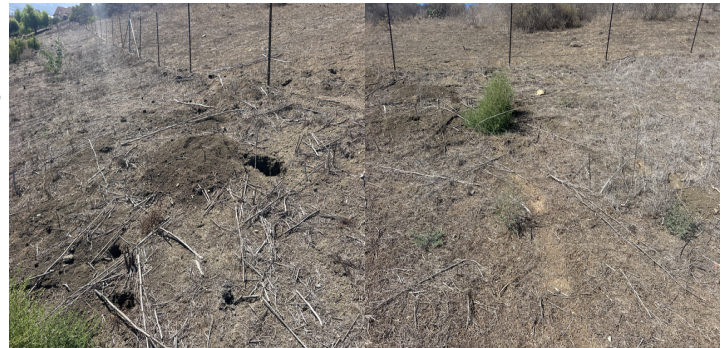
Site Condition: B.3
Observation Date: 10/06/2025
Description: Ground cracking/rilling on upper hillside, potential ground squirrel activity

Recommendation: Continue to monitor

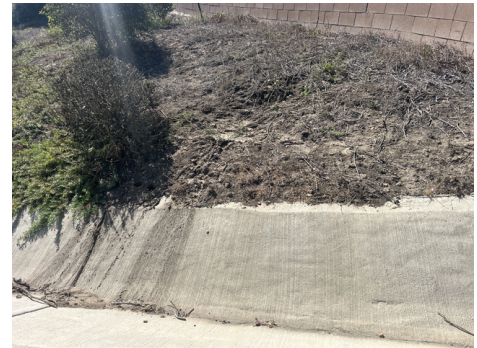
Site Condition: B.4
Observation Date: 10/06/2025
Description: Soil sloughing and mud runoff into concrete-lined ditch

Recommendation: Continue to monitor

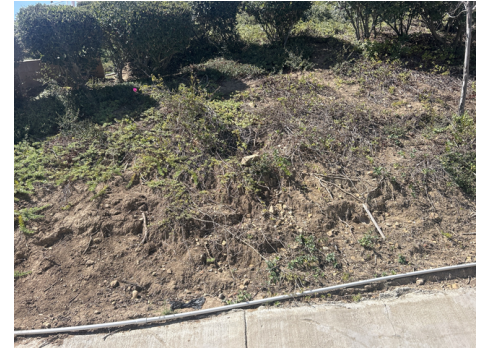
Site Condition: B.5
Observation Date: 10/06/2025
Description: Soil sloughing on slope above concrete ditch
Recommendation: Continue monitoring
Field Representative: EM, SD

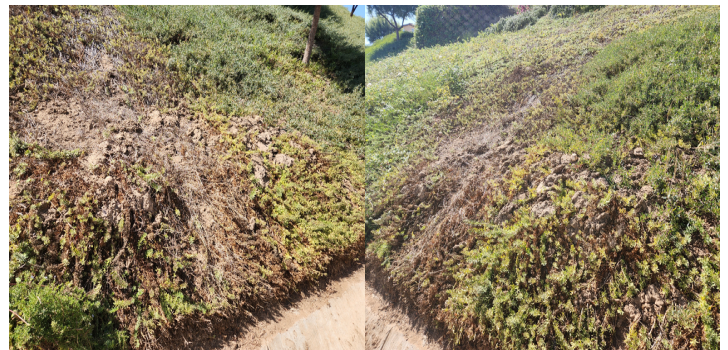
Site Condition: B.6
Observation Date: 10/06/2025
Description: Soil sloughing on slope above concrete ditch
Recommendation: Continue to monitor
Field Representative: EM, SD

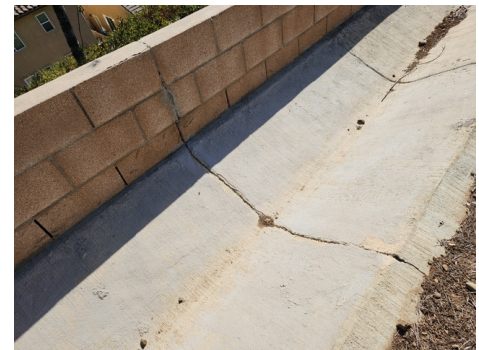
In general, retaining and splash walls within the GHAD appear to be in good condition. Previously patched cracks within Parcel "B" are performing well. During this visit, additional cracking was observed along the concrete-lined drainage ditches above Lots 1–14 and within Parcel "B" (Site Conditions C.1 through C.8). Cracks range from approximately ¼ to 1 inch in width, with minor offsets in some areas. Many appear associated with localized movement along adjacent ditch expansion joints and are likely influenced by surrounding vegetation. Cracks greater than ½ inch should be sealed to maintain wall integrity. Continued monitoring is recommended.

Site Condition: C.1
Observation Date: 10/06/2025
Description: Localized cracks in previously repaired splash wall
Recommendation: Patch where needed
Field Representative: EM, SD

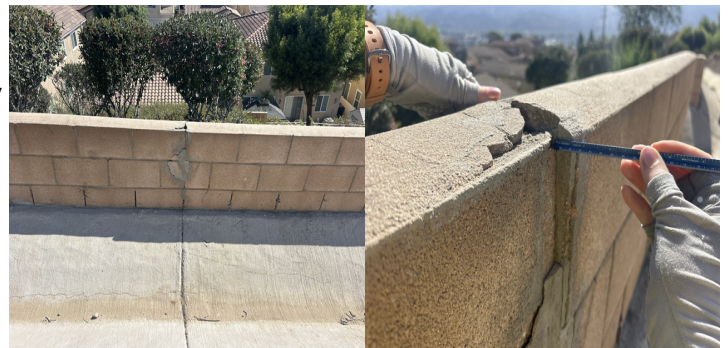
Site Condition: C.2
Observation Date: 10/06/2025
Description: Localized cracking and offset in previously repaired splash wall
Recommendation: Patch where needed
Field Representative: EM, SD

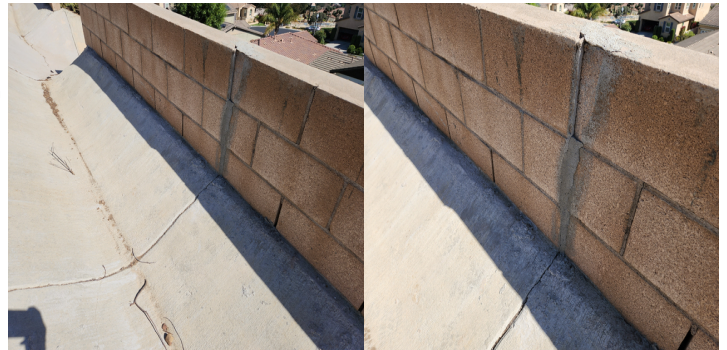
Site Condition: C.3
Observation Date: 10/06/2025
Description: Localized offset in previously repaired splash wall
Recommendation: Continue to monitor
Field Representative: EM, SD

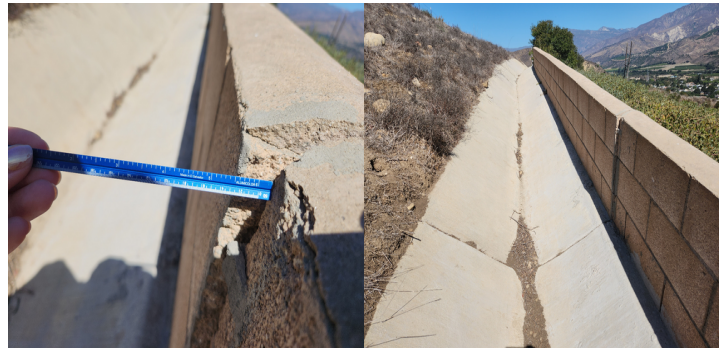
Site Condition: C.4
Observation Date: 10/06/2025
Description: Localized offset in splash wall
Recommendation: Continue to monitor
Field Representative: EM, SD

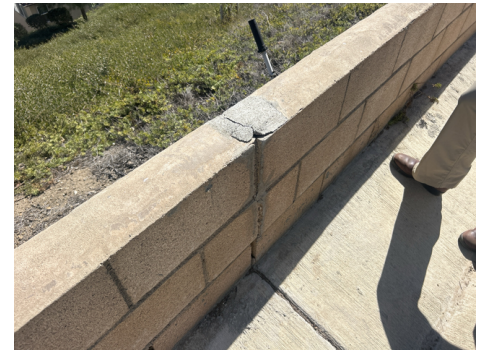
Site Condition: C.5
Observation Date: 10/06/2025
Description: Localized offset in splash wall
Recommendation: Continue to monitor
Field Representative: EM, SD

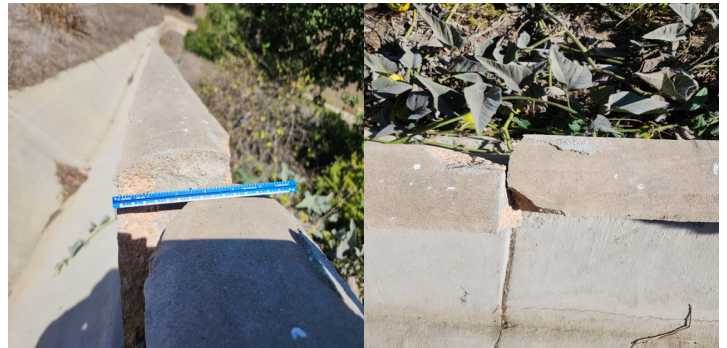
Site Condition: C.6
Observation Date: 10/06/2025
Description: Localized offset of splash wall
Recommendation: Patch where needed
Field Representative: EM, SD

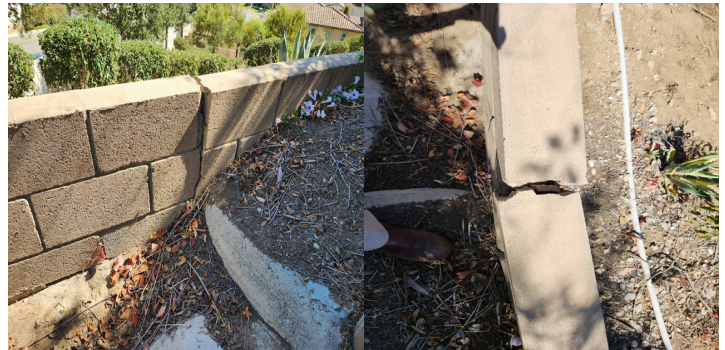
Site Condition: C.7
Observation Date: 10/06/2025
Description: Localized offset in splash wall
Recommendation: Patch where needed
Field Representative: EM, SD

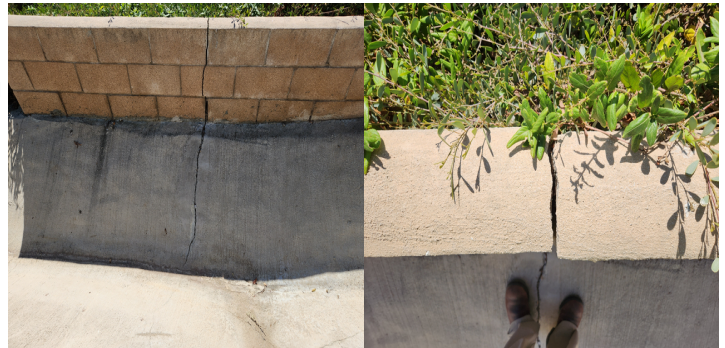
Site Condition: C.8
Observation Date: 10/06/2025
Description: Offset in splash wall leading down concrete-lined ditch
Recommendation: Patch where needed
Field Representative: EM, SD

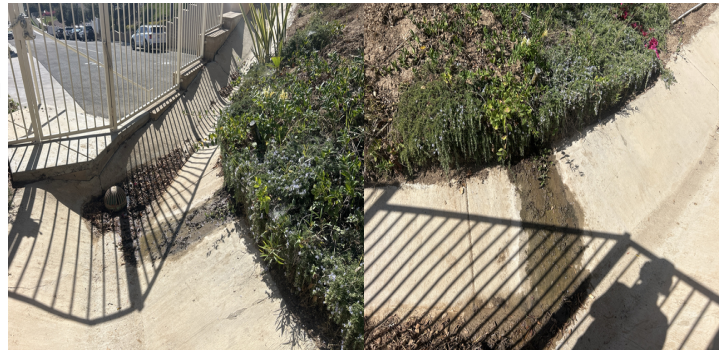
Site Condition: D.1
Observation Date: 10/06/2025
Description: Potential irrigation leak above concrete-lined ditch
Recommendation: Replace sprinkler head
Field Representative: EM, SD

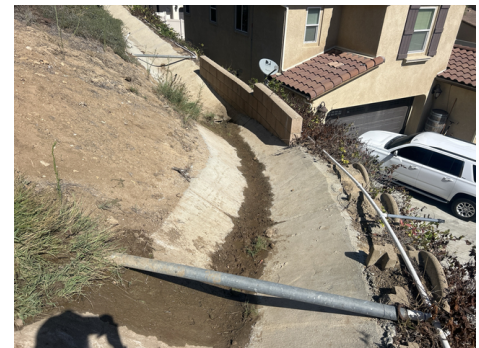
Site Condition: D.2
Observation Date: 10/06/2025
Description: Potential irrigation leak above concrete-lined ditch
Recommendation: Replace sprinkler head
Field Representative: EM, SD

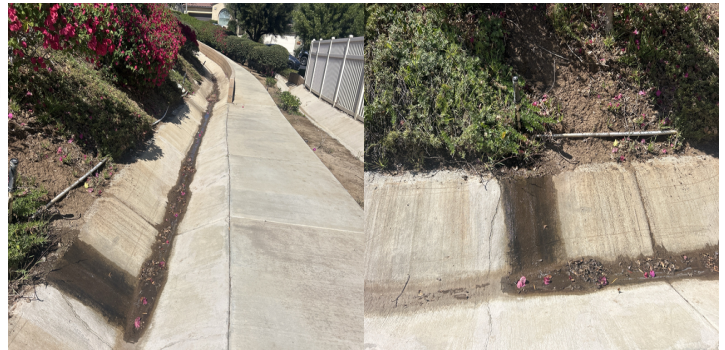
Site Condition: D.3
Observation Date: 10/06/2025
Description: Potential irrigation leak above concrete-lined ditch
Recommendation: Replace sprinkler head
Field Representative: EM, SD

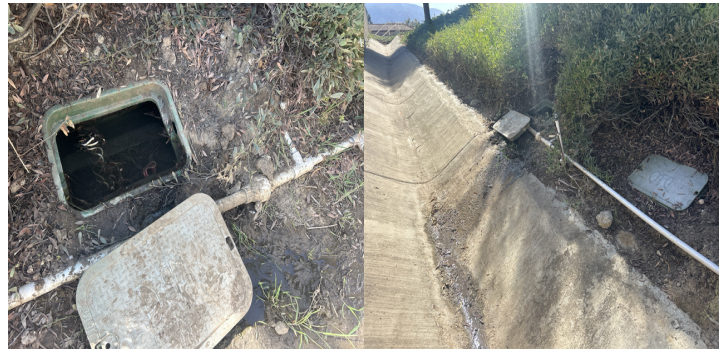
Site Condition: D.4
Observation Date: 10/06/2025
Description: Potential irrigation leak and ponded water
Recommendation: Repair irrigation
Field Representative: EM, SD

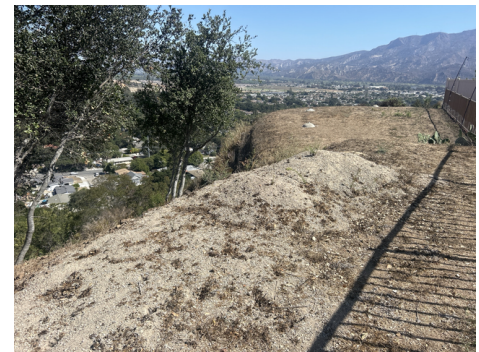
Site Condition: E.1
Observation Date: 10/06/2025
Description: Resident materials placed on GHAD property
Recommendation: Remove all material from GHAD property
Field Representative: EM, SD
