Project No.
7290.002.024

Subject: Ridgeview at Vista Glen
Santa Paula, California

SANTA PAULA GEOLOGIC HAZARD ABATEMENT DISTRICT MONITORING – FALL 2024

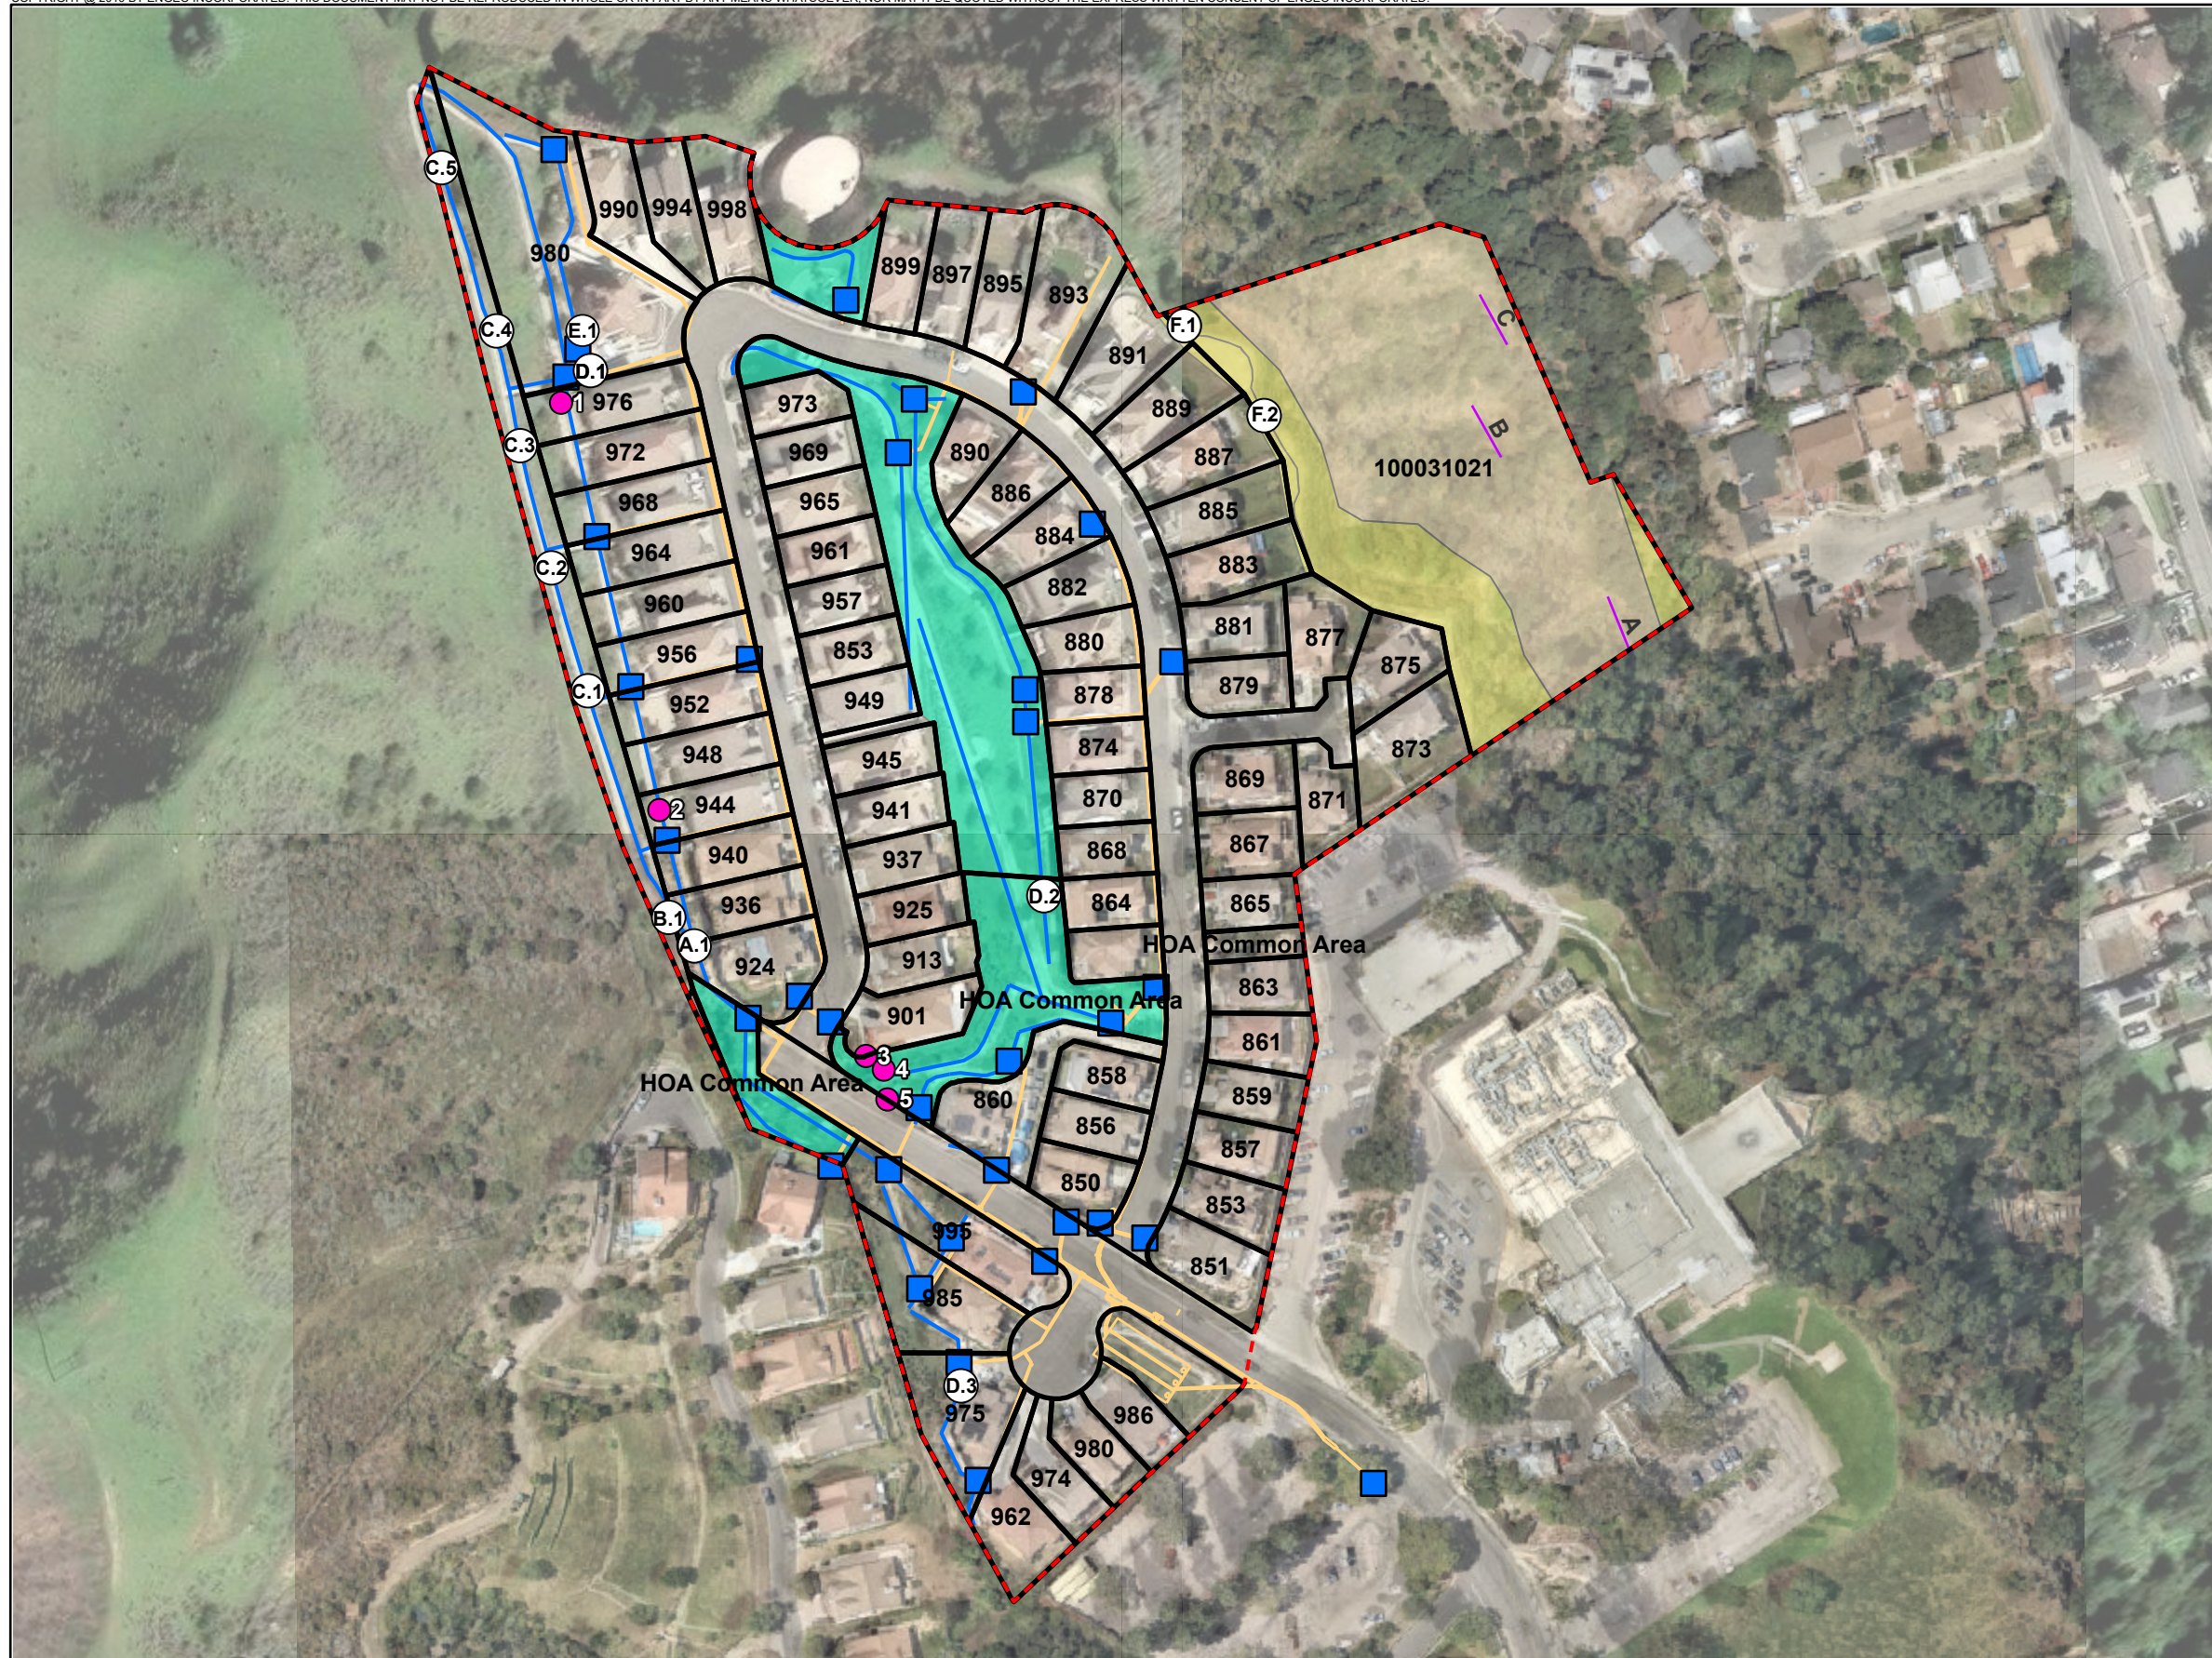
Site Plan

In general, the subsurface subdrain outlets located within the GHAD limits were in good condition, containing only very minor vegetation and debris (Figure 1). At the time of our visit, we did not observe flow from the observable drain outlets.

Three Geobruigg ring net debris flow barriers were constructed within Parcel “C,” downslope of three drainage swales, as part of site development (Figure 1). The Geobruigg debris flow barriers were inaccessible due to significant vegetation growth within Parcel “C.” Therefore, we reviewed the current conditions of the debris flow barriers using recent aerial photography of the area. We will plan to secure the services of a subcontractor to clear an access path through the vegetation for future monitoring events. As provided in the Geobruigg manual, vegetation growing along the base of the barriers and accumulating behind the barriers will be removed by the GHAD as part of its scheduled maintenance activities.

The underground stormwater detention basin and CDS unit were observed from the manholes within and adjacent to Parcel “F” (Figure 1). At the time of our site visit, no odor was noticed, and minor vegetation and sediment were observed, which will be removed during scheduled GHAD maintenance.

The slopes were observed for evidence of slope instability, including landslides, erosion, diverted drainage, or standing water. In general, slopes appeared to be performing well, with the exception of a minor area of soil erosion above the concrete-lined drainage ditches west of 936 Coronado Circle (Site Condition B.1, Figure 1). This area will continue to be monitored to determine if severity increases to the point of requiring mitigation.

As shown in Figure 1, the limit of the GHAD is immediately upslope of the concrete-lined drainage ditches and GHAD-maintained areas do not extend to the existing barbed wire fence along the neighboring property.
