Project No.
7290.002.025

December 1, 2025

Subject: Ridgeview at Vista Glen
Santa Paula, California

SANTA PAULA GEOLOGIC HAZARD ABATEMENT DISTRICT MONITORING – FALL 2025

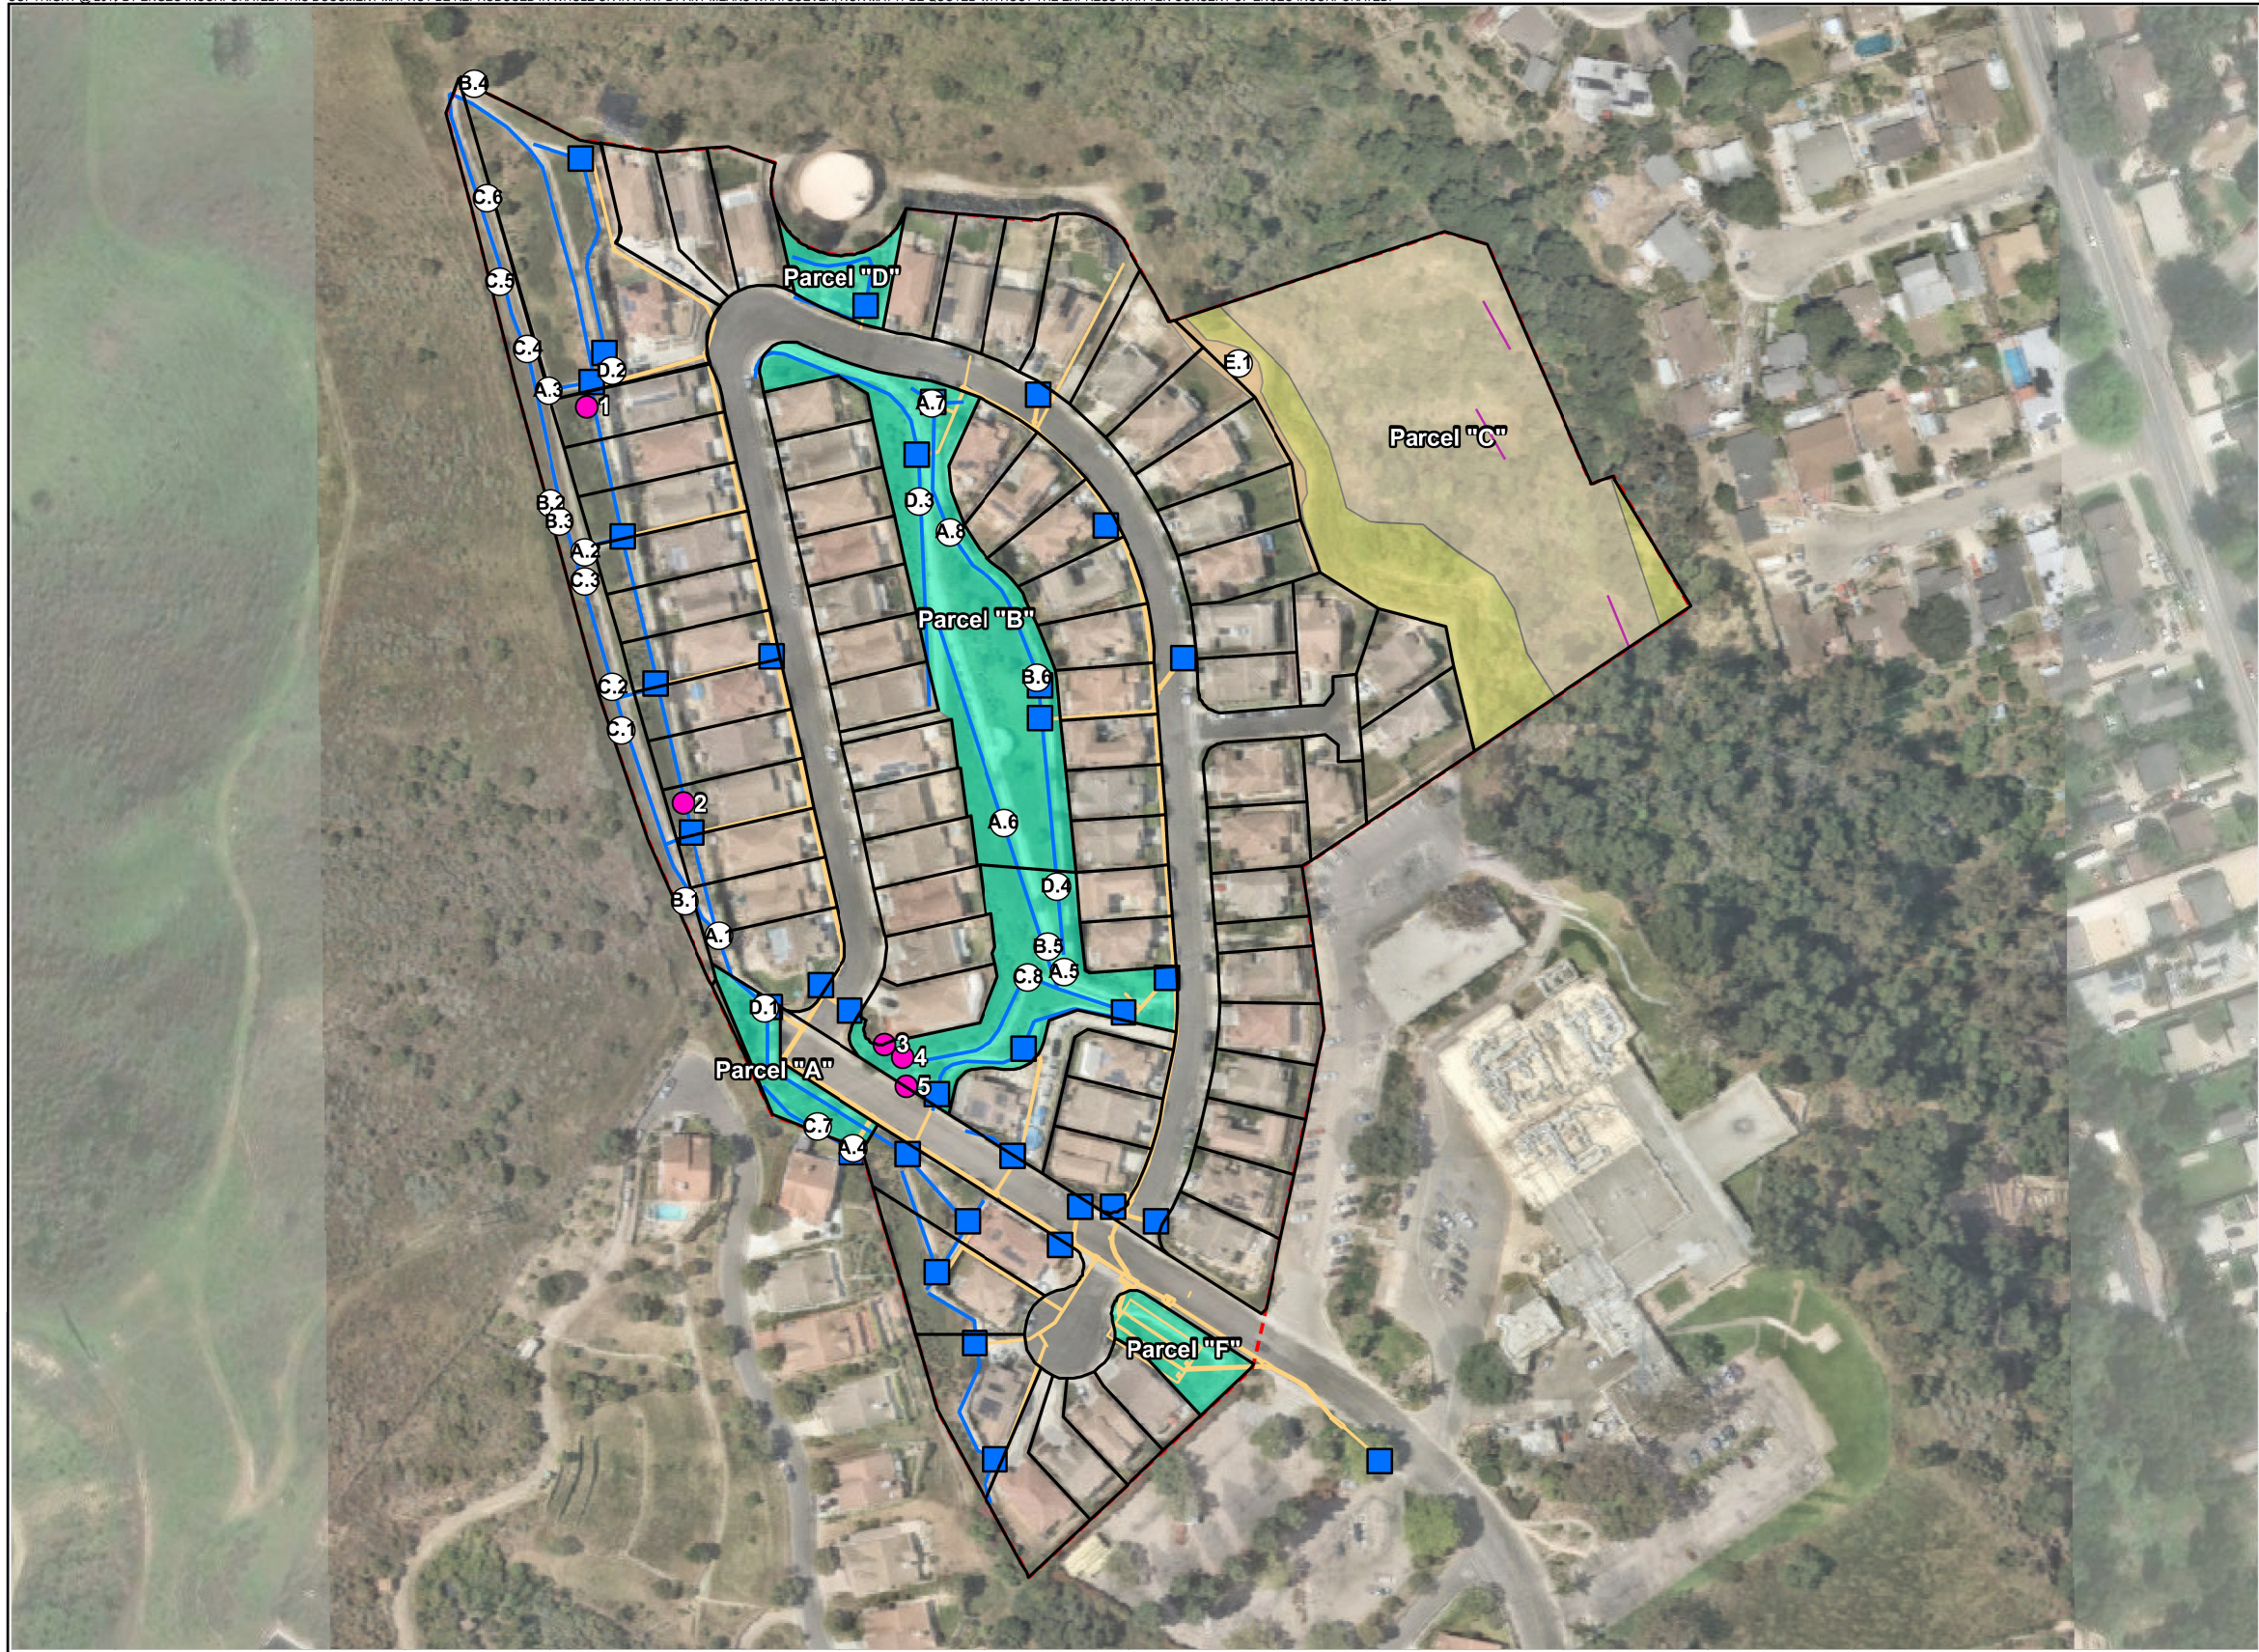
FIGURE 1

Concrete-lined surface drainage ditches were checked for accumulation of debris/sediment and for obvious distress, such as cracking or shifting of the concrete. As shown in Figure 1, there are approximately 4,000 linear feet of concrete-lined drainage ditches within the Santa Paula GHAD. Concrete-lined drainage ditches were generally clear of debris at the time of the site visit. As part of the scheduled routine site maintenance, the GHAD removes vegetation and other unwanted material from the -concrete-lined ditches prior to the winter rainy season.

Three Geobrug ring net debris flow barriers were constructed within Parcel "C," downslope of three drainage swales, as part of site development (Figure 1). The Geobrug debris flow barriers

The underground stormwater detention basin and CDS unit were observed from the manholes within and adjacent to Parcel “F” (Figure 1). At the time of our site visit, no odor was noticed.

As noted in Figure 1, GHAD responsibilities extend only to areas upslope of the concrete-lined drainage ditches; the GHAD is not responsible for the area extending to the barbed wire fence at the neighboring property line.
