**SANTA PAULA GEOLOGIC HAZARD
ABATEMENT DISTRICT (GHAD)
PLAN OF CONTROL**

SANTA PAULA, CALIFORNIA

ENGEO INCORPORATED

MARCH 10, 2008

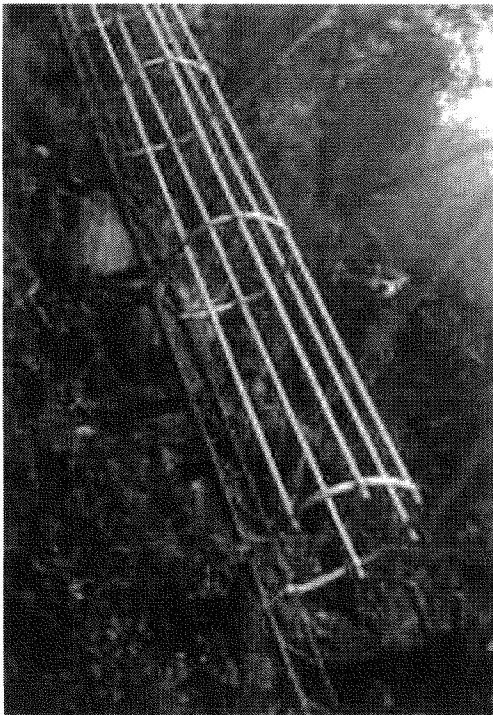
Figure 1 **Example of a ladder for climbing**

The accessibility of the barrier should be guaranteed to the extent that all load-bearing components can be inspected. The necessary infrastructure will depend on the terrain. The figure below gives an example for a secure climbing ladder.

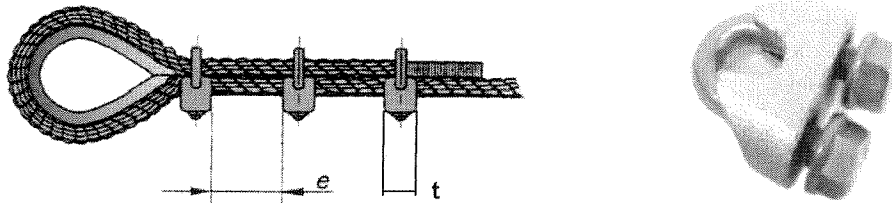
The clip stirrups ("u-bolts") are always applied on the unstressed rope end, the jaws ("saddle") always on the stressed rope ("Never saddle a dead horse").

Extract from EN 13411-5 (DIN 1142)

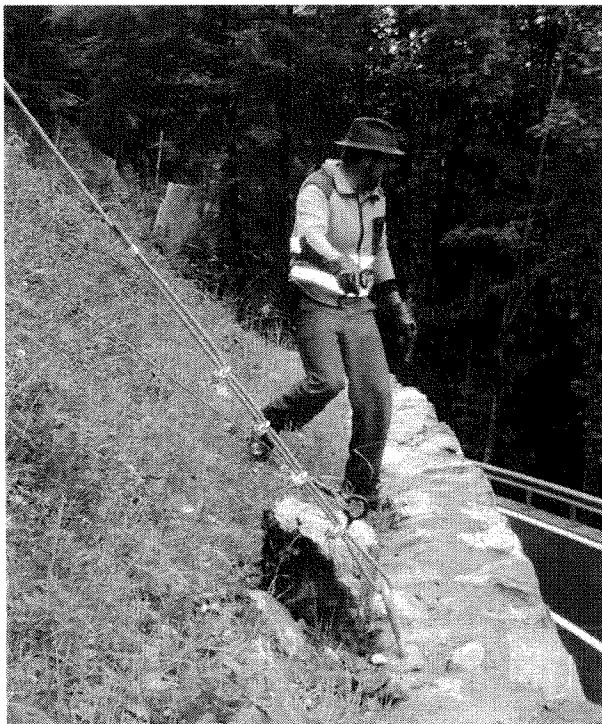
Figure 2 Emptying rocks safely (with rope secured)

The shackles on the top support rope and on the edge towards the neighboring ring nets are removed. The net can be taken down and laid upon the ground. Then the net can be manually or mechanically cleaned with a front-end loader or similar. Care must be taken not to damage the ring net. On very steep slopes, the rocks slide and roll downslope on their own after the net has been taken down. Make sure that the rocks rolling down the slope do not cause any damage (see figure 2).

Be aware that the filled ring net can be under great tension because of the weight in the net. This should be taken into consideration when removing the shackles. The net should be secured with additional ropes (three to six ropes), which are fastened above on the net (these are best applied on the second ring row), guided over the support rope and either held by workers or guided with hand winches to anchors laid uphill. On very steep slopes, the bottom edge of the net can also be secured in a similar way. Then the entire net with its contents can be laid down like a basket on safe ground.

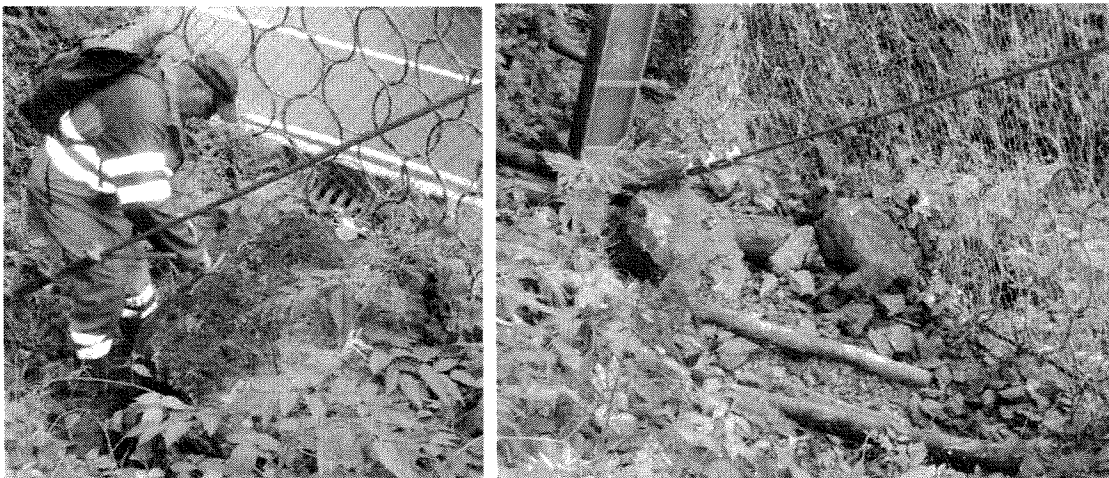
Figure 3 Breaking up a block with explosive

Large blocks that cannot be lifted out or evacuated must be broken up into smaller sizes. The following methods come into question depending on the situation:

- manual
- explosive (see figure 3)
- expansion cement ("cold explosive agent"). For this the rocks must be drilled, filled with the "propellant" (e.g., the Betonamit company) and water added. After about one day the rock is broken and can be cleared.

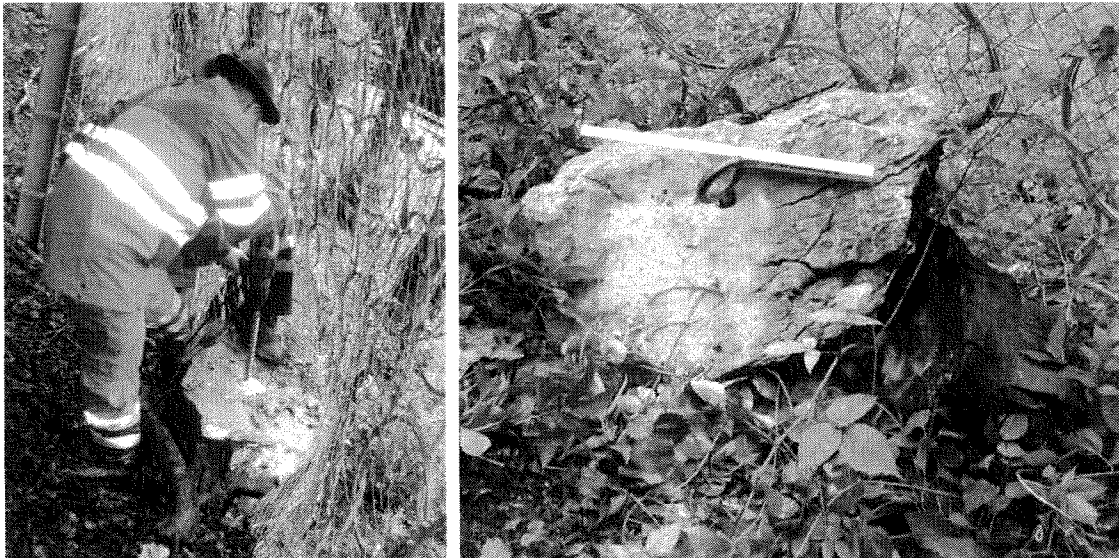
Figure 4 Providing the block with towing hooks

If a crane is available, the rocks can also be fitted with a wire hanger. For this the rocks must be drilled. The eyelet bolt can be fastened chemically (e.g., HILTI "HIT"), or a drilled-through screw can be fastened with a nut. So-called heavy-duty dowel pins, which use friction for fastening, can also be used.

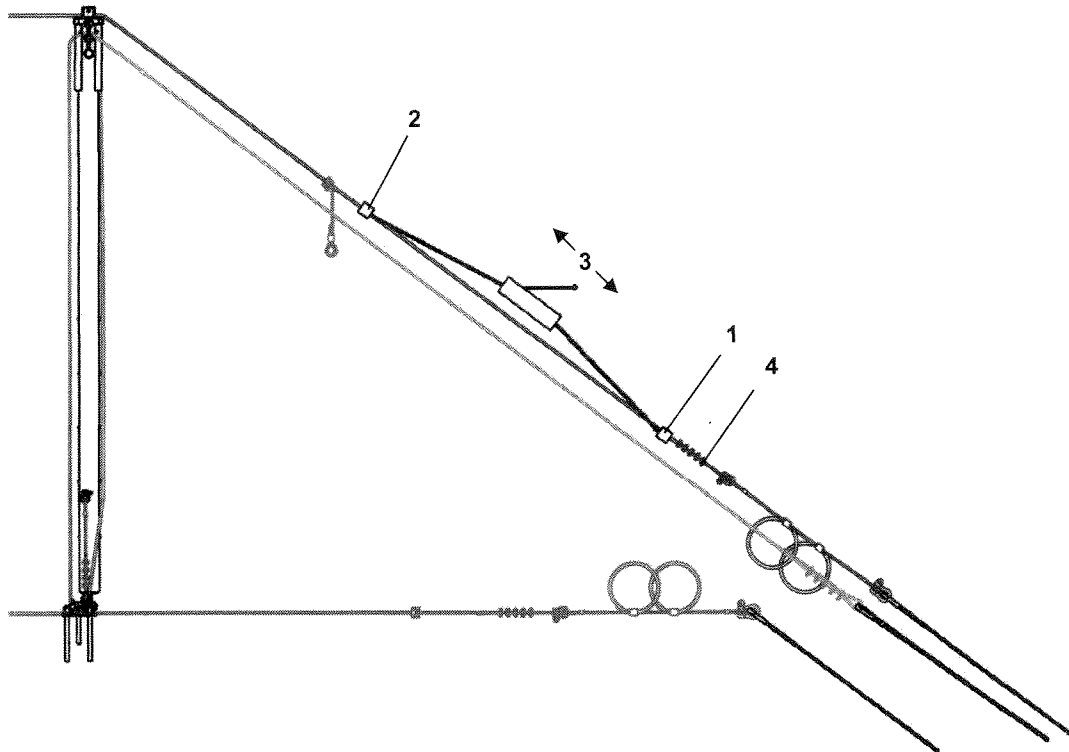
Figure 6 Tensioning sagging nets

The affected top support rope must be fastened with a hand winch on the rope end that forms a loop with the wire rope clips (1). The other end of the hand winch can be fastened on the top support rope as shown (2). The hand winch is tensioned (3). The wire rope clips are released until the rope can slide through. Then the rope is again tensioned with the hand winch. Finally the wire rope clips are tensioned with a torque wrench with the right torque value (4).

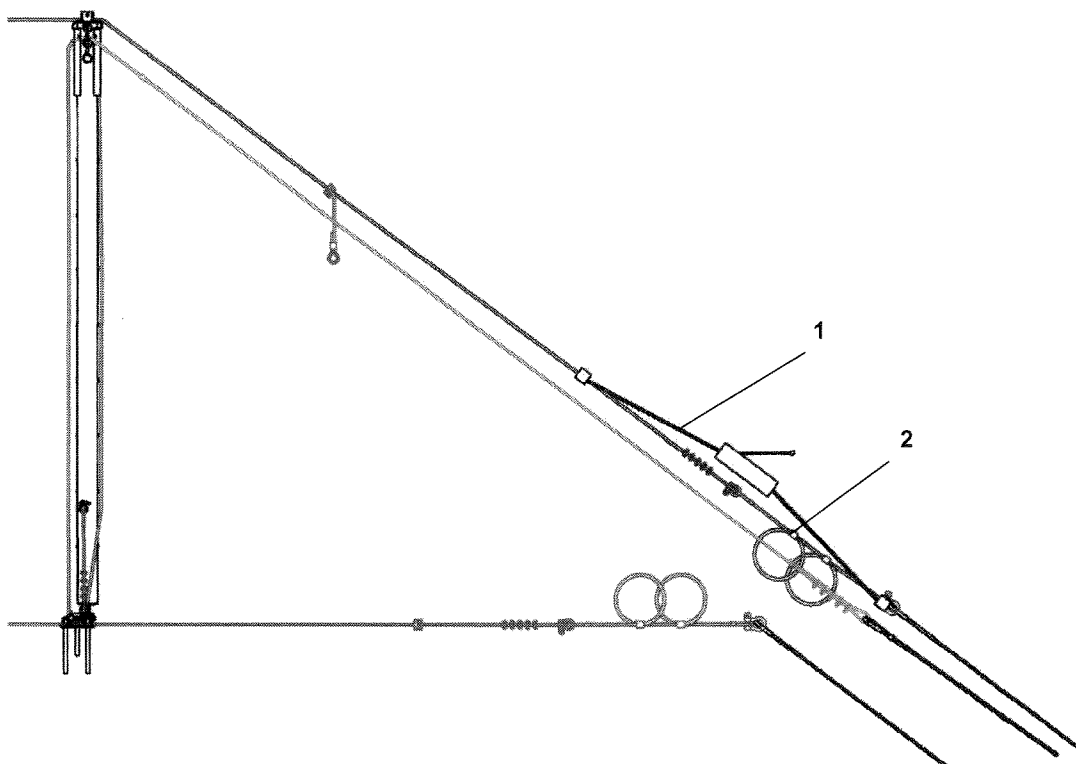
Figure 7 Replacing rope slings with brake rings

A hand winch is fastened to the support rope on one side and on the other side to the spiral rope anchor (1). The rope is tensioned until the rope sling with brake rings (2) is no longer under tension and can be replaced. After releasing the hand winch, the support rope must be retensioned as described in section 6.1.

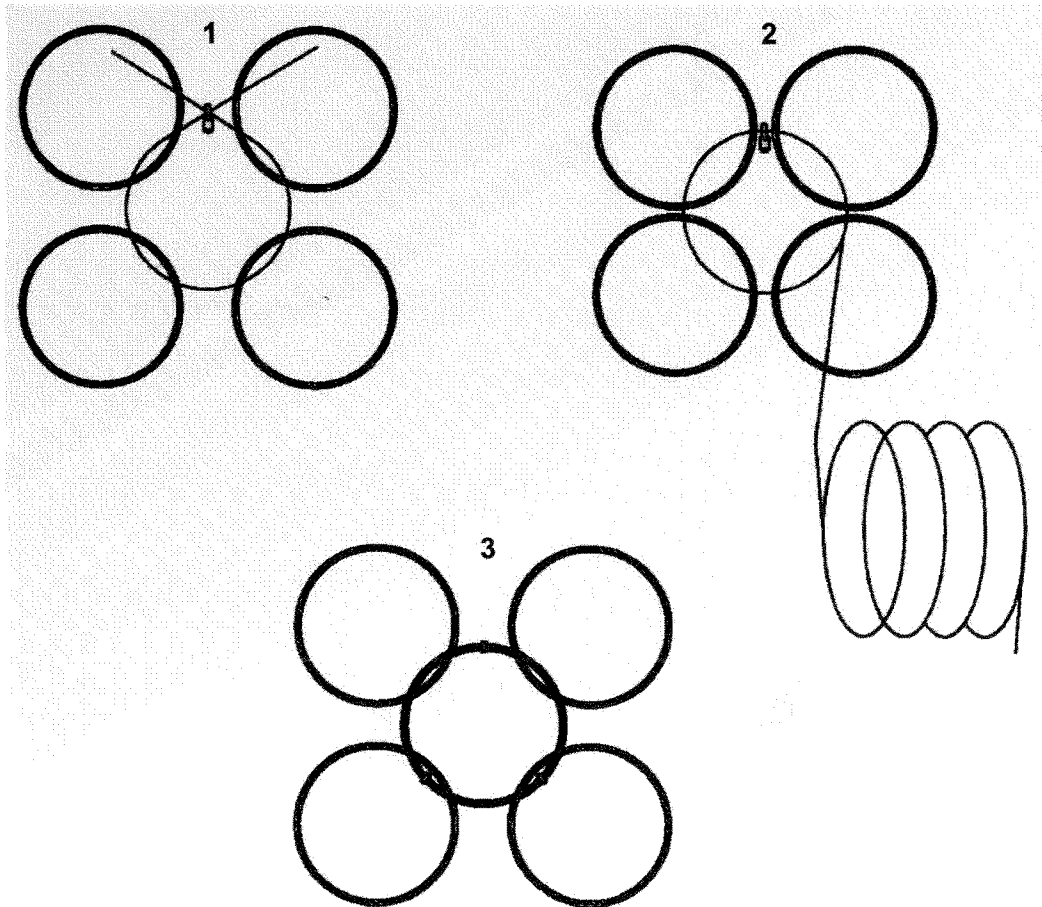
Figure 8 Replacing a Rocco ring

A portion of a replacement rope with a diameter of 4 to 8 mm is pulled through the (4) rings adjacent to the affected ring. This temporary rope is tensioned to a diameter that is smaller than the single ring, and then fastened with a wire rope clip (1). Now the ring bundle can be inserted into the four neighboring rings (2) by sticking a wire end into the neighboring rings. Then the bundle can be rotated until the entire bundle has been inserted. Then the ring bundle is fastened with three wire rope clips of the right size along the length of the ring (3). Finally the temporary rope can be released.

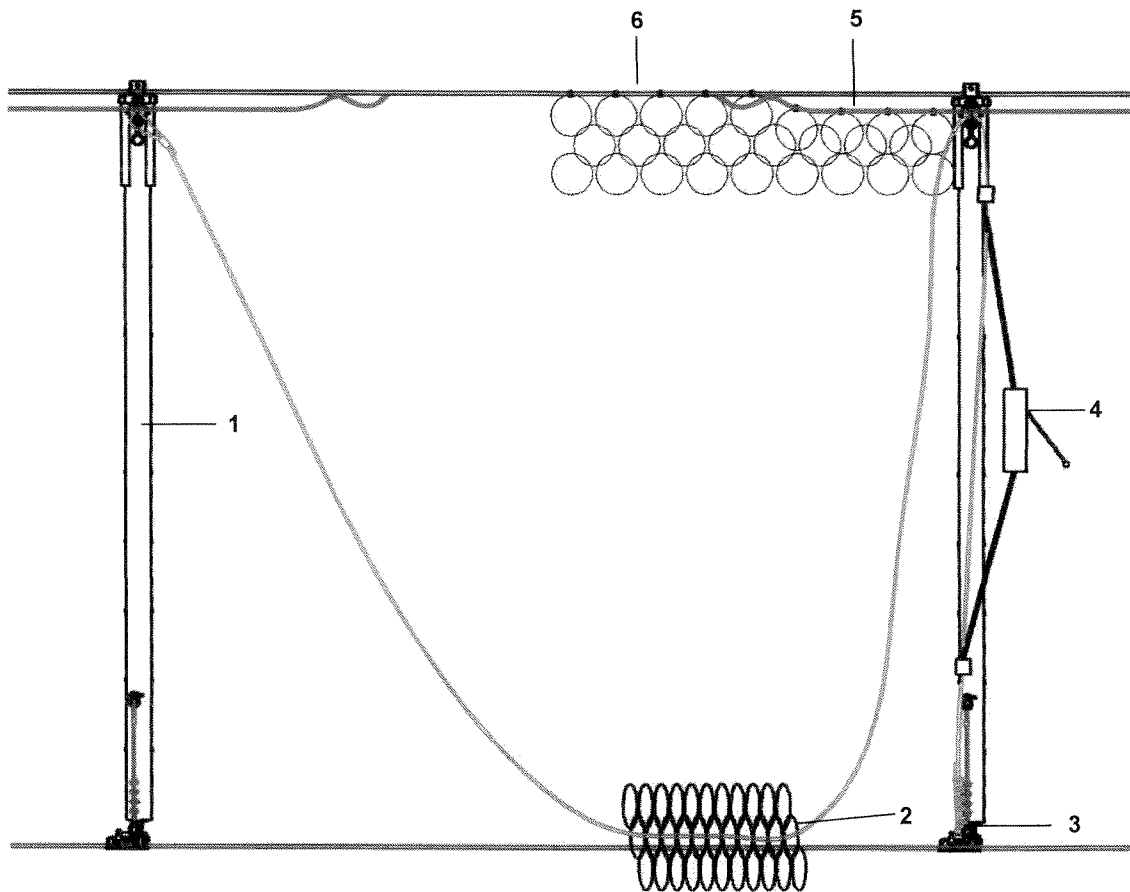
Figure 9 Replacing a Rocco net

- l) The rings at the bottom of the net are similarly fastened temporarily to the bottom support rope with 2 or 3 shackles.
- m) The nets are permanently fastened as follows: The four ROCCO rings next to the post are installed on the RUNTOP rope (5), the rest on the support rope (6). The corner rings with the end posts are fastened according to the product manual of the specific barrier.

- n) This procedure is repeated until all nets are fastened on the support ropes and connected to each other.

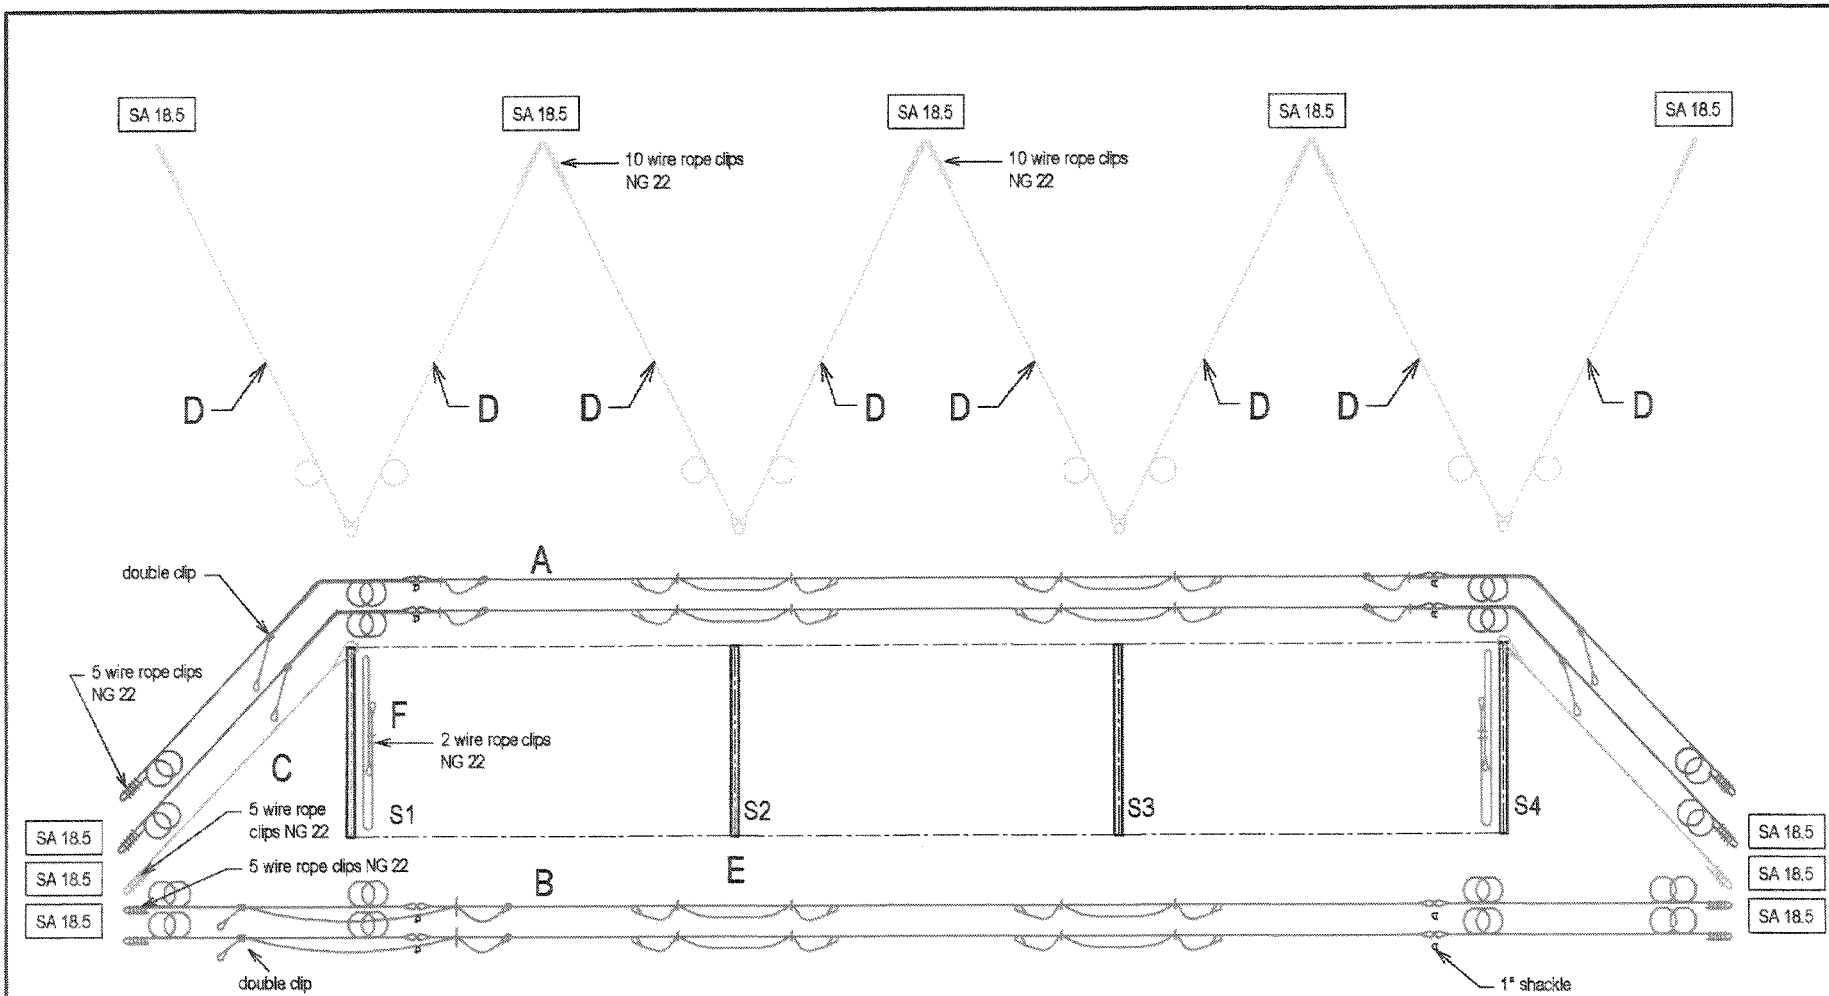
- A: Top support rope Ø22 mm with 8 brake rings GS-8002
- B: Bottom support rope Ø22 mm with 8 brake rings GS-8002
- C: Lateral anchor rope Ø22 mm
- D: Upslope anchor rope Ø22 mm GEOBINEX with 1 brake ring GN-9017
- E: RUNTOP rope Ø22 mm, L=7.6m
- F: Vertical rope Ø22 mm

modification:	M: %	substitute for: GS-1061 e ed. 26.01.05
		replaced by:
RXI-200 Rope assembly Energy class 7 (2000 kJ)		drawn 19.04.05 ol
		checked 19.04.05 ze
		edition 19.04.05 of
FATZER AG CH-8580 Romanshorn		GS-1061 e

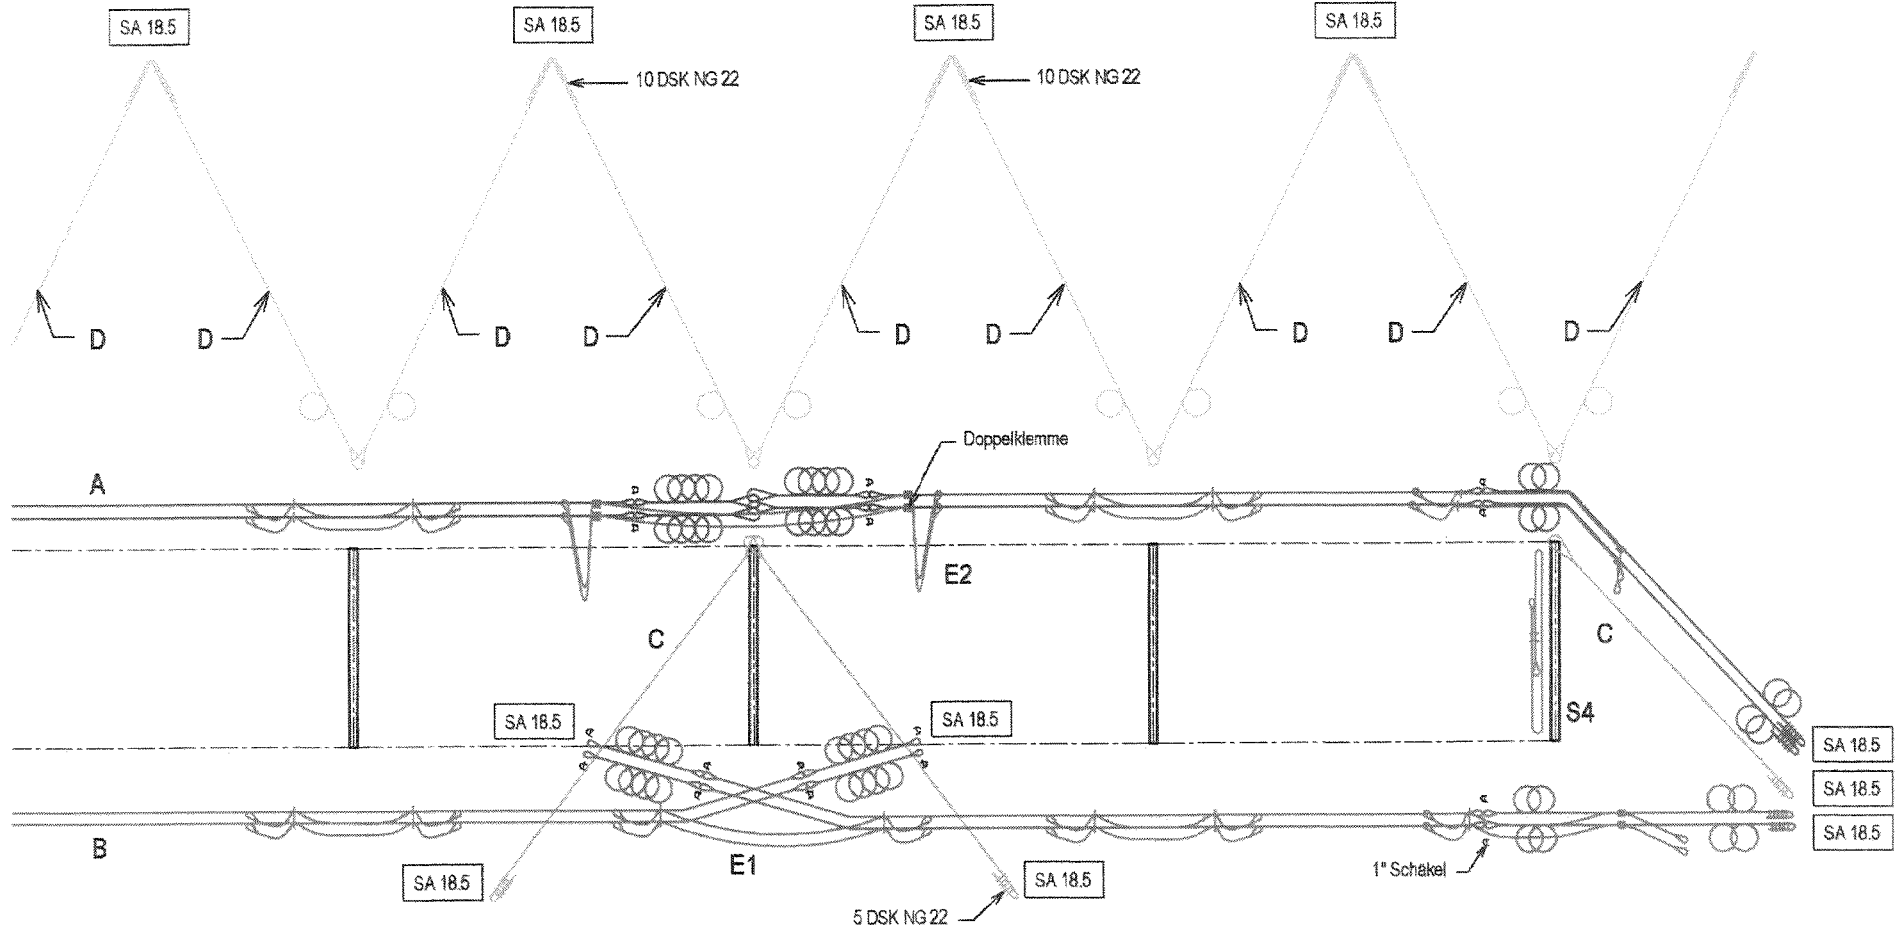
- A: Oberes Tragseil Ø22 mm mit 8 Bremsringen GS-8002
- B: Unteres Tragseil Ø22 mm mit 8 Bremsringen GS-8002
- C: Seitenabspannung Ø22 mm
- ⊖ Rückhalteseil Ø22 mm GEOBINEX mit Bremsring GN-9017
- E: Laufseil Ø22 mm E1: L=7.6 m, E2: L=15.6 m
- F: Vertikalseil Ø22 mm
- G: Zwischenabspannung Ø22 mm

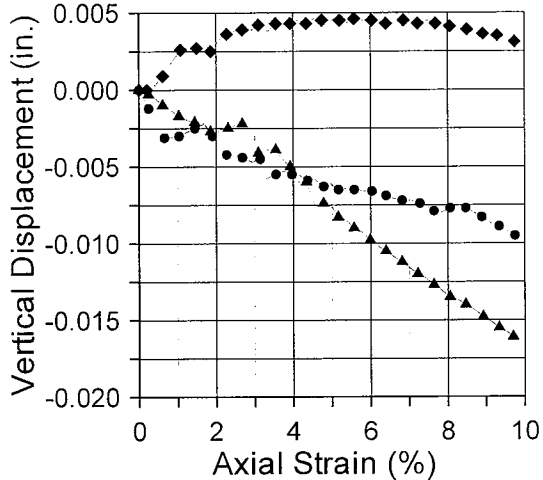
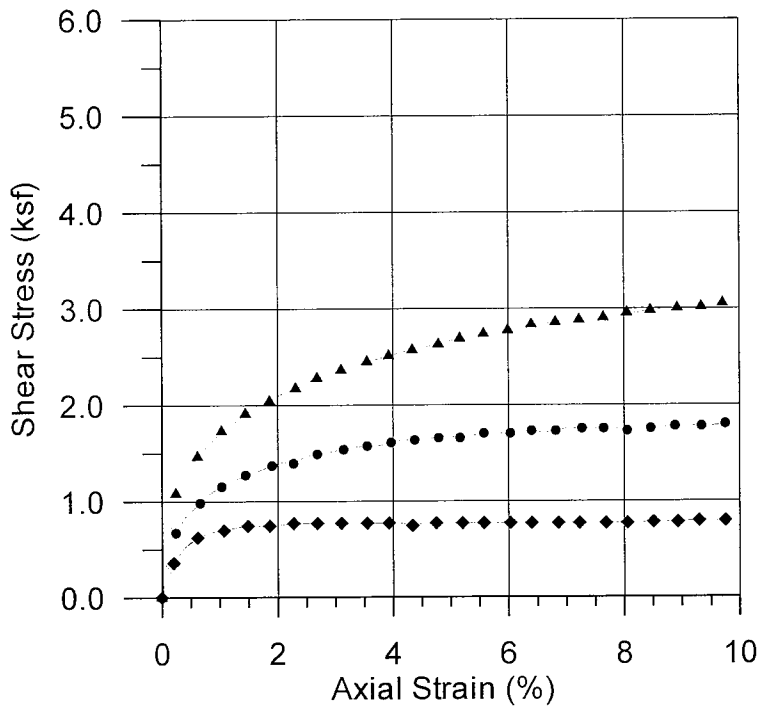
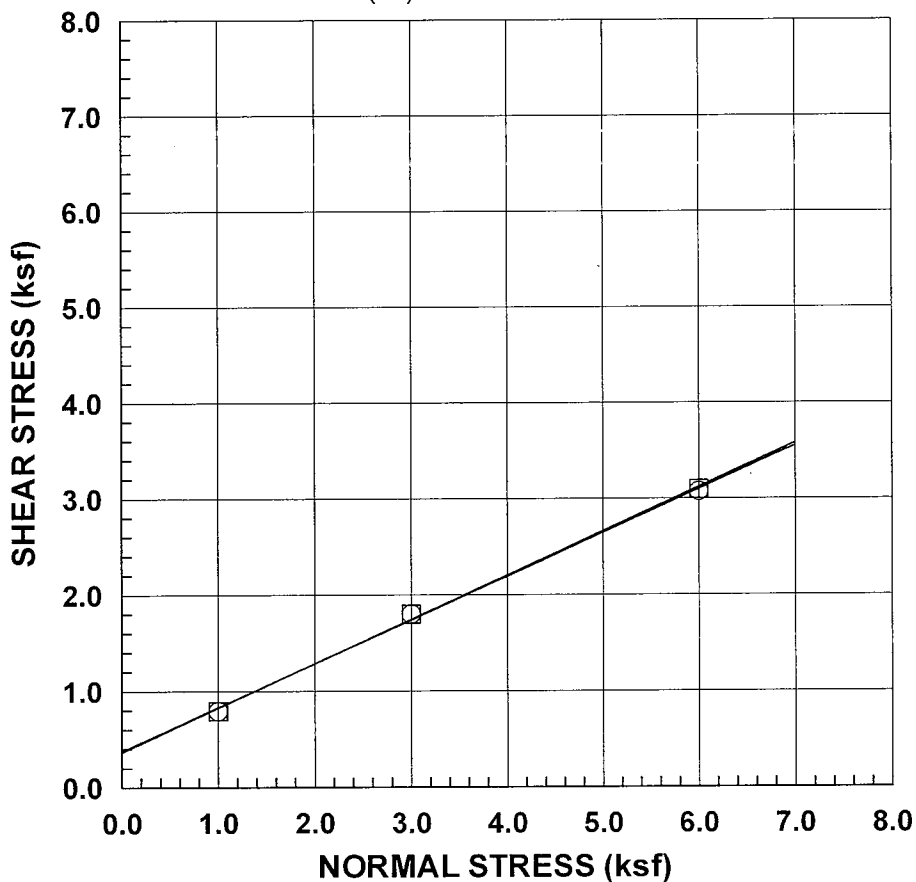
Job No: 1489.00
 Plate No: B-1

Specimen No.	1	2	3
Normal Stress (ksf)	1	3	6
Peak Stress (ksf)	0.792	1.8	3.096
Peak Displacement (in)	9.091	9.731	10.33
Ultimate Stress (ksf)	0.792	1.8	3.072
Ultimate Displacement (in)	0.246	0.245	0.245
Initial Dry Density	111.1	111.2	111.2
Initial Moisture Content (%)	9.744	9.673	9.673
Strain Rate (in/min)	0.020

Strain Legend	
◆	1 ksf
●	3 ksf
▲	6 ksf

Strength Legend	
□	Peak
○	Ultimate

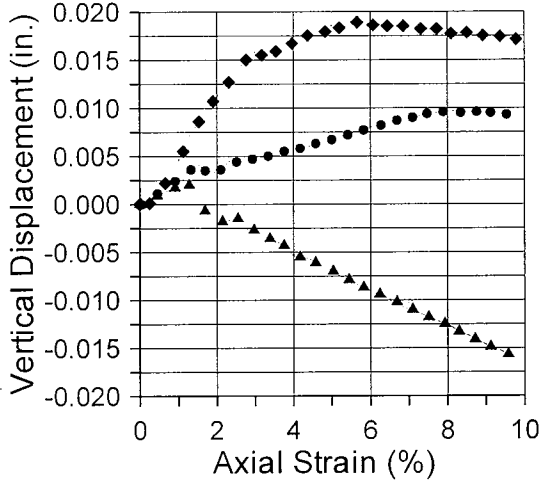
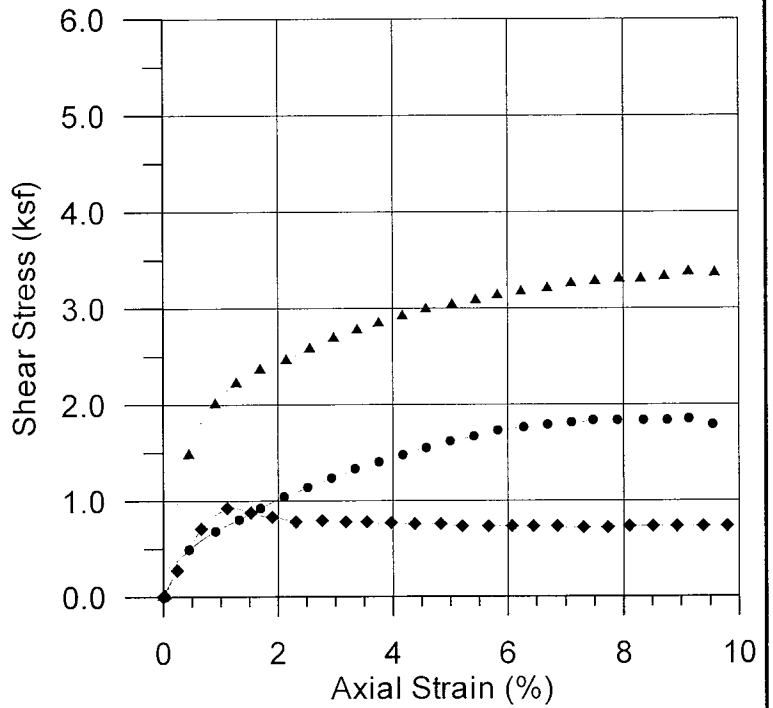
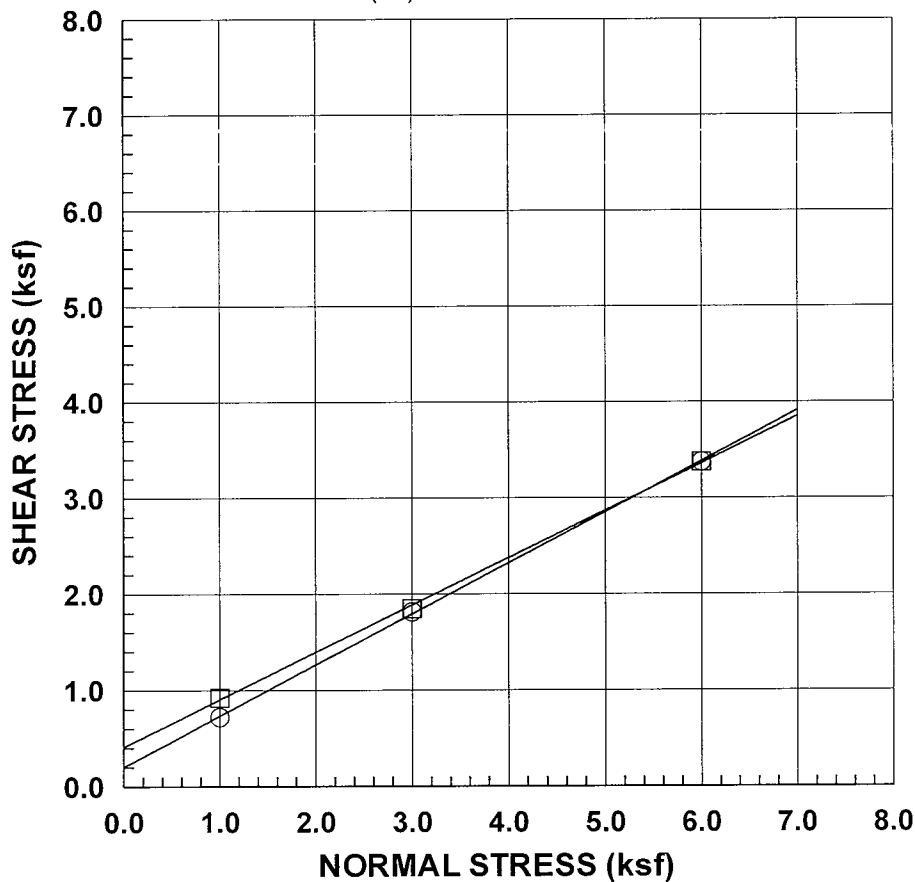
ALBUS-KEEFE & ASSOCIATES, INC. GEOTECHNICAL CONSULTANTS	DIRECT SHEAR	Job No: 1489.00
		Plate No: B-2

Specimen No.	1	2	3
Normal Stress (ksf)	1	3	6
Peak Stress (ksf)	0.924	1.848	3.372
Peak Displacement (in)	1.095	9.132	9.132
Ultimate Stress (ksf)	0.72	1.812	3.372
Ultimate Displacement (in)	0.246	0.242	0.242
Initial Dry Density	116.5	116.5	116.5
Initial Moisture Content (%)	9.487	9.487	9.487
Strain Rate (in/min)	0.050

Strain Legend	
◆	1 ksf
●	3 ksf
▲	6 ksf

Strength Legend	
□	Peak
○	Ultimate

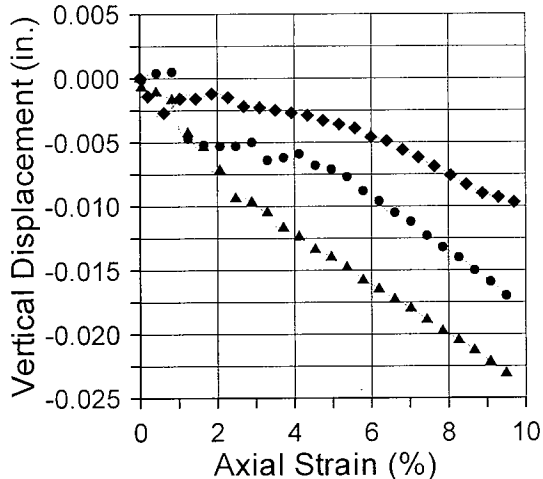
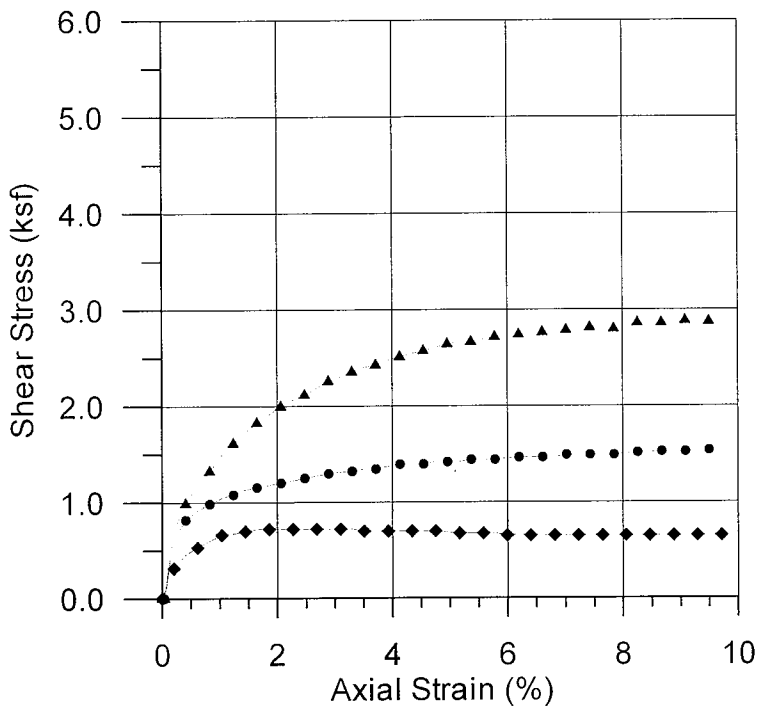
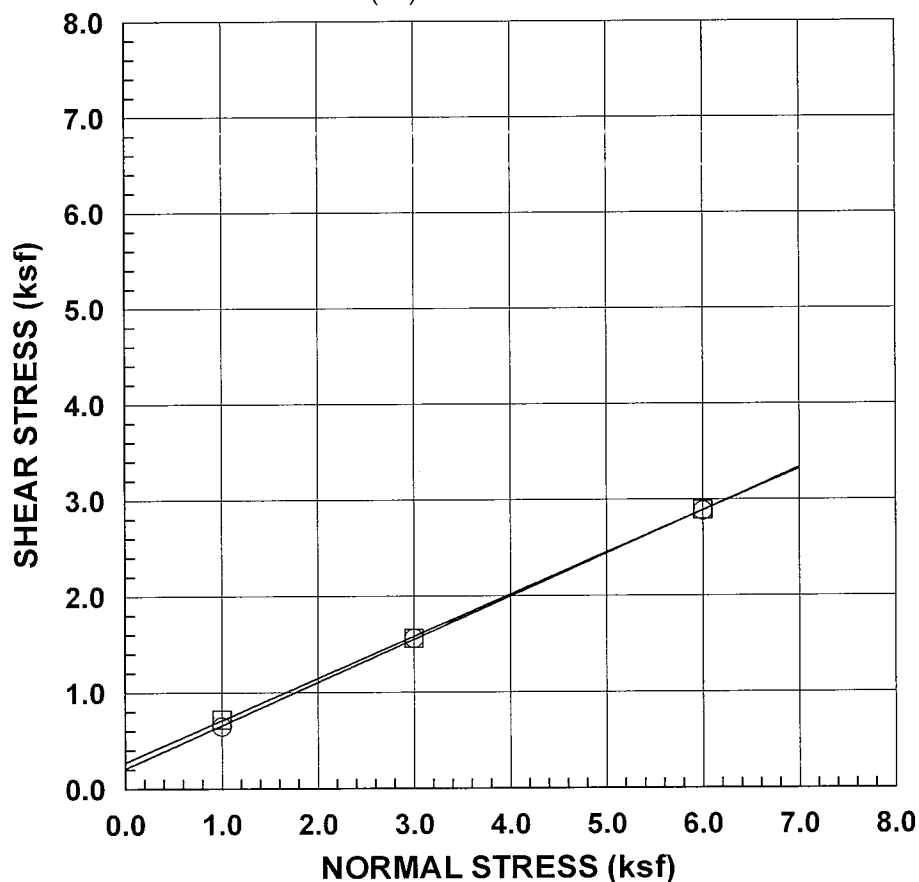
ALBUS-KEEFE & ASSOCIATES, INC. GEOTECHNICAL CONSULTANTS	DIRECT SHEAR	Job No: 1489.00
		Plate No: B-3

Specimen No.	1	2	3
Normal Stress (ksf)	1	3	6
Peak Stress (ksf)	0.72	1.56	2.892
Peak Displacement (in)	1.653	9.917	10.12
Ultimate Stress (ksf)	0.648	1.56	2.88
Ultimate Displacement (in)	0.245	0.24	0.24
Initial Dry Density	106.7	106.7	106.7
Initial Moisture Content (%)	11.47	11.47	11.47
Strain Rate (in/min)	0.010

Strain Legend	
◆	1 ksf
●	3 ksf
▲	6 ksf

Strength Legend	
□	Peak
○	Ultimate

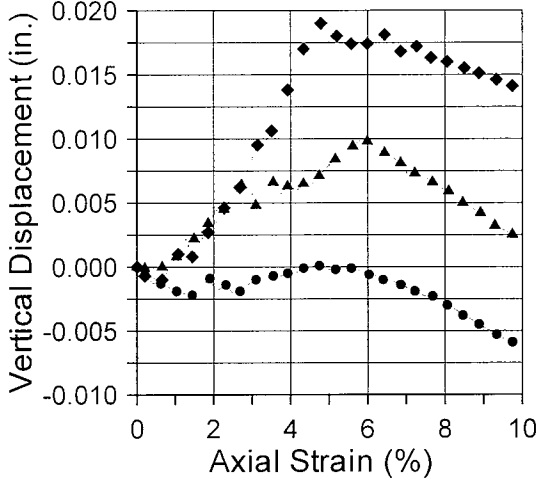
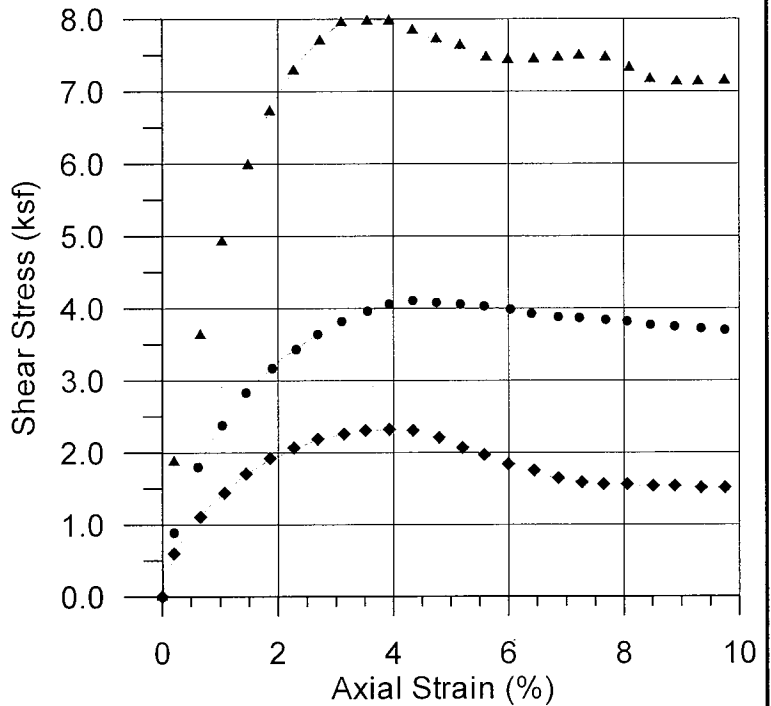
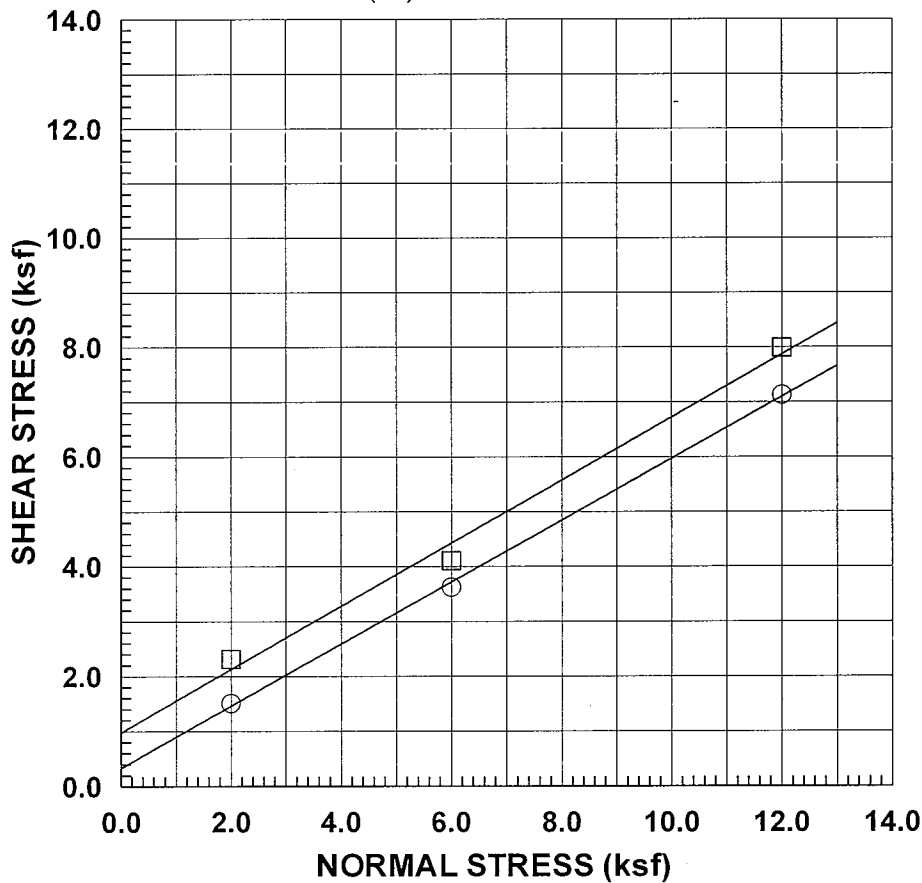
Specimen No.	1	2	3
Normal Stress (ksf)	1	2	4
Peak Stress (ksf)	2.316	4.104	7.992
Peak Displacement (in)	4.339	4.339	0
Ultimate Stress (ksf)	1.512	3.624	7.128
Ultimate Displacement (in)	0.245	0.246	0.246
Initial Dry Density	113.1	111.7	111.5
Initial Moisture Content (%)	16.35	16.35	16.35
Strain Rate (in/min)	0.020

Strain Legend	
◆	2 ksf
●	6 ksf
▲	12 ksf

Strength Legend	
□	Peak
○	Ultimate

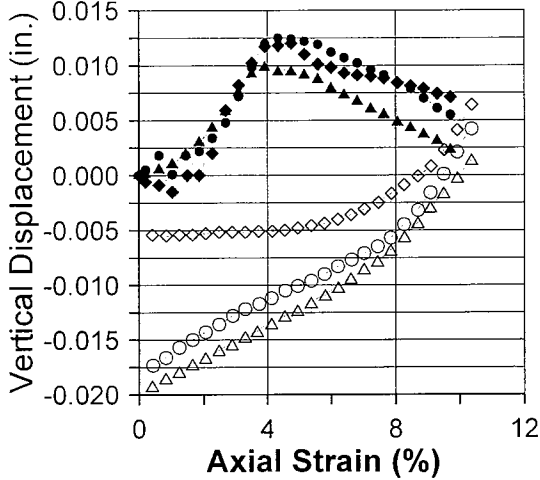
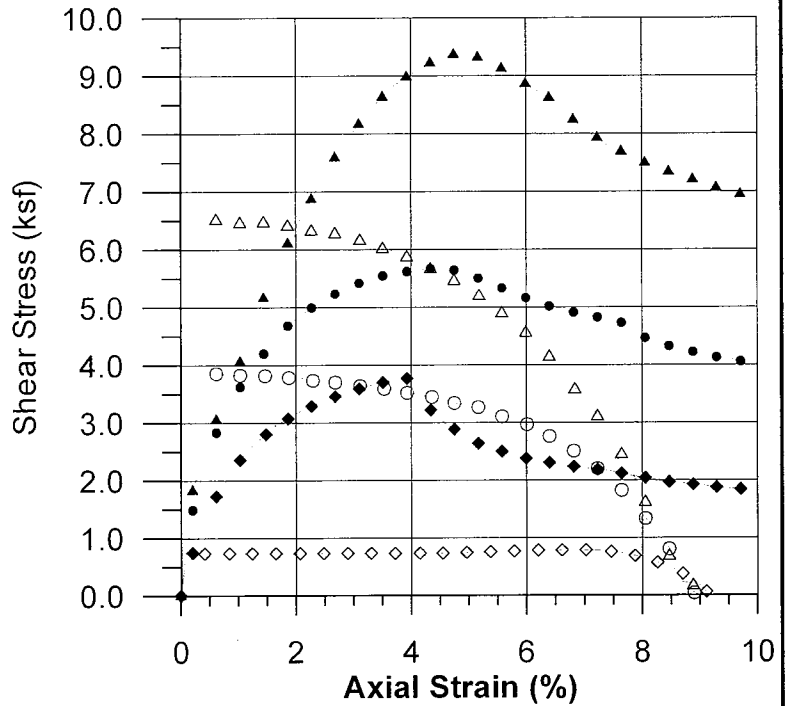
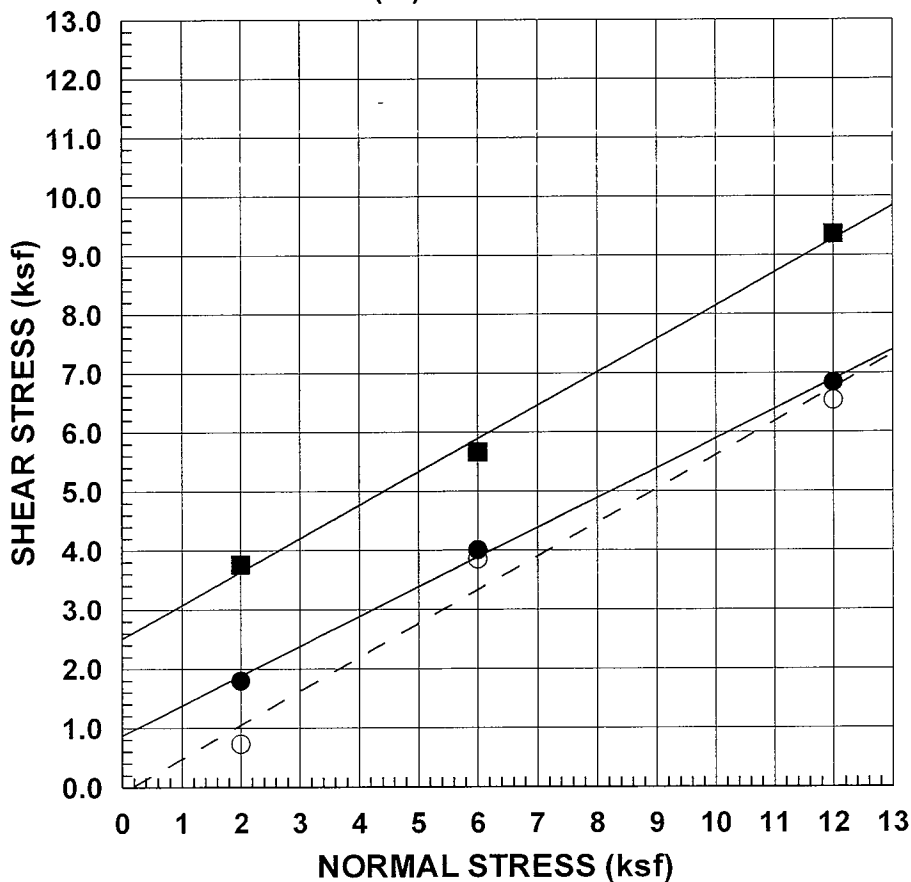
ALBUS-KEEFE & ASSOCIATES, INC. GEOTECHNICAL CONSULTANTS	DIRECT SHEAR	Job No: 1489.00
		Plate No: B-5

Specimen No.	1	2	3
Normal Stress (ksf)	2	6	12
Peak Stress (ksf)	3.768	5.664	9.359
Peak Displacement (in)	3.926	4.339	4.752
Ultimate Stress (ksf)	1.8	4.008	6.84
Ultimate Displacement (in)	0.245	0.245	0.245
Initial Dry Density	101.2	99.58	101.4
Initial Moisture Content (%)	30.71	30.71	30.71
Strain Rate (in/min)	0.010

Strain Legend	
◆	2 ksf
●	6 ksf
▲	12 ksf
◇	2ksf reshear
○	6ksf reshear
△	12ksf reshear

Strength Legend	
■	Peak
●	Ultimate
○	Reshear Ultimate

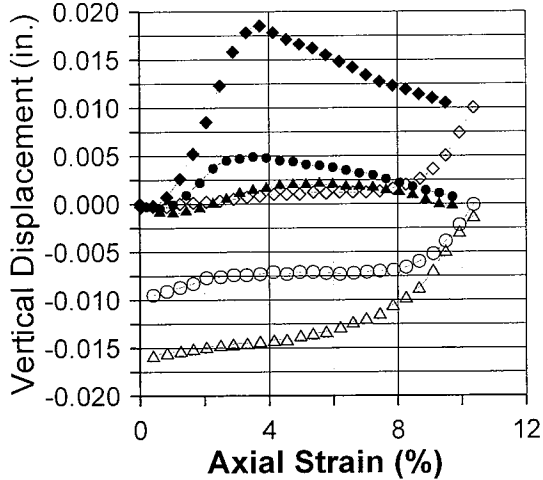
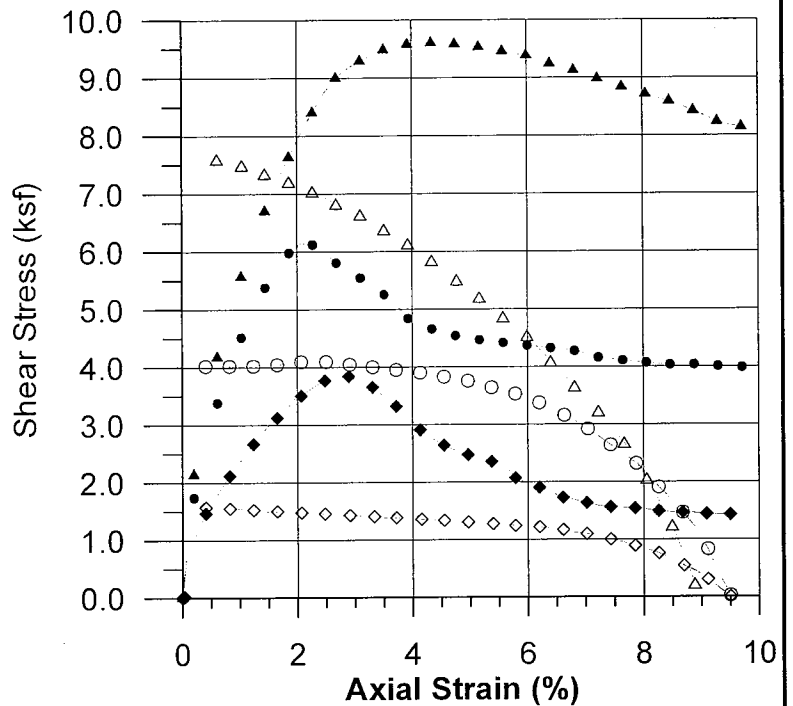
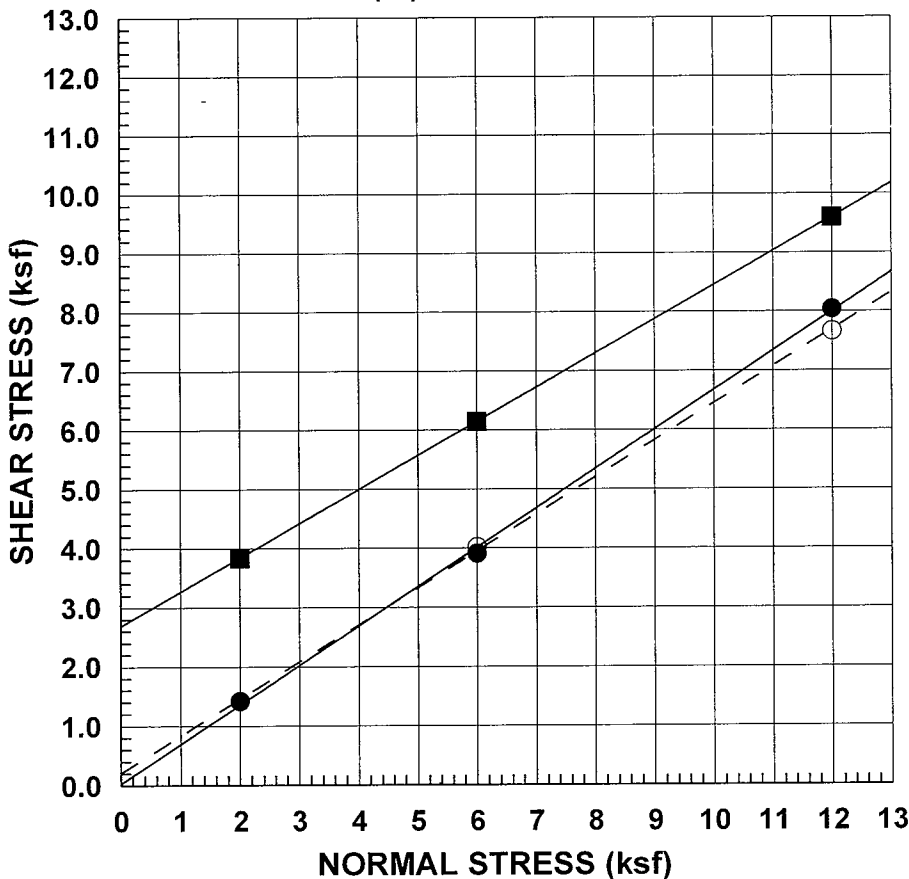
ALBUS-KEEFE & ASSOCIATES, INC. GEOTECHNICAL CONSULTANTS	DIRECT SHEAR	Job No: 1489.00
		Plate No: B-6

Specimen No.	1	2	3
Normal Stress (ksf)	2	6	12
Peak Stress (ksf)	3.84	6.144	9.599
Peak Displacement (in)	2.686	2.066	4.339
Ultimate Stress (ksf)	1.416	3.912	8.04
Ultimate Displacement (in)	0.24	0.245	0.245
Initial Dry Density	119.7	118.8	118.6
Initial Moisture Content (%)	13.7	13.7	13.7
Strain Rate (in/min)	0.010

Strain Legend	
◆	2 ksf
●	6 ksf
▲	12 ksf
◇	2ksf reshear
○	6ksf reshear
△	12ksf reshear

Strength Legend	
■	Peak
●	Ultimate
○	Reshear Ultimate

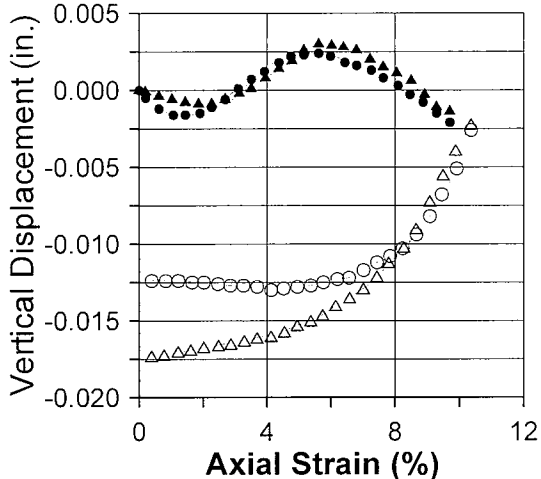
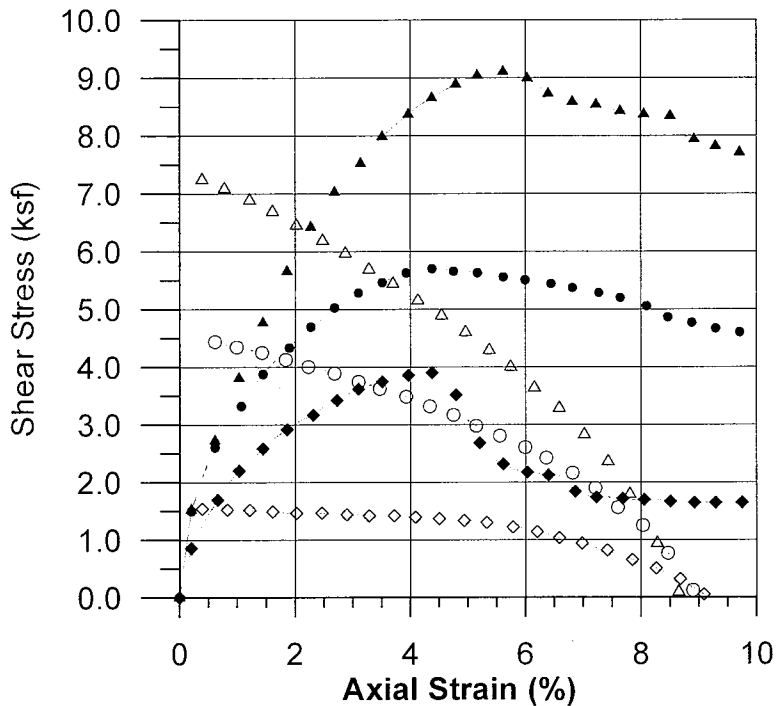
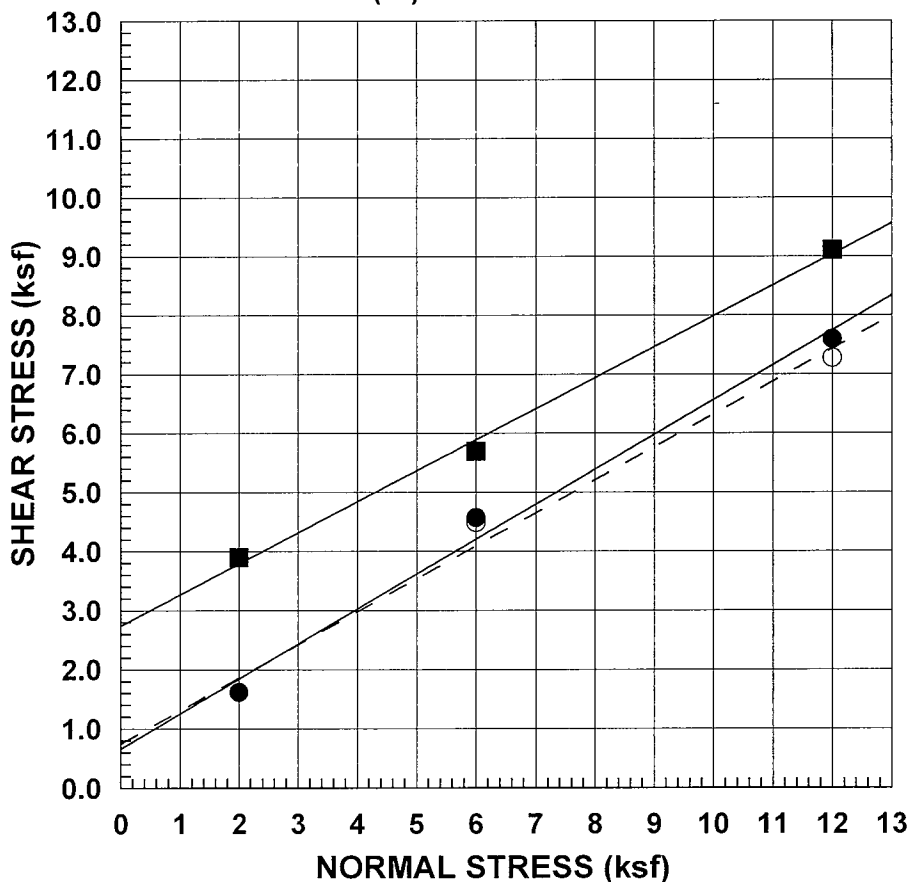
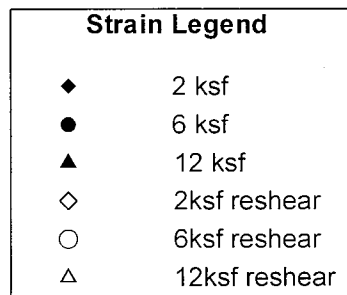
Plate No: B-7

Specimen No.	1	2	3
Normal Stress (ksf)	2	6	12
Peak Stress (ksf)	3.9	5.7	9.107
Peak Displacement (in)	0	4.339	4.752
Ultimate Stress (ksf)	1.62	4.572	7.596
Ultimate Displacement (in)	0.245	0.246	0.245
Initial Dry Density	118.8	119.6	119.3
Initial Moisture Content (%)	13.37	13.37	13.37
Strain Rate (in/min)	0.020

SAMPLE LOCATION	SAMPLE TYPE	SAMPLE DESCRIPTION
HS-6 @ 27'	UNDIST-SAT-RESHEAR	Sandy Silt (ML) some Gravel
