**SANTA PAULA GEOLOGIC HAZARD
ABATEMENT DISTRICT (GHAD)
PLAN OF CONTROL**

SANTA PAULA, CALIFORNIA

ENGEO INCORPORATED

MARCH 10, 2008

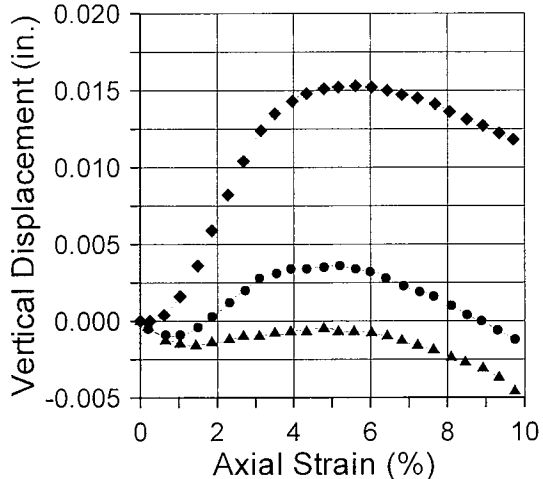
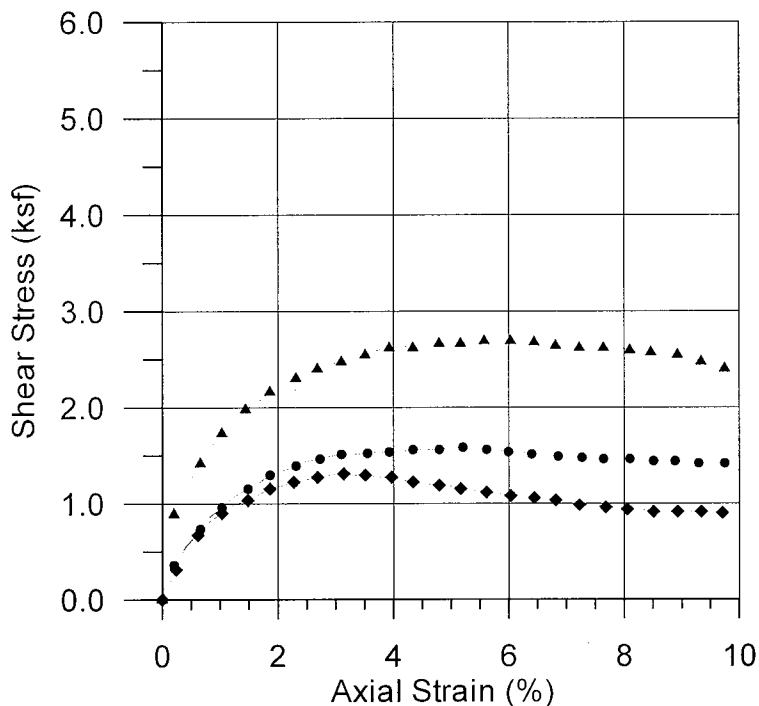
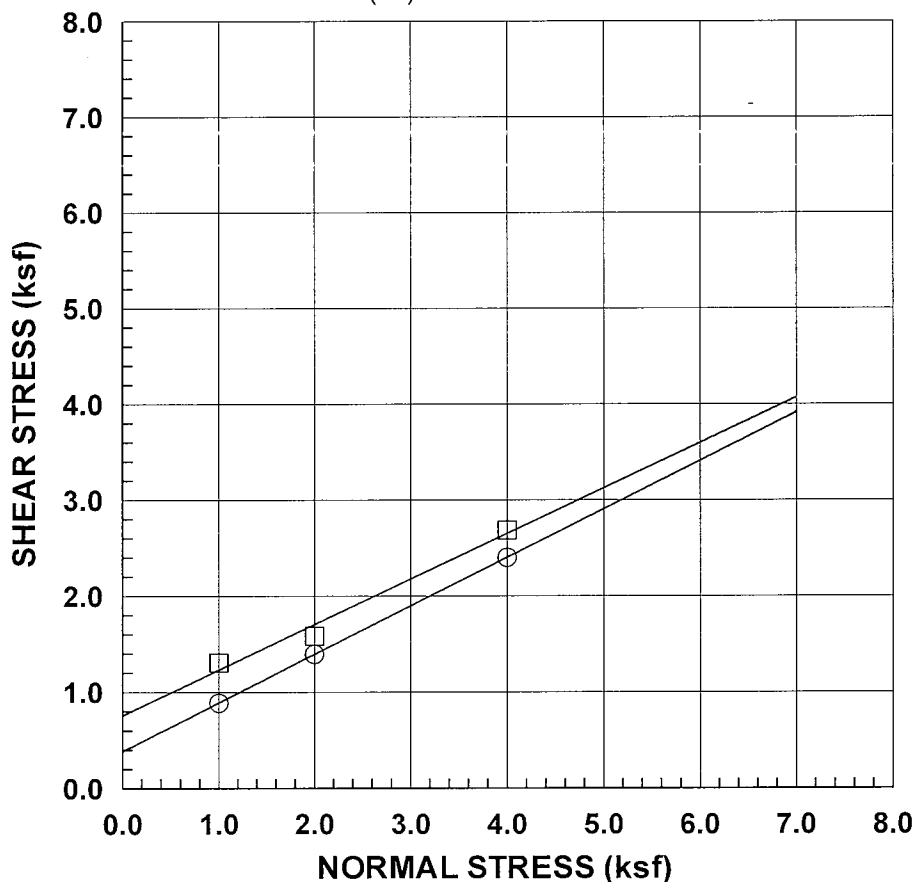
ALBUS-KEEFE & ASSOCIATES, INC. GEOTECHNICAL CONSULTANTS	DIRECT SHEAR	Job No: 1489.00
		Plate No: B-8

Specimen No.	1	2	3
Normal Stress (ksf)	1	2	4
Peak Stress (ksf)	1.308	1.584	2.688
Peak Displacement (in)	0	0	5.579
Ultimate Stress (ksf)	0.888	1.392	2.4
Ultimate Displacement (in)	0.246	0.246	0.245
Initial Dry Density	109.9	110.2	109.7
Initial Moisture Content (%)	18.63	18.63	18.63
Strain Rate (in/min)	0.020

Strain Legend	
◆	1 ksf
●	2 ksf
▲	4 ksf

Strength Legend	
□	Peak
○	Ultimate

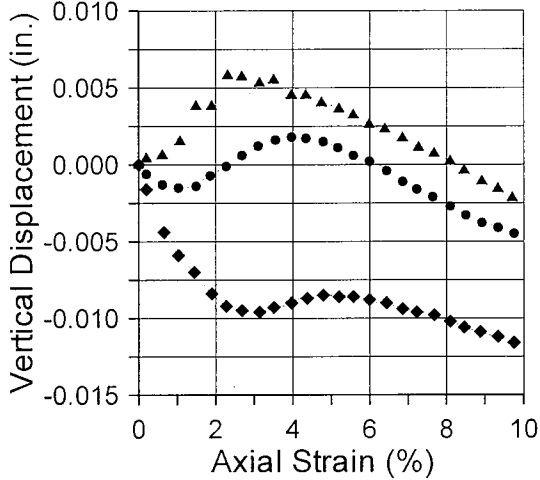
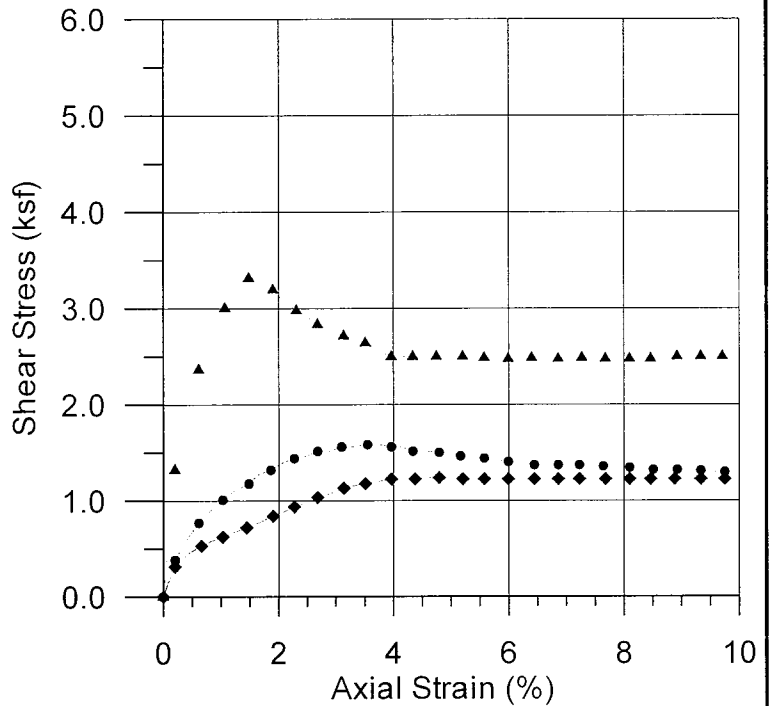
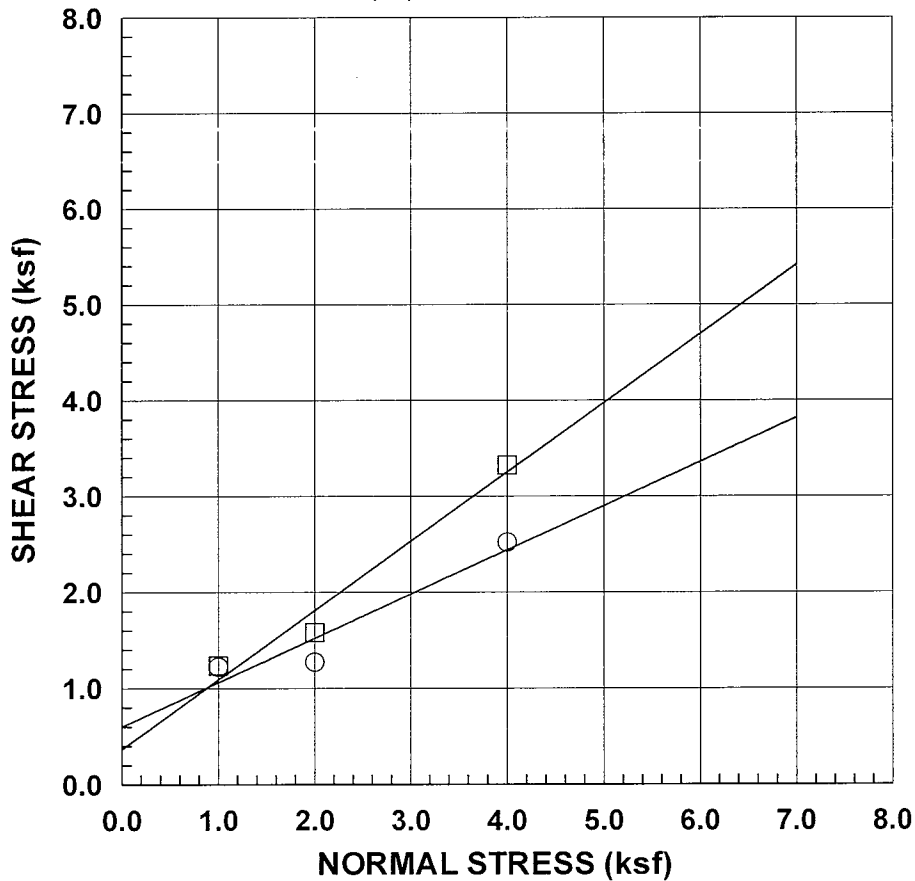
ALBUS-KEEFE & ASSOCIATES, INC. GEOTECHNICAL CONSULTANTS	DIRECT SHEAR	Job No: 1489.00
		Plate No: B-9

Specimen No.	1	2	3
Normal Stress (ksf)	1	2	4
Peak Stress (ksf)	1.236	1.584	3.324
Peak Displacement (in)	4.566	0	1.653
Ultimate Stress (ksf)	1.224	1.272	2.52
Ultimate Displacement (in)	0.245	0.245	0.245
Initial Dry Density	103.3	106.4	106.6
Initial Moisture Content (%)	19.43	19.43	19.43
Strain Rate (in/min)	0.020

Strain Legend	
◆	1 ksf
●	2 ksf
▲	4 ksf

Strength Legend	
□	Peak
○	Ultimate

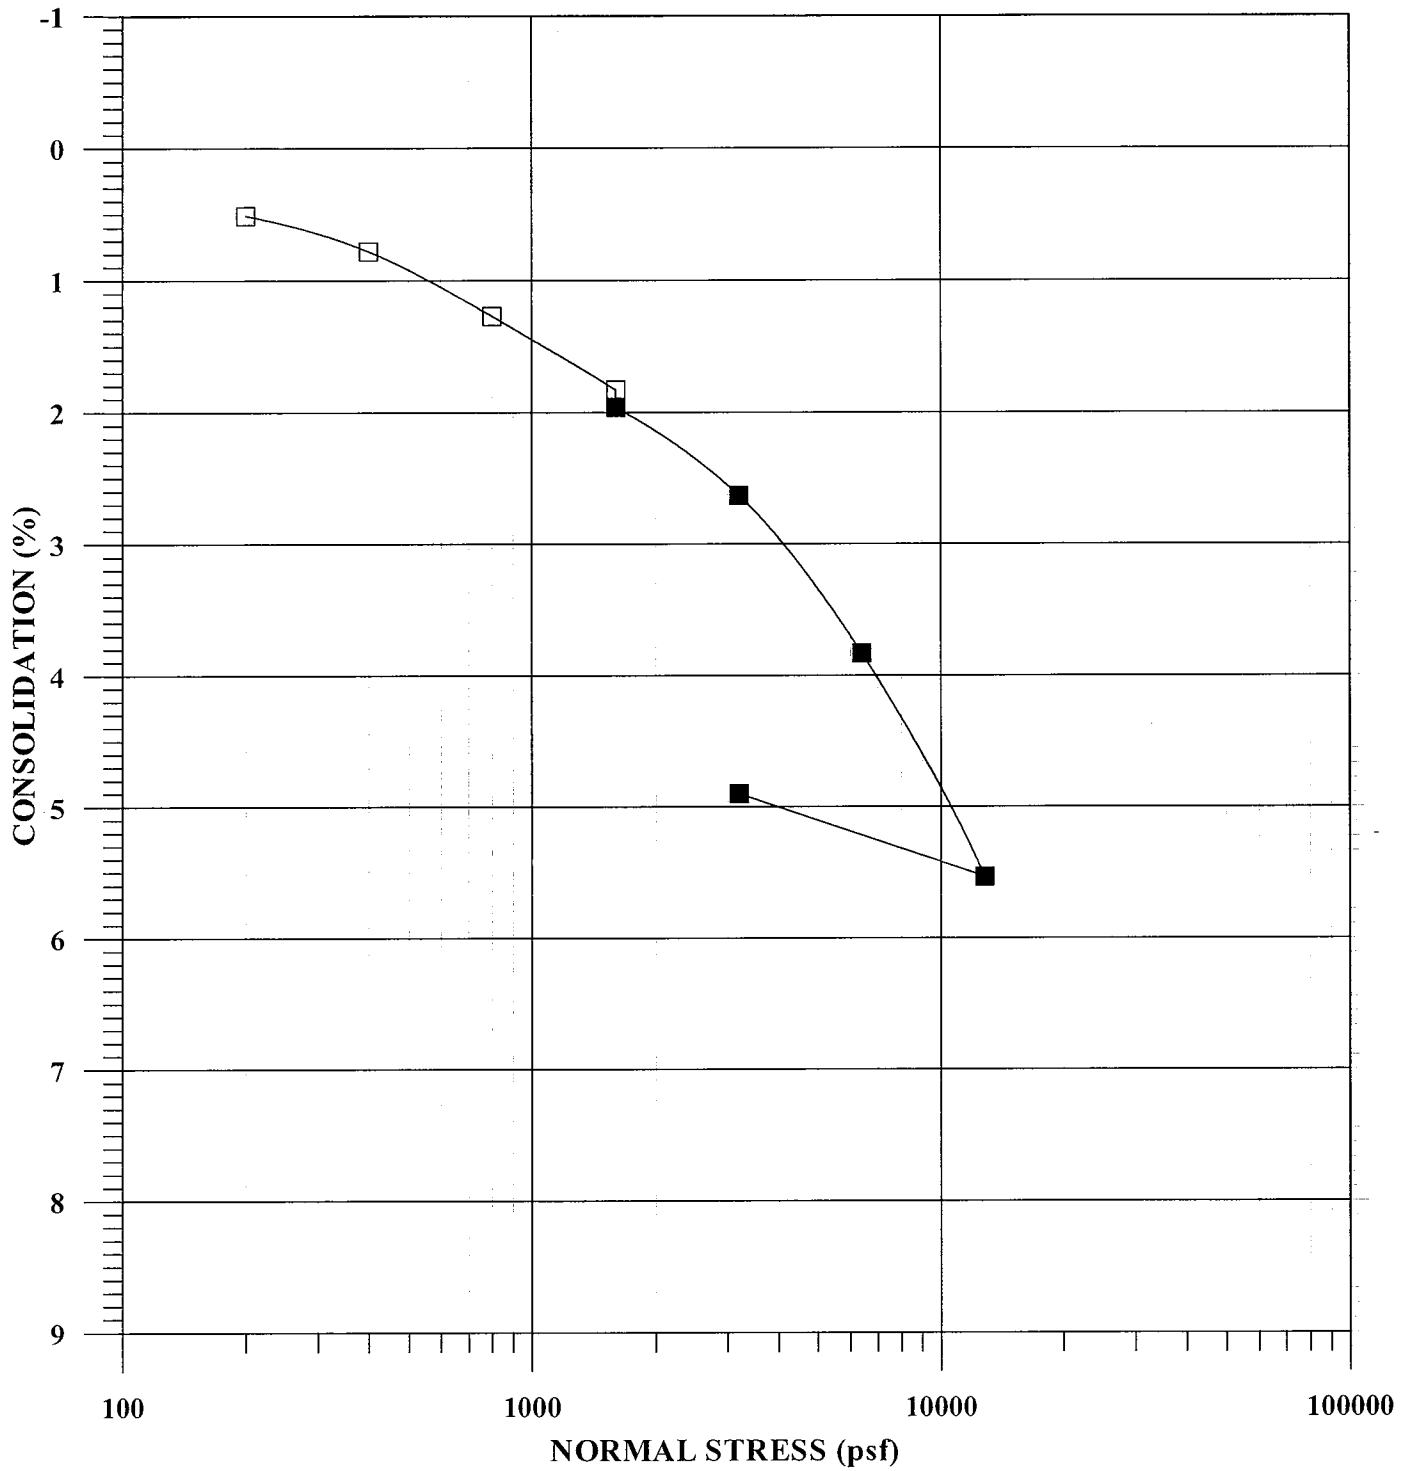
ALBUS-KEEFE & ASSOCIATES, INC. GEOTECHNICAL CONSULTANTS	CONSOLIDATION TEST RESULTS	Job No: 1489.00
		Figure No: B-10

Sample Location:	HS-1	Initial Dry Density (pcf):	106.9	Legend □ Field Moisture ■ Saturated
Sample Depth:	7'	Initial Moisture Content (%):	16.3	
Classification:		Final Moisture Content (%):	18.5

Consolidation tests were performed in general accordance with ASTM D 2435-96. Axial loads were applied in several increments to a laterally restrained 1-inch-high sample. Loads were applied in a geometric progression by doubling the previous load, and the resulting deformations were recorded at selected time intervals. The test samples were inundated at a surcharge loading approximately equal to the existing or proposed total overburden pressures in order to evaluate the effects of a sudden increase in moisture content (hydroconsolidation potential). Results of these tests are graphically presented on Plates B-10 through B-26.

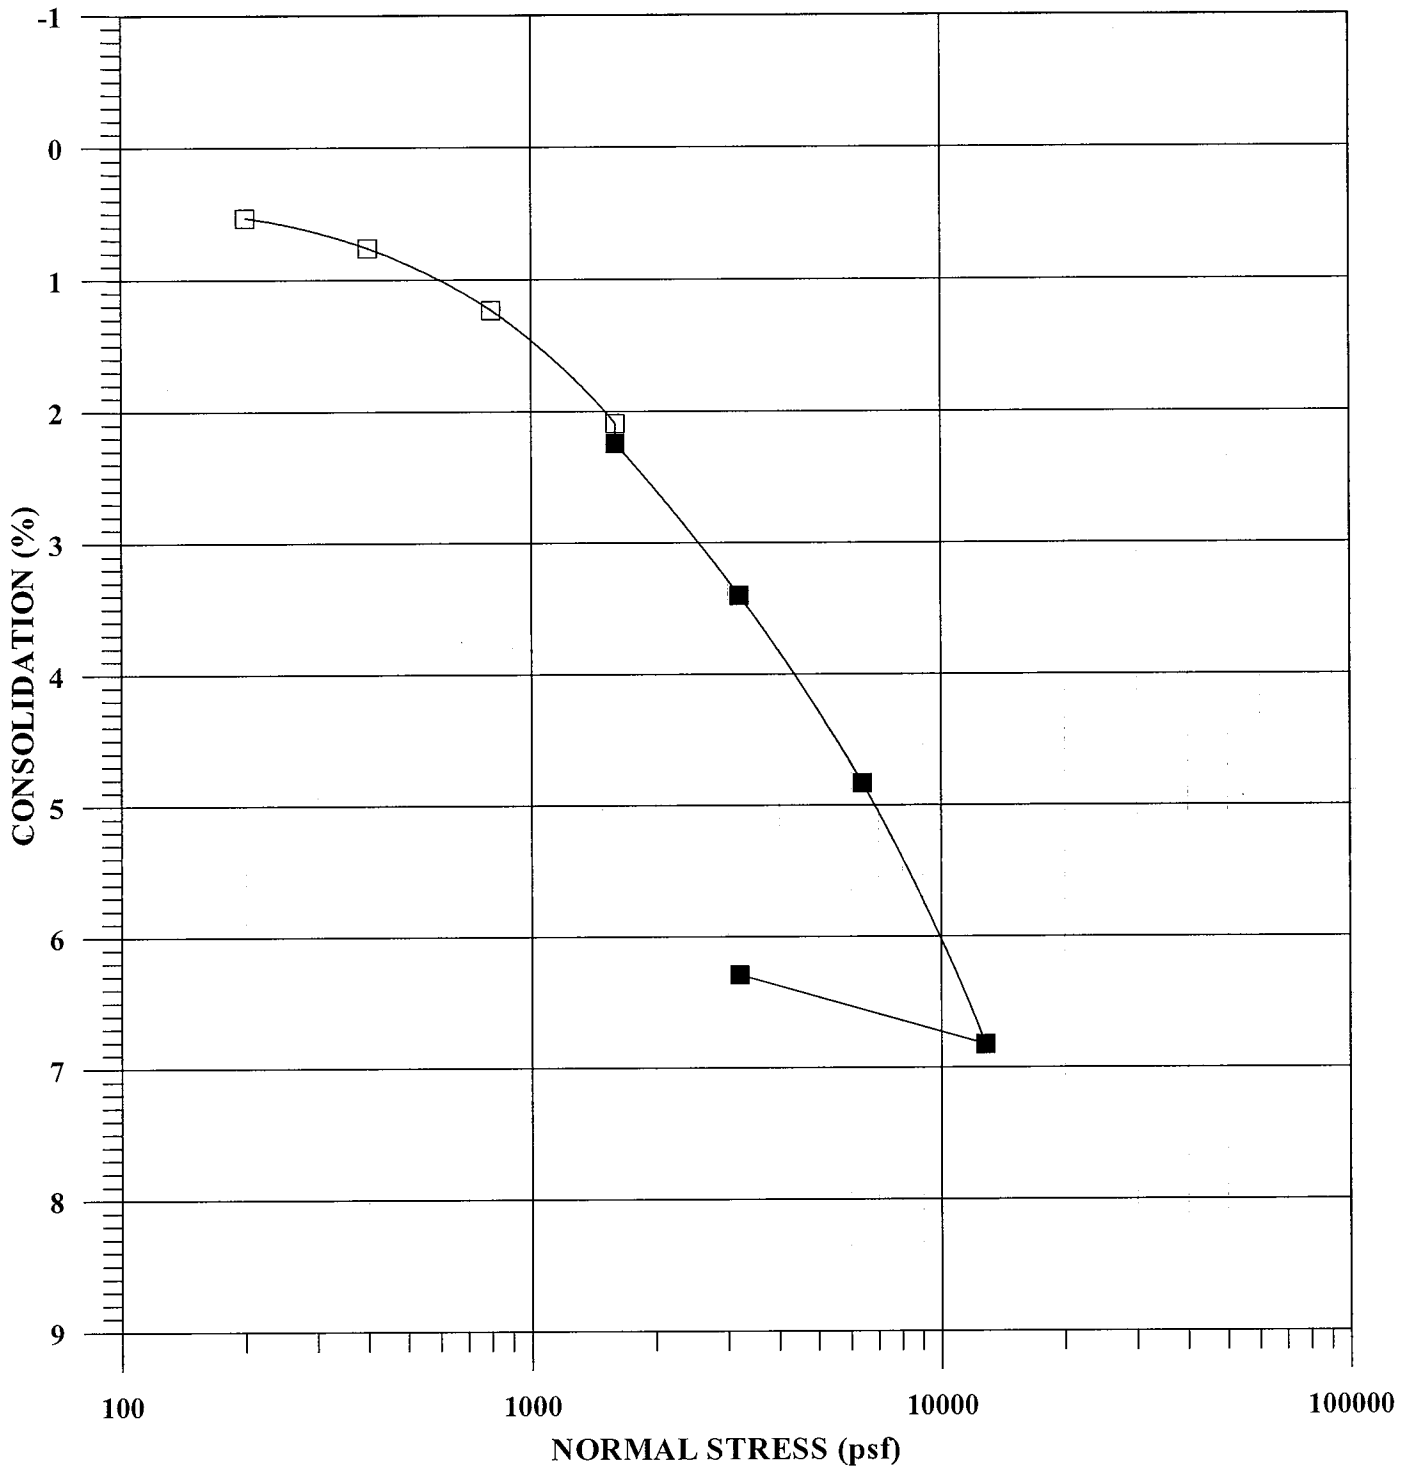
ALBUS-KEEFE & ASSOCIATES, INC. GEOTECHNICAL CONSULTANTS	CONSOLIDATION TEST RESULTS	Job No: 1489.00
		Figure No: B-11

Sample Location:	HS-1	Initial Dry Density (pcf):	108.1	Legend □ Field Moisture ■ Saturated
Sample Depth:	10'	Initial Moisture Content (%):	16.4	
Classification:		Final Moisture Content (%):	18.9

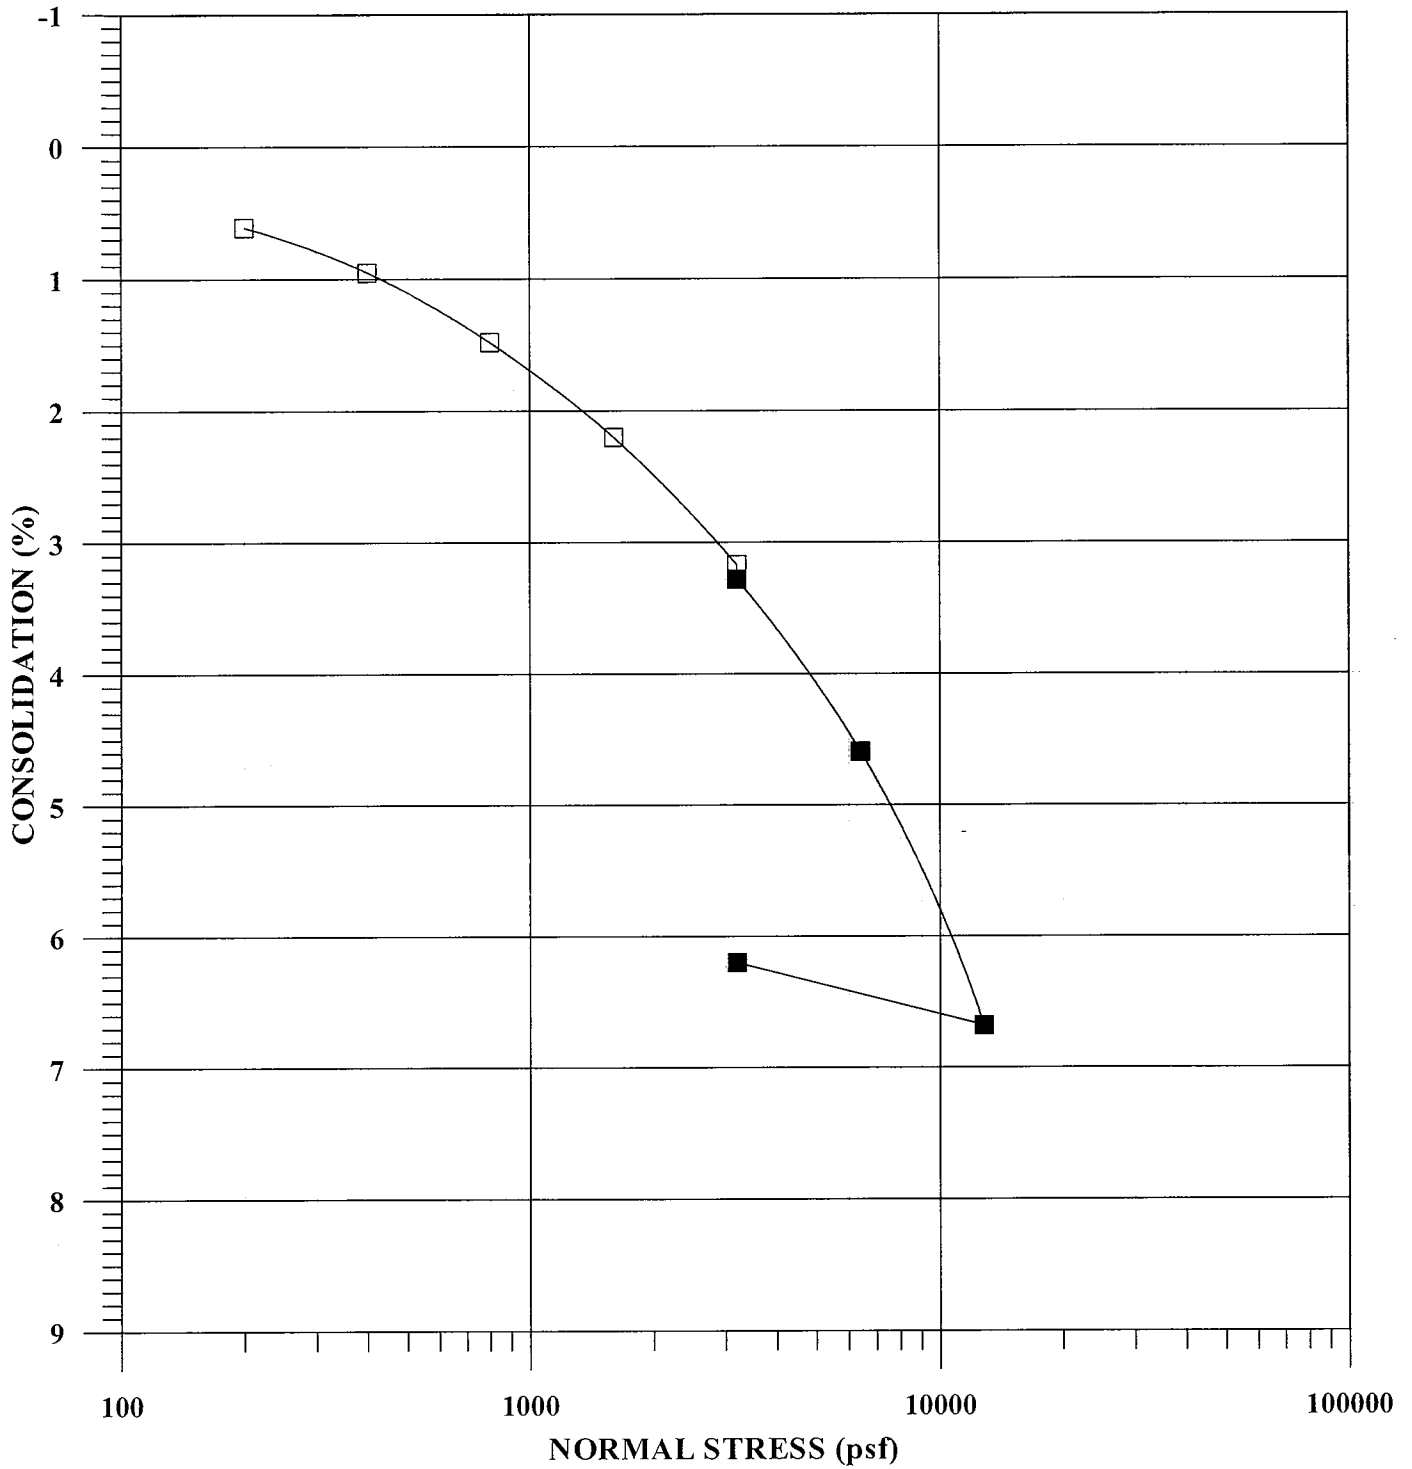
ALBUS-KEEFE & ASSOCIATES, INC. GEOTECHNICAL CONSULTANTS	CONSOLIDATION TEST RESULTS	Job No: 1489.00
		Figure No: B-13

Sample Location:	HS-1	Initial Dry Density (pcf):	103.8	Legend □ Field Moisture ■ Saturated
Sample Depth:	20'	Initial Moisture Content (%):	18.8	
Classification:		Final Moisture Content (%):	21.0

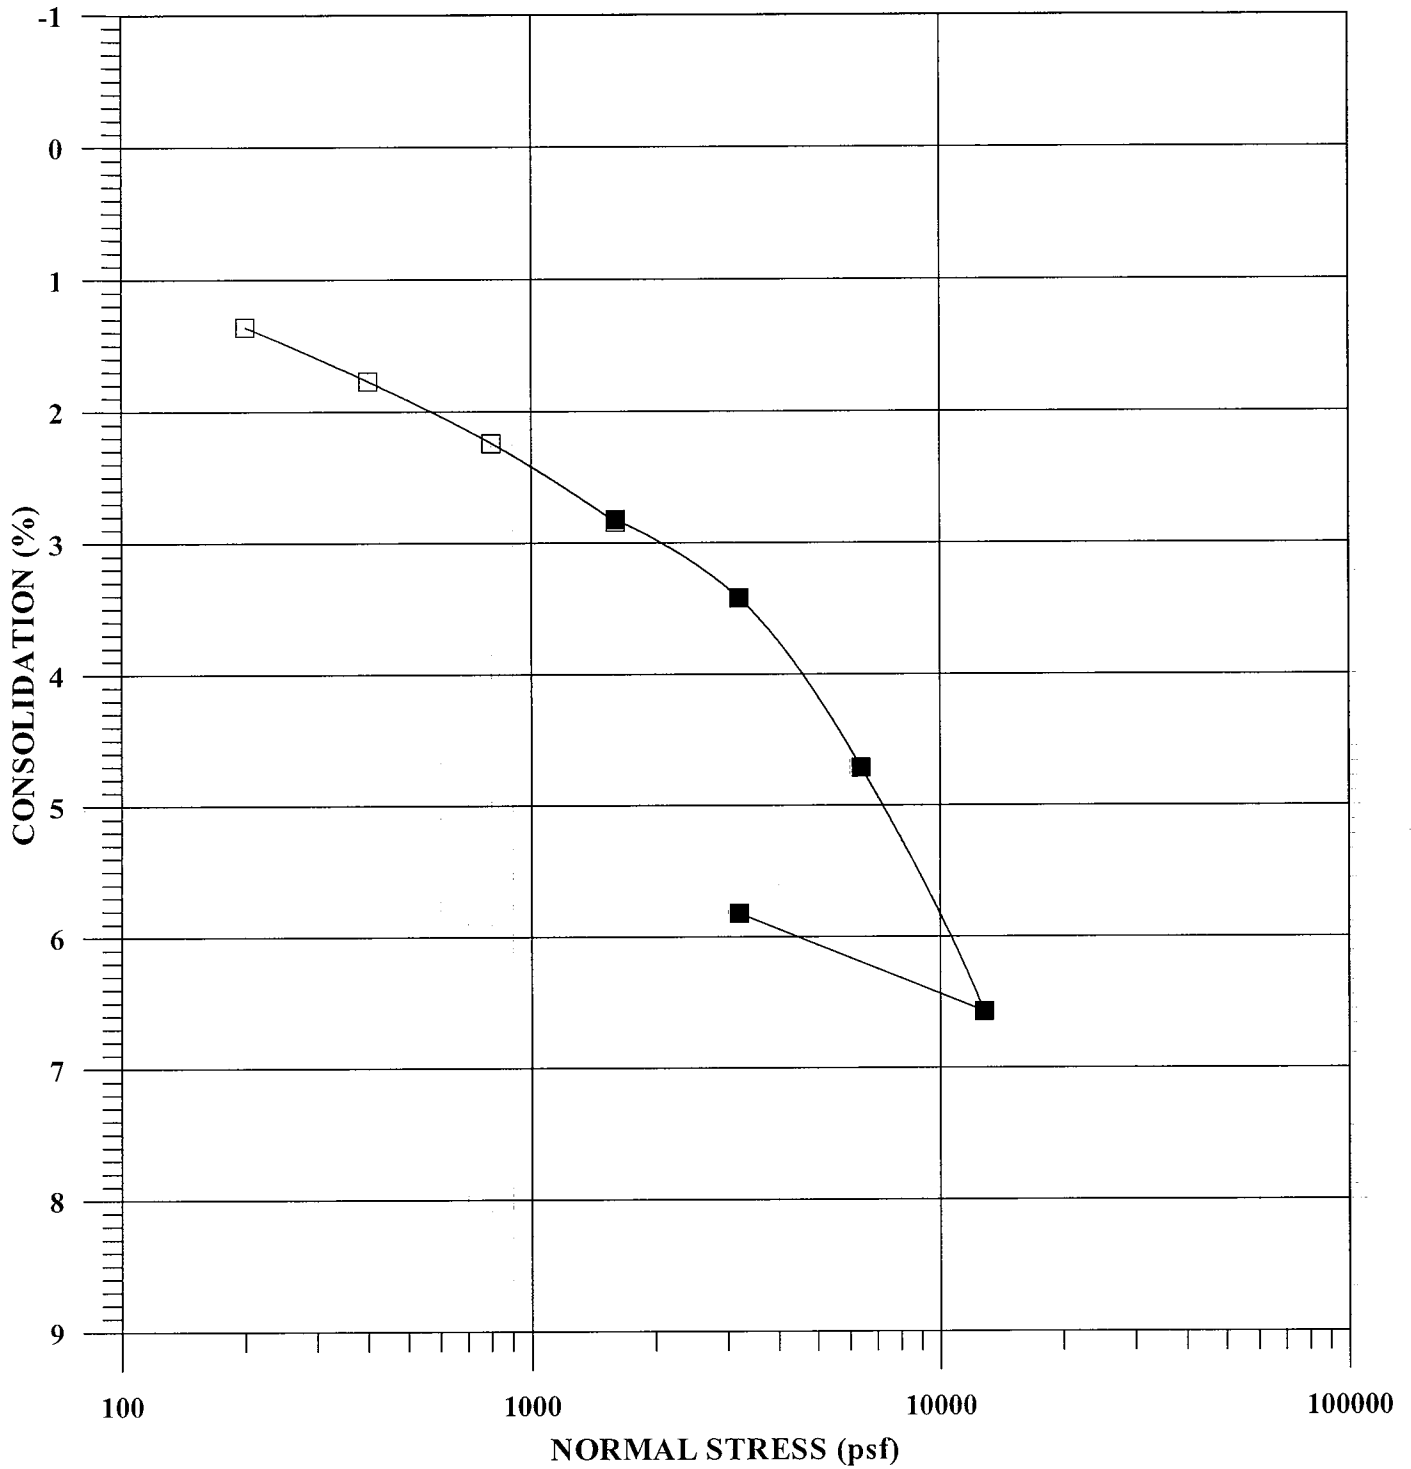
ALBUS-KEEFE & ASSOCIATES, INC. GEOTECHNICAL CONSULTANTS	CONSOLIDATION TEST RESULTS	Job No: 1489.00
		Figure No: B-14

Sample Location:	HS-2	Initial Dry Density (pcf):	109.9	Legend □ Field Moisture ■ Saturated
Sample Depth:	5'	Initial Moisture Content (%):	18.5	
Classification:		Final Moisture Content (%):	18.8

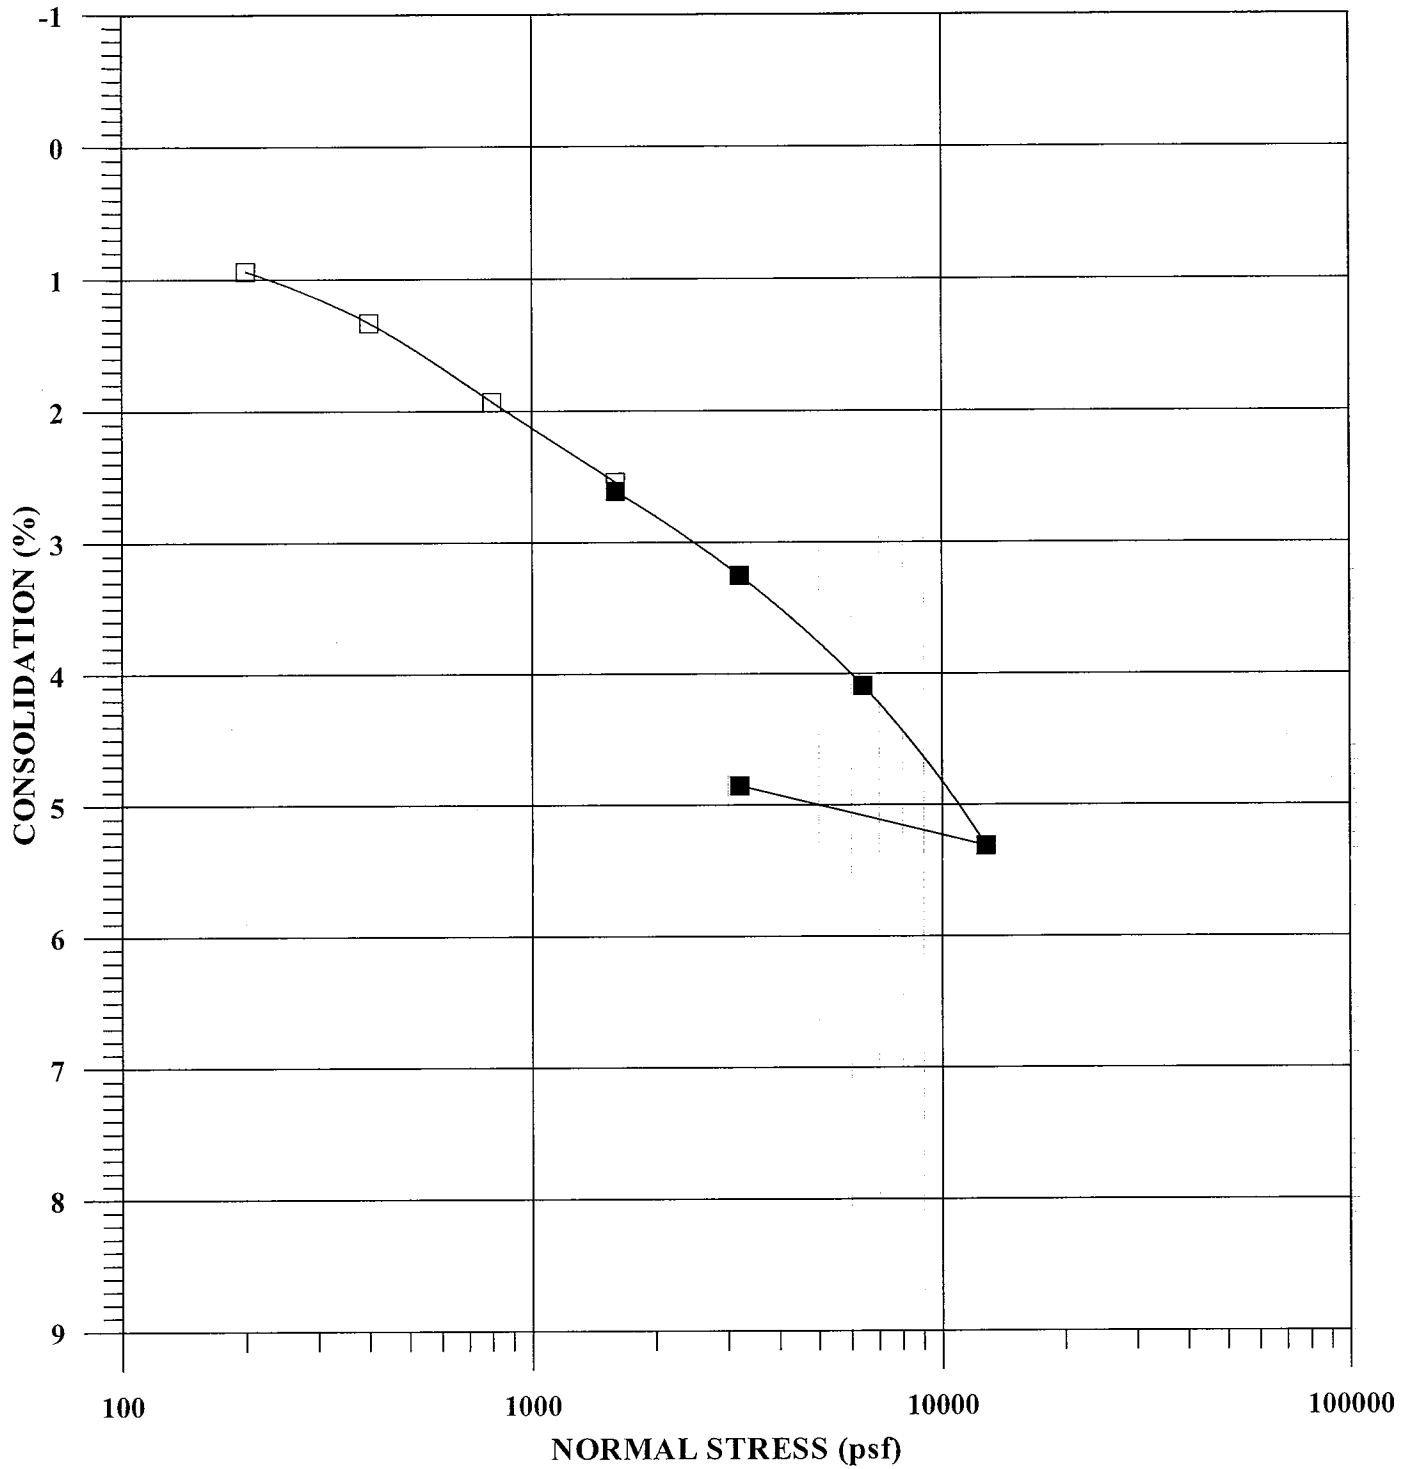
ALBUS-KEEFE & ASSOCIATES, INC. GEOTECHNICAL CONSULTANTS	CONSOLIDATION TEST RESULTS	Job No: 1489.00
		Figure No: B-15

Sample Location:	HS-2	Initial Dry Density (pcf):	106.8	Legend <input type="checkbox"/> Field Moisture <input checked="" type="checkbox"/> Saturated
Sample Depth:	10'	Initial Moisture Content (%):	18.5	
Classification:		Final Moisture Content (%):	20.0

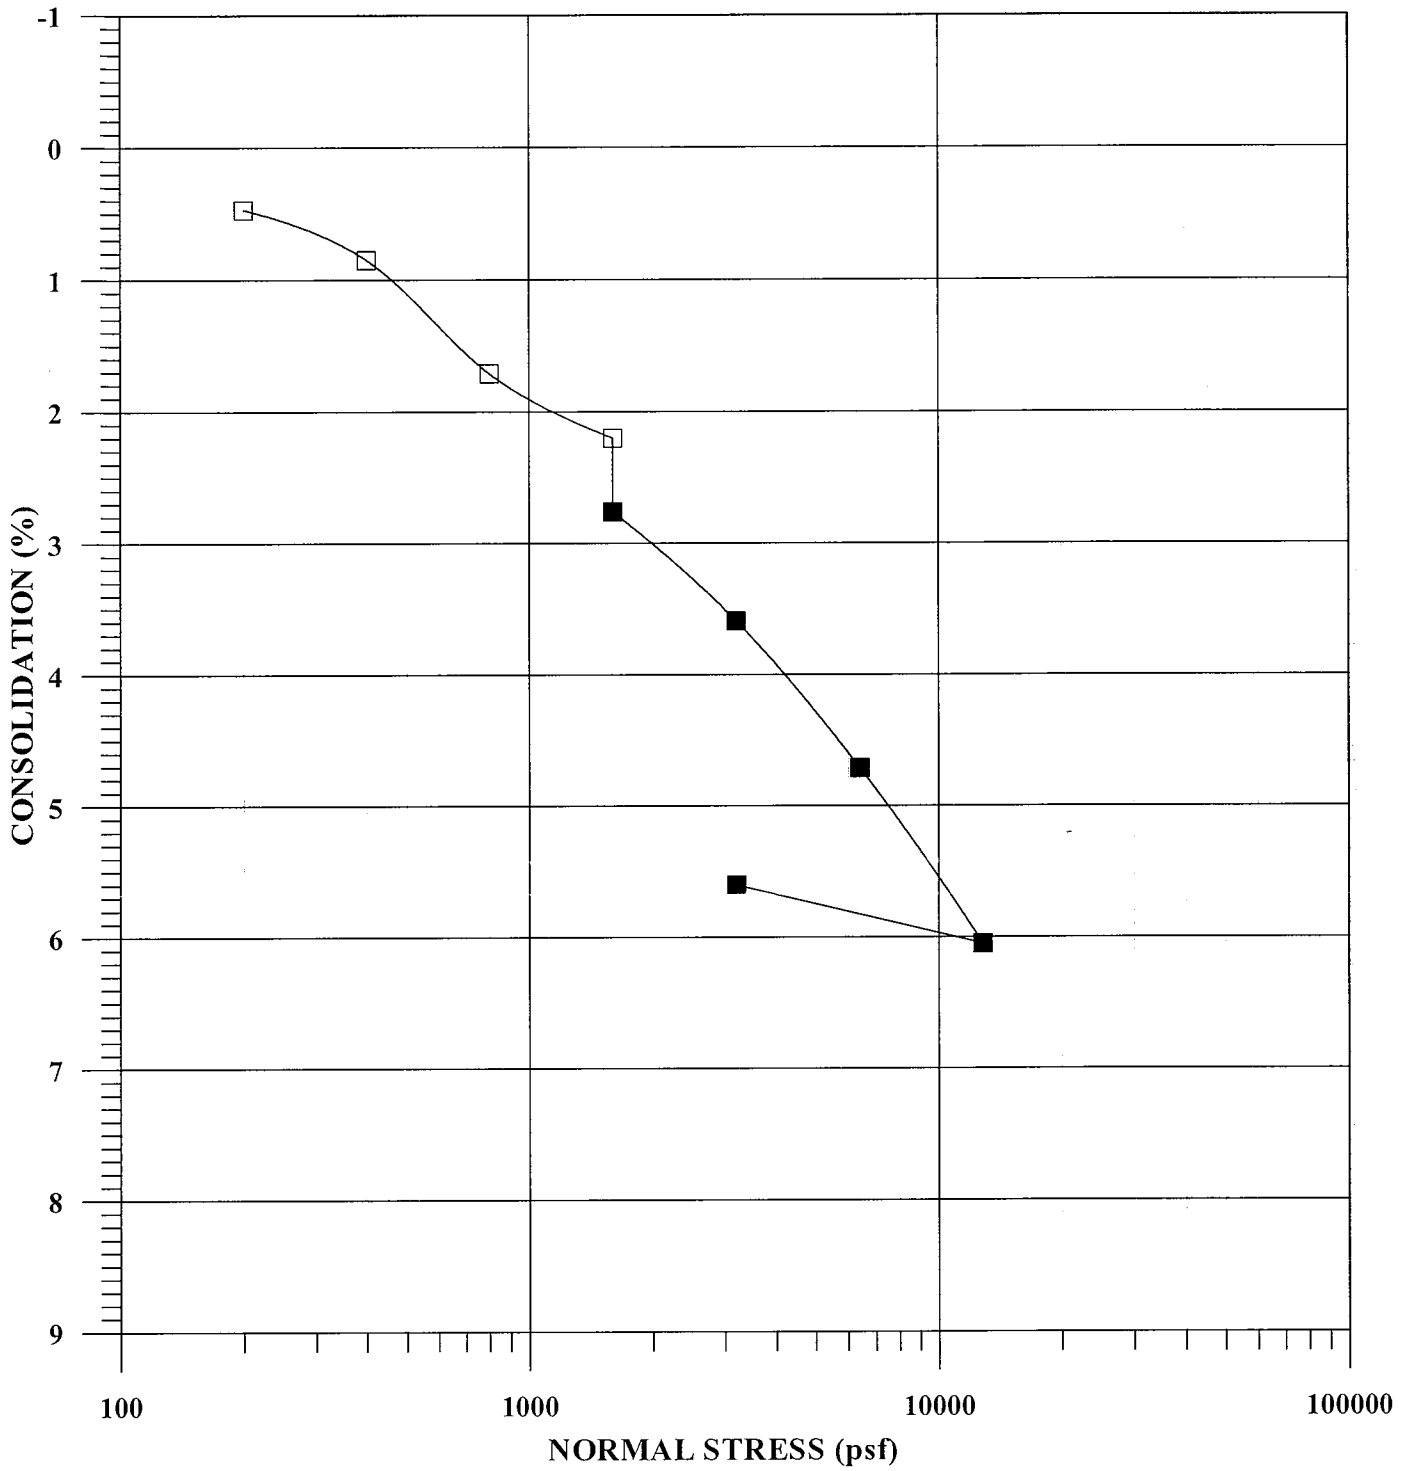
Figure No: B-18

Sample Location:	HS-3	Initial Dry Density (pcf):	107.3	Legend □ Field Moisture ■ Saturated
Sample Depth:	10'	Initial Moisture Content (%):	17.7	
Classification:		Final Moisture Content (%):	20.0

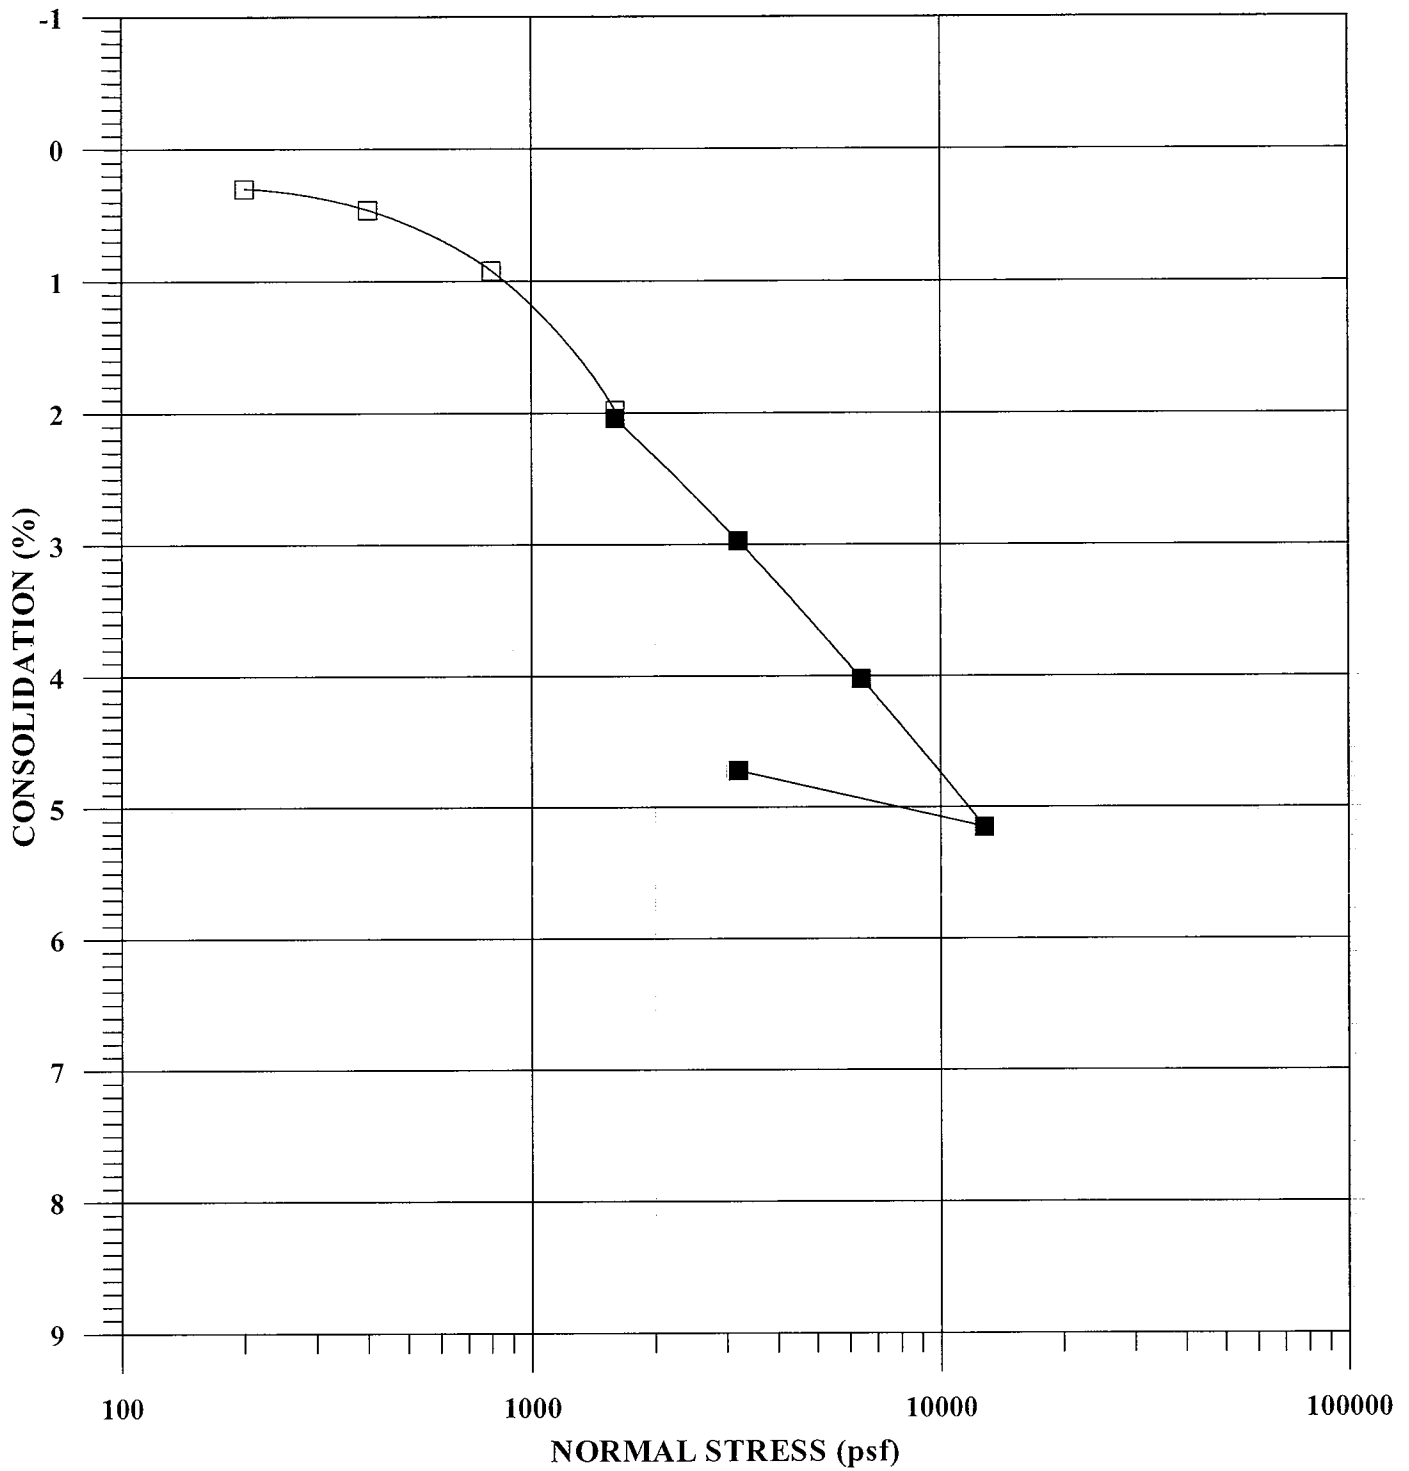
ALBUS-KEEFE & ASSOCIATES, INC. GEOTECHNICAL CONSULTANTS	CONSOLIDATION TEST RESULTS	Job No: 1489.00
		Figure No: B-19

Sample Location:	HS-4	Initial Dry Density (pcf):	112.9	Legend □ Field Moisture ■ Saturated
Sample Depth:	5'	Initial Moisture Content (%):	15.2	
Classification:		Final Moisture Content (%):	17.7

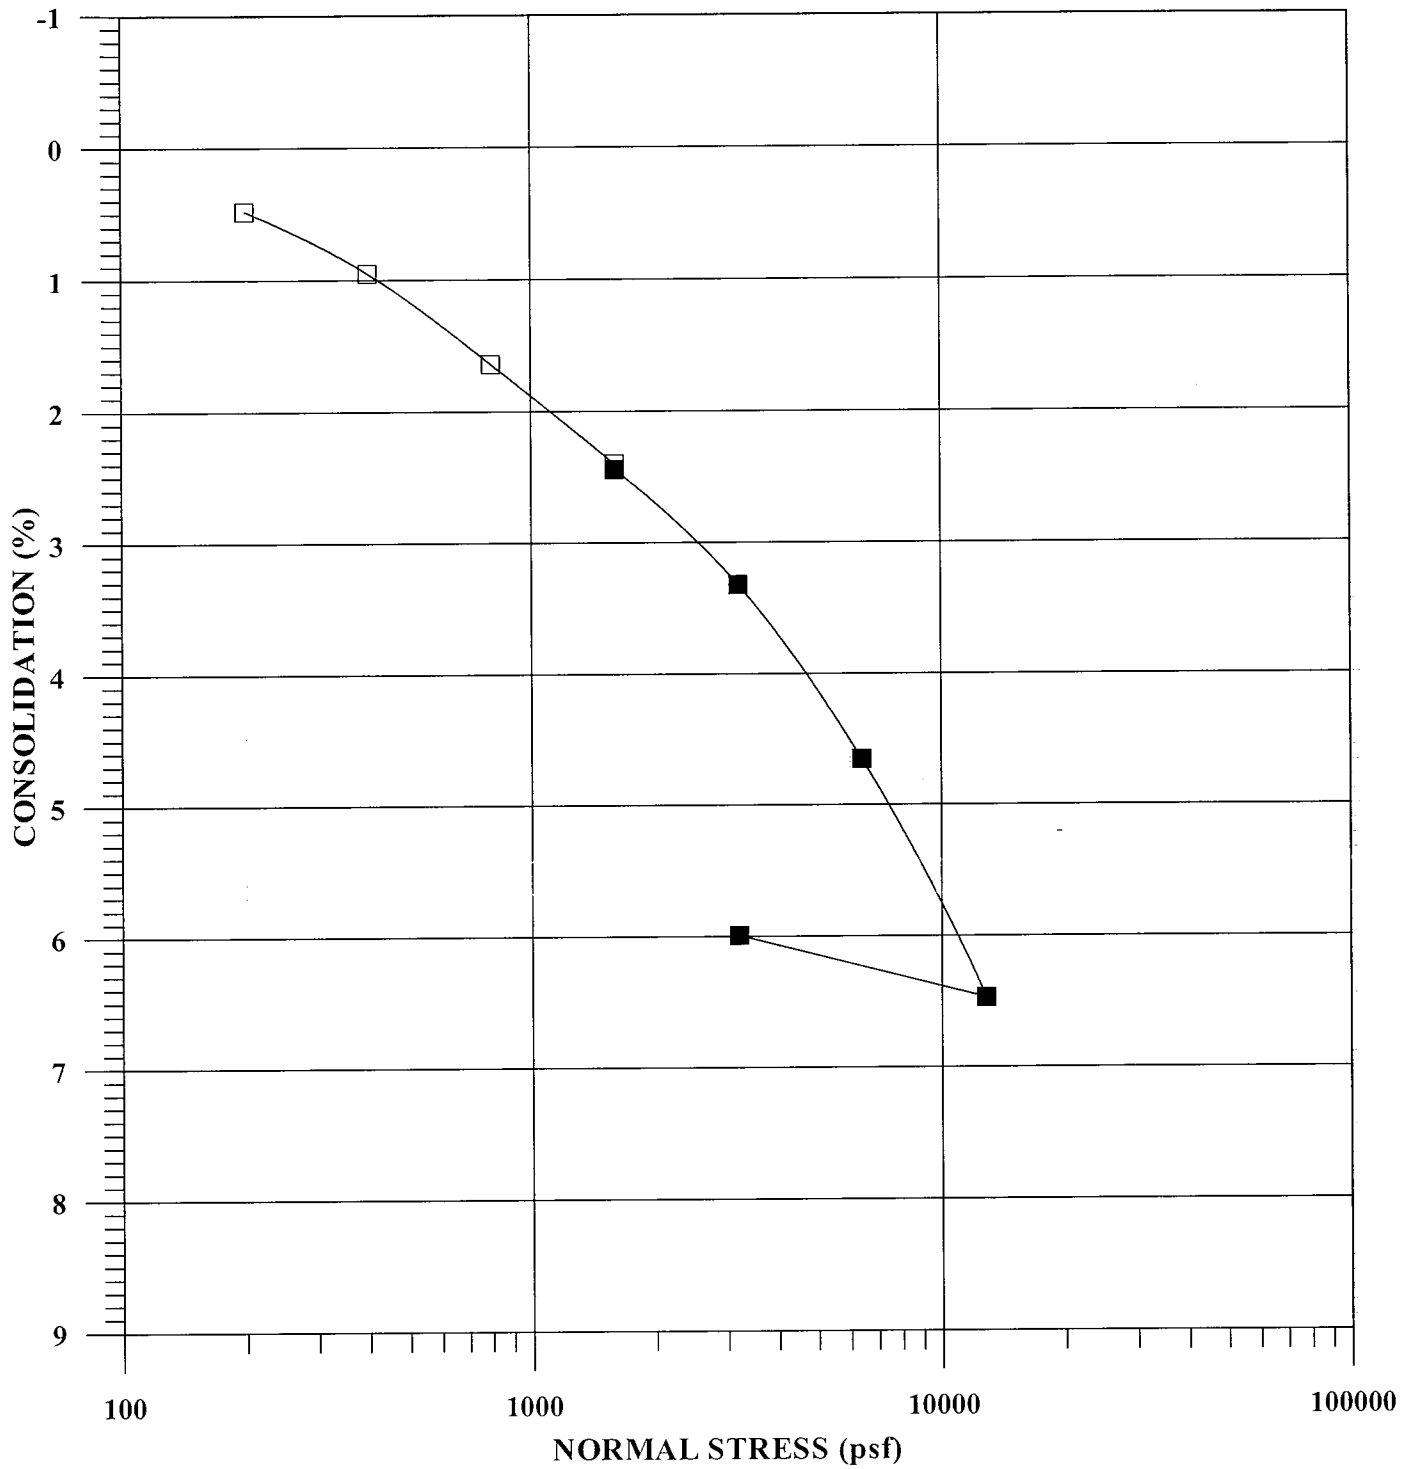
Figure No: B-23

Sample Location:	HS-5	Initial Dry Density (pcf):	106.8	Legend <input type="checkbox"/> Field Moisture <input checked="" type="checkbox"/> Saturated
Sample Depth:	15'	Initial Moisture Content (%):	18.2	
Classification:		Final Moisture Content (%):	20.9

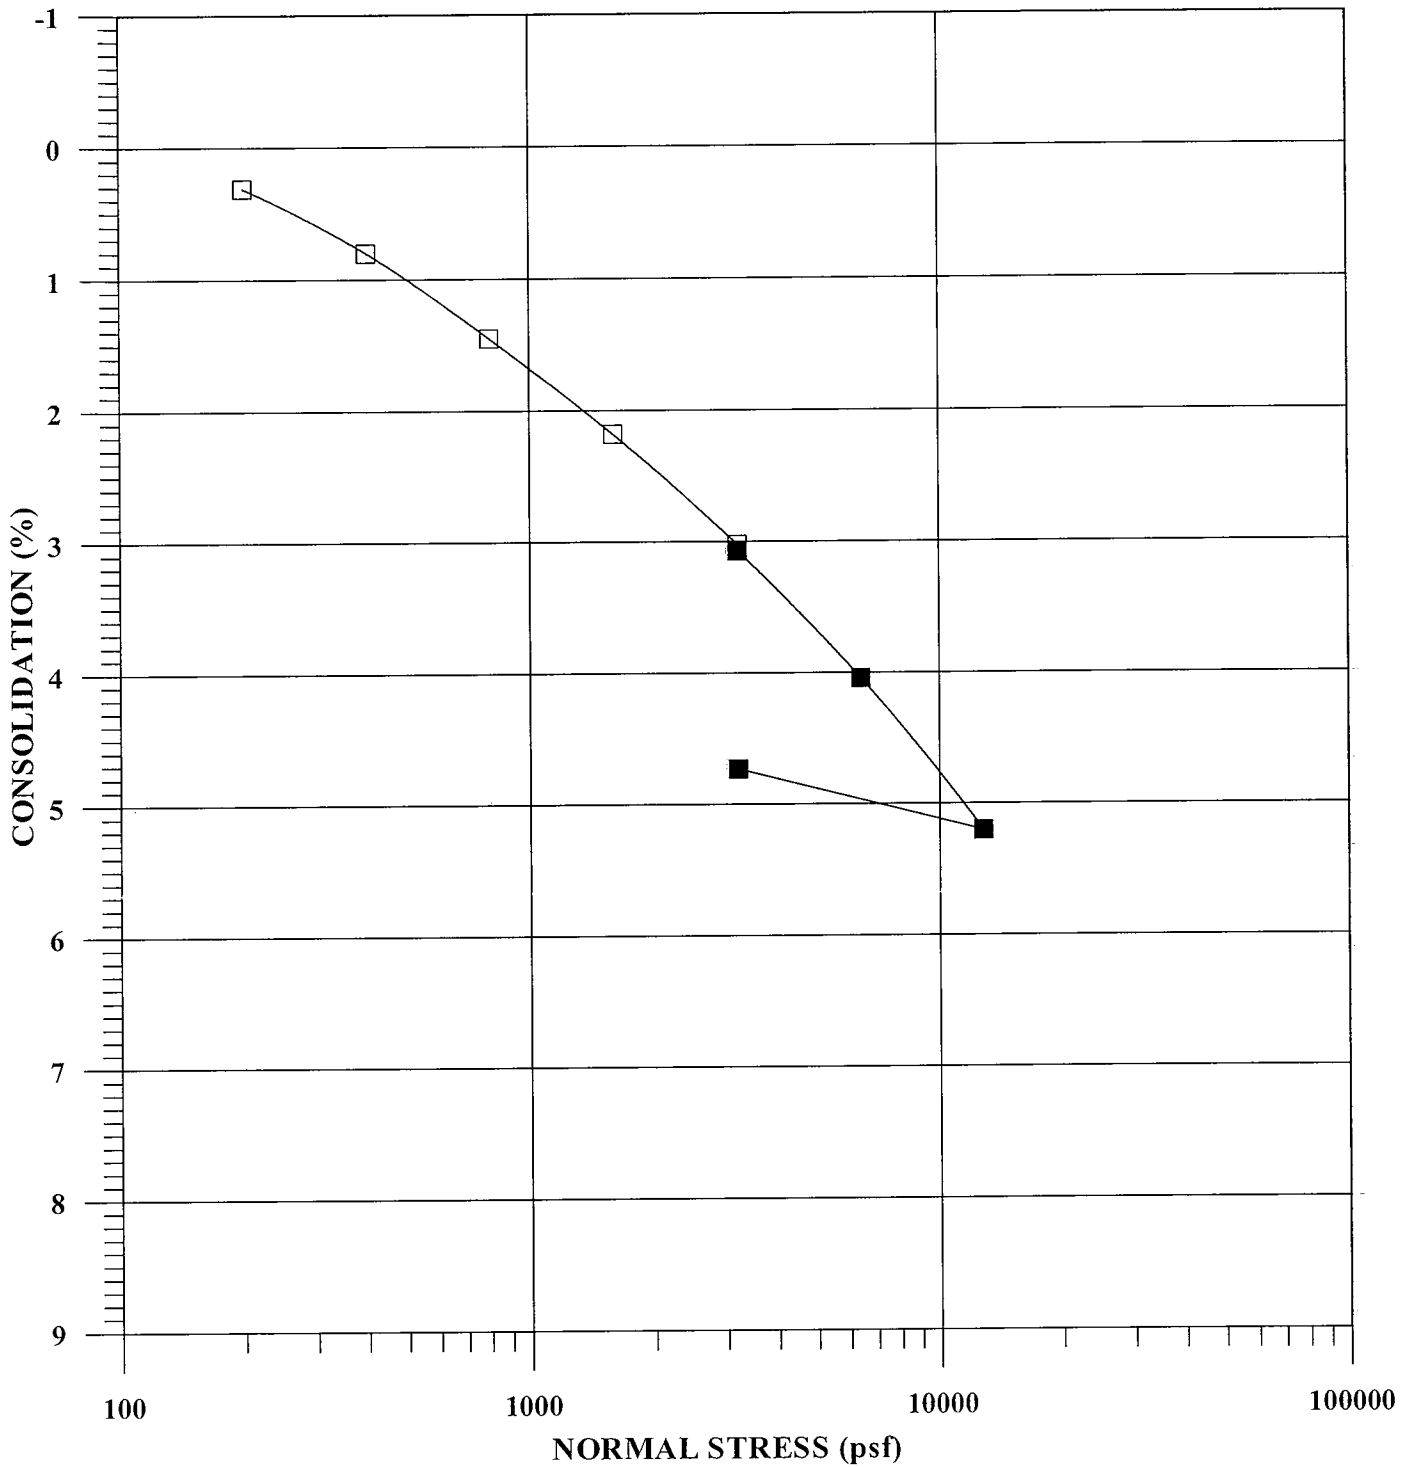
Figure No: B-24

Sample Location:	HS-7	Initial Dry Density (pcf):	118.6	Legend <input type="checkbox"/> Field Moisture <input checked="" type="checkbox"/> Saturated
Sample Depth:	5'	Initial Moisture Content (%):	13.9	
Classification:		Final Moisture Content (%):	15.9
