**SANTA PAULA GEOLOGIC HAZARD
ABATEMENT DISTRICT (GHAD)
PLAN OF CONTROL**

SANTA PAULA, CALIFORNIA

ENGEO INCORPORATED

MARCH 10, 2008

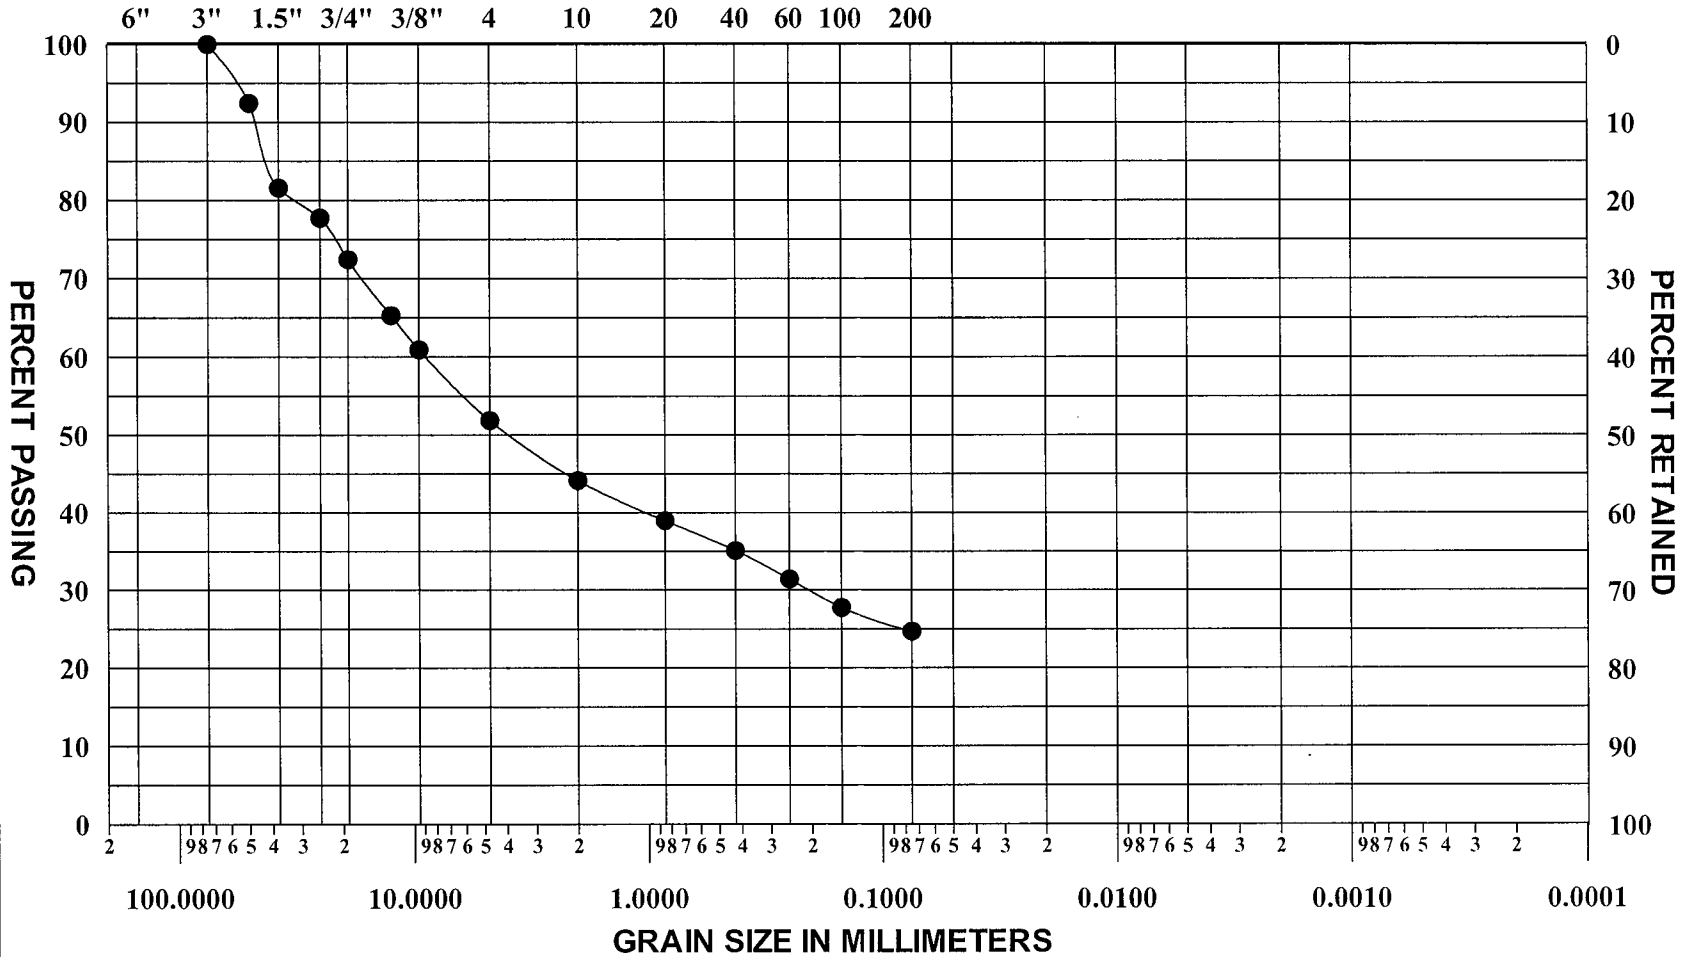
COBBLES	GRAVEL		SAND			SILT AND CLAY
	COARSE	FINE	COARSE	MEDIUM	FINE

U.S. STANDARD SIEVE SIZES

LOCATION	DEPTH	SYMBOL	LL	PI	CLASSIFICATION
B-1	16'	● ——— ●			Silty Sand & Gravel (GM-SM)
		■ - - - ■			
		▲ - - - ▲			
		◆ - - - ◆

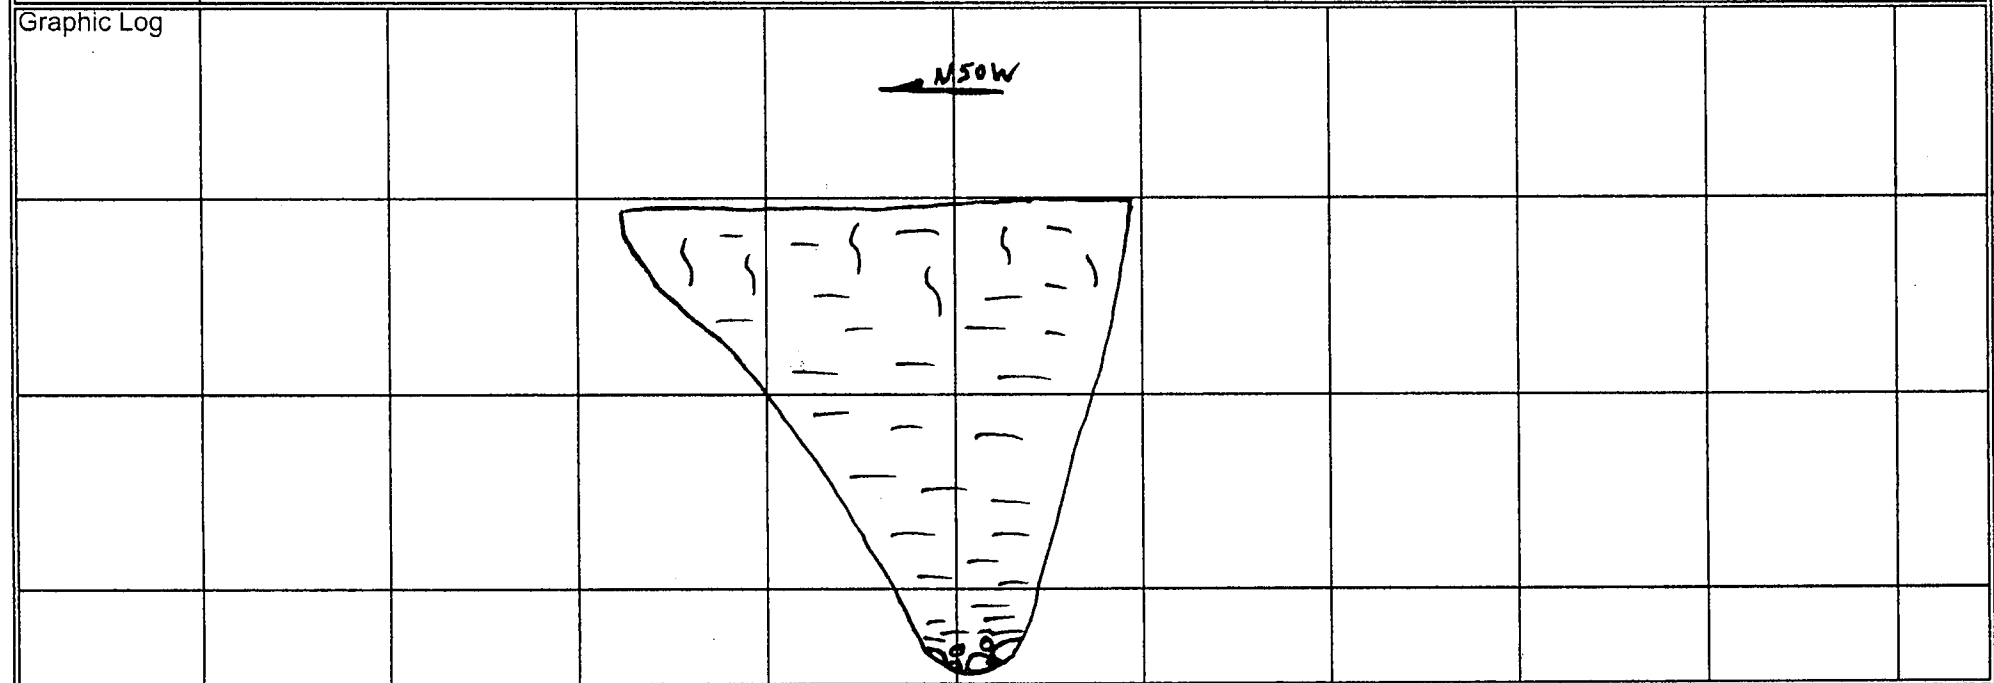
scale 1" = 5'	GEOLABS-WESTLAKE VILLAGE	W.O. 8988	PLATE TP2
---------------	--------------------------	-----------	-----------

LOG OF EXCAVATION Trench No. TP2	Logged By: SBS	Date Excavated: 7/11/05	Client: Comstock Homes
-------------------------------------	----------------	-------------------------	------------------------

Depth (ft)	Description	Comments
0 - 2	<u>Terrace Deposits</u> : Dark yellowish brown silty SAND, dense, damp, abundant 1-2mm pores, abundant roots and rootlets.	
2 - 5	Grades to dark yellowish brown SILT with clay, hard, moist, weakly cemented, abundant pinhole pores.	
5 - 12	Grades to dark yellow brown CLAY with silt, very stiff, moist, abundant pinhole pores, easy to excavate.	
@12'	Subrounded coarse cobble-boulder clasts of arkosic sandstone.	
Total Depth - 12' No groundwater No caving Backfilled

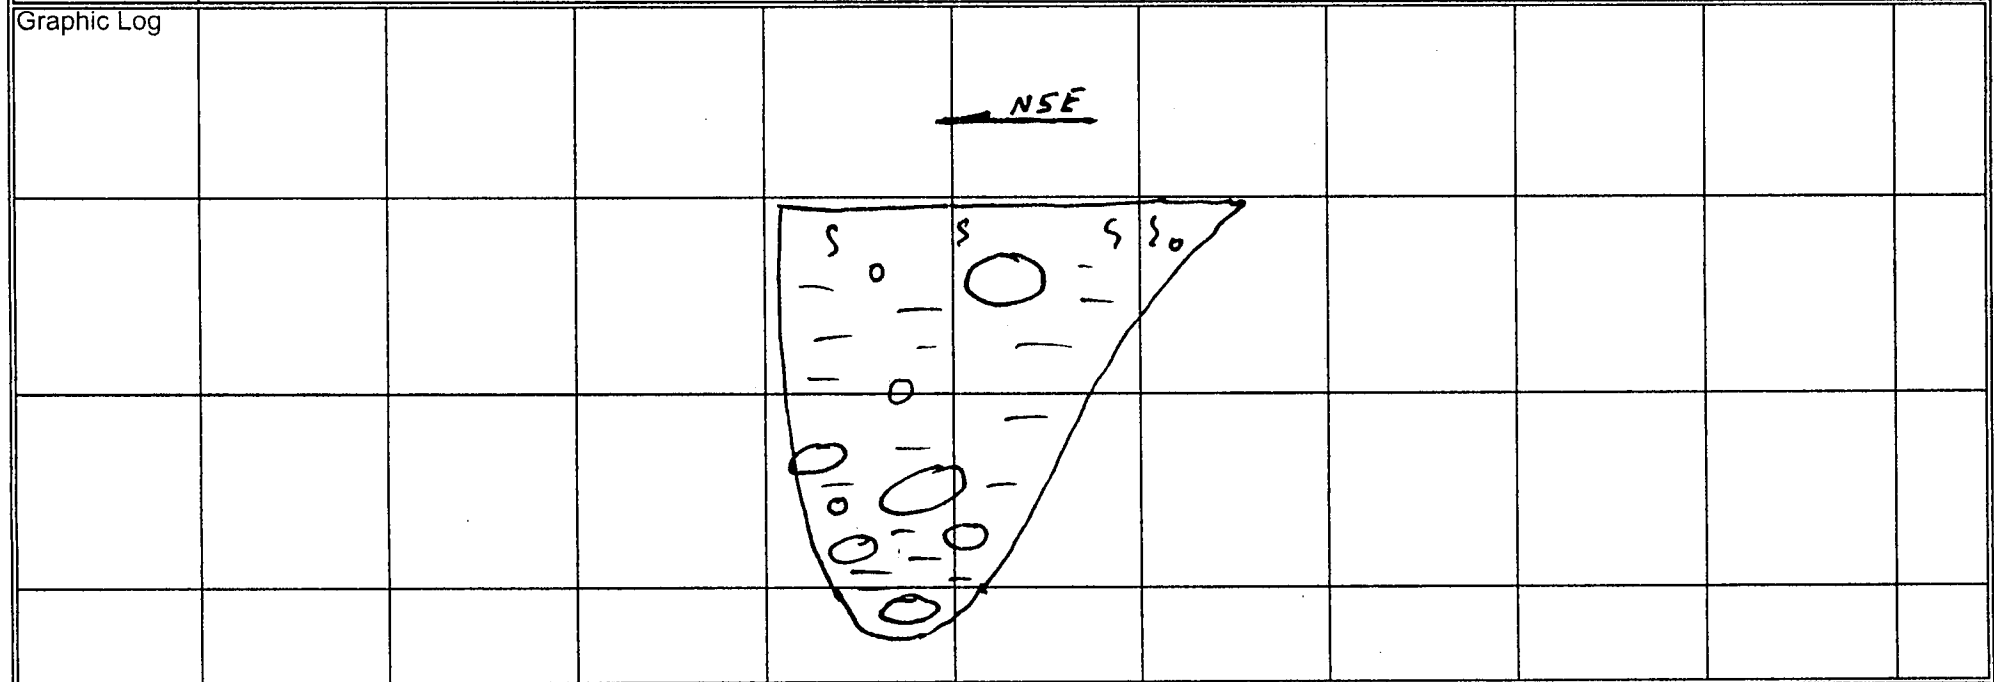
scale 1" = 5'	GEOLABS-WESTLAKE VILLAGE	W.O. 8988	PLATE TP5
---------------	--------------------------	-----------	-----------

LOG OF EXCAVATION Trench No. TP5	Logged By: SBS	Date Excavated: 7/11/05	Client: Comstock Homes
-------------------------------------	----------------	-------------------------	------------------------

Depth (ft)	Description	Comments
0 - 6	<u>Terrace Deposits</u> : Dark yellowish brown very clayey SILT with subrounded coarse cobble-boulder clasts (of arkosic sandstone), very stiff, damp to 2', moist below, abundant root hairs and 1-2mm pores to 2' depth, abundant pinhole pores below.	
6 - 12	Grades to subrounded cobble-boulder clasts (of angular sandstone) in dark yellowish brown clayey SILT, very stiff, moist, abundant pinhole pores.	
Total Depth - 12' No groundwater No caving Backfilled

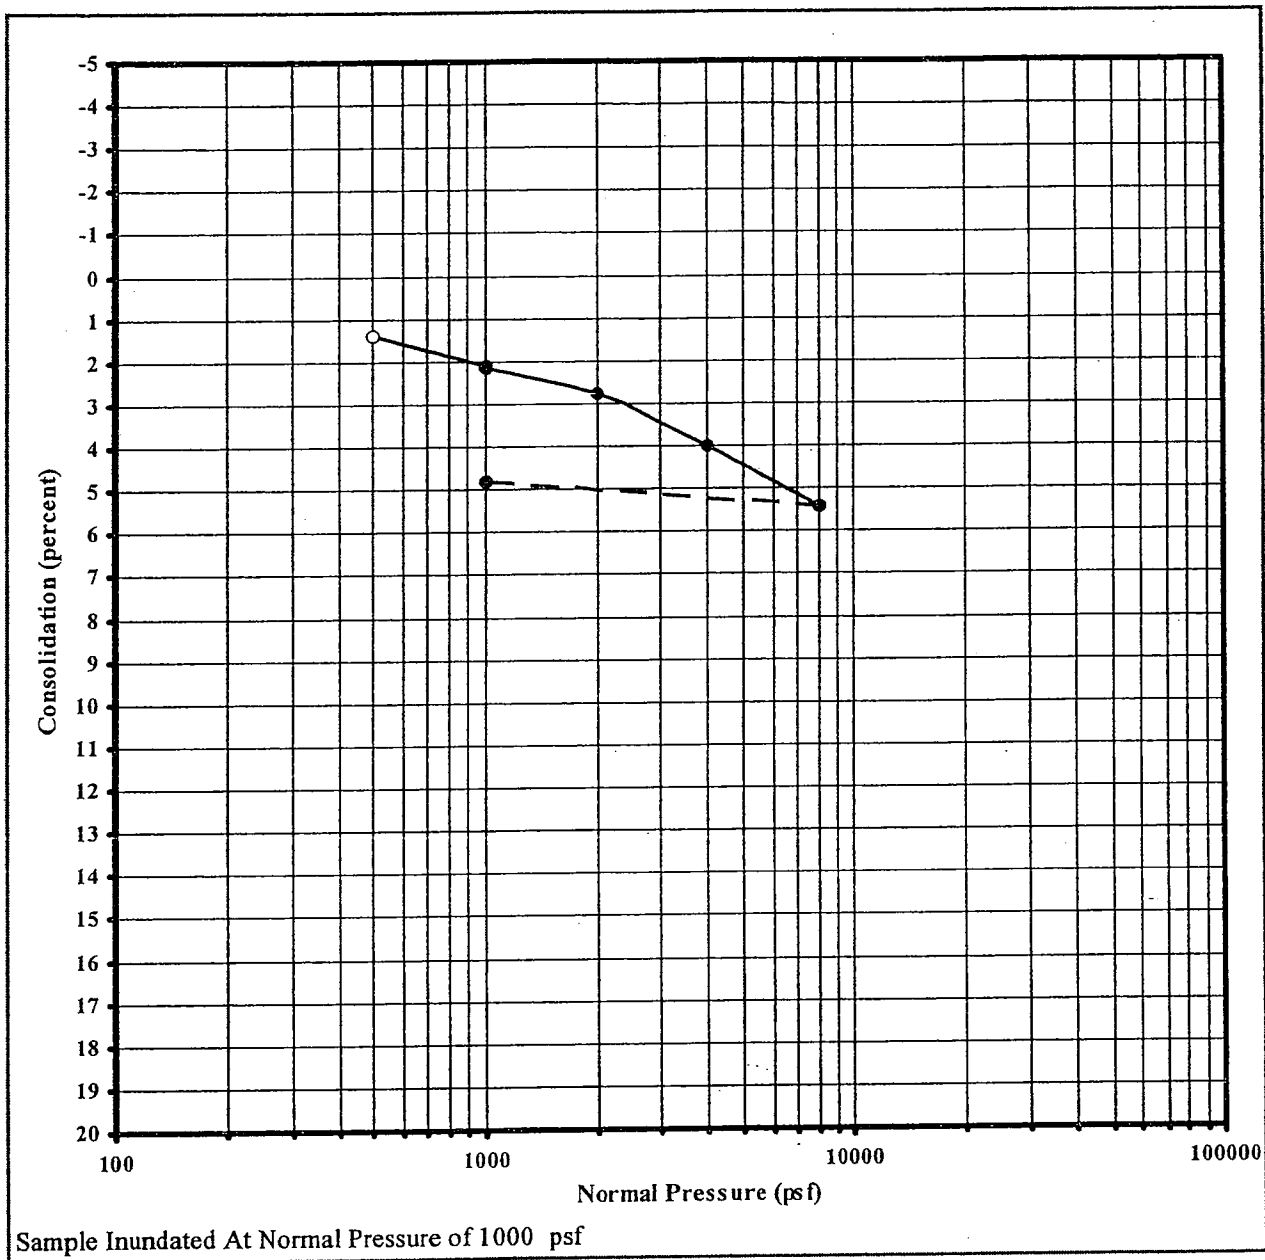
CONSOLIDATION RESULTS

Undisturbed Sample

Sample Location: GWV1

Sample Depth: 5 ft.

Initial Moisture: 18.5 %

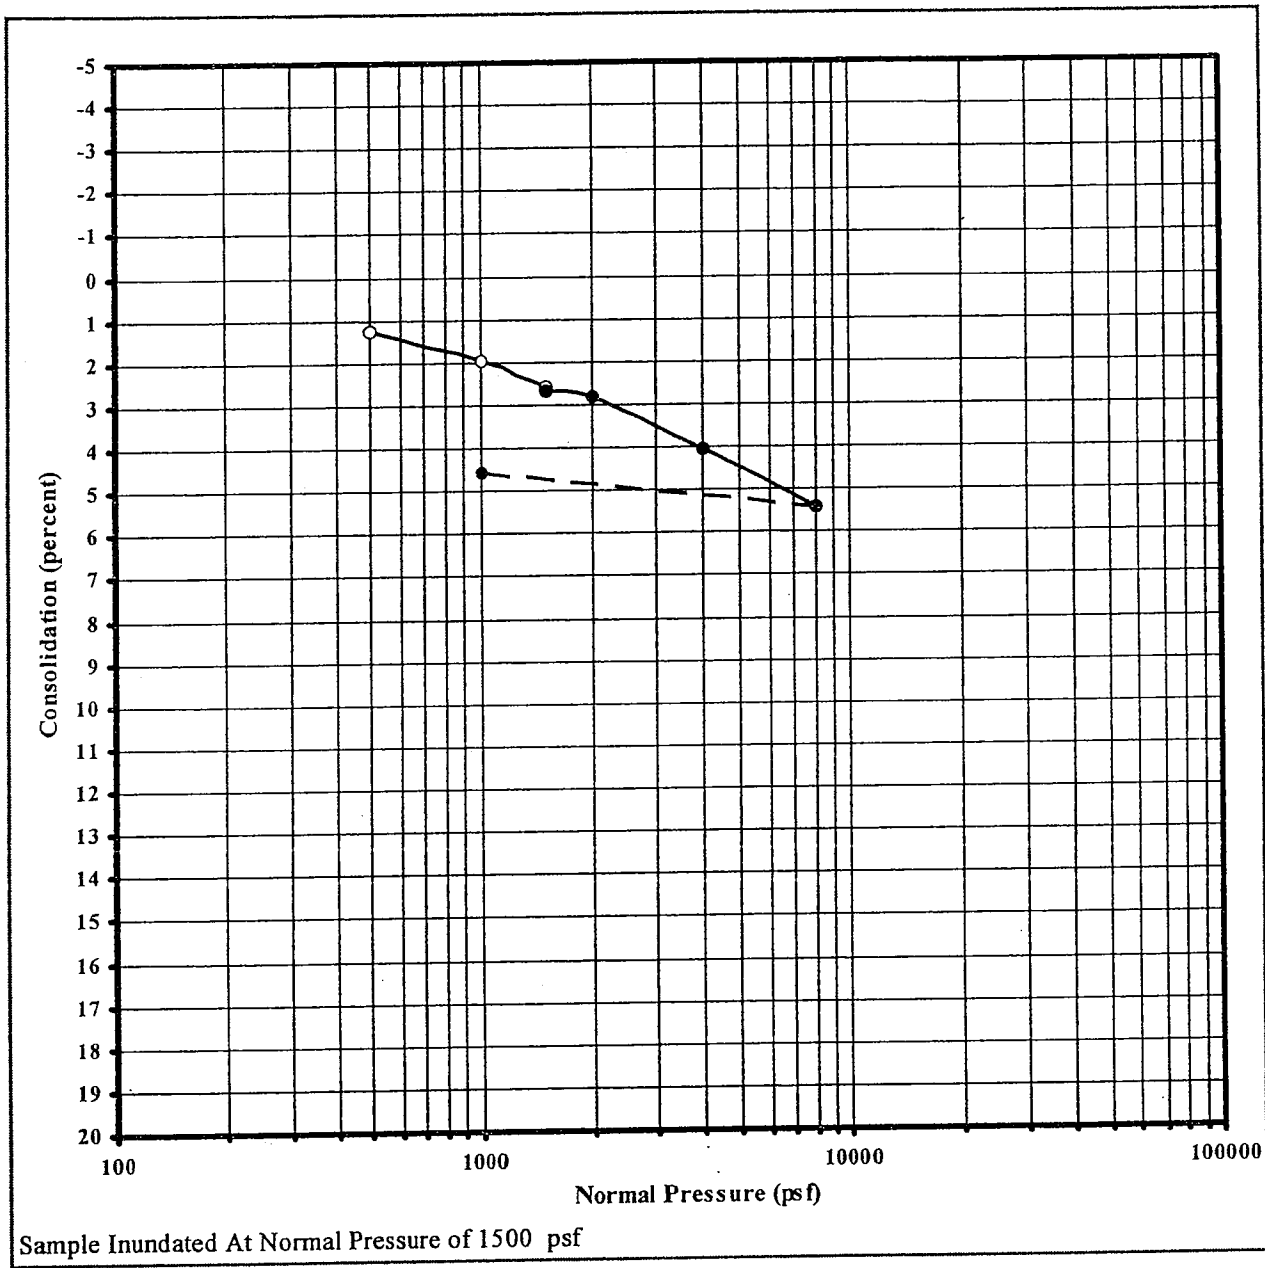
CONSOLIDATION RESULTS

Undisturbed Sample

Sample Location: GWV1

Sample Depth: 5 ft.

Initial Moisture: 18.5 %

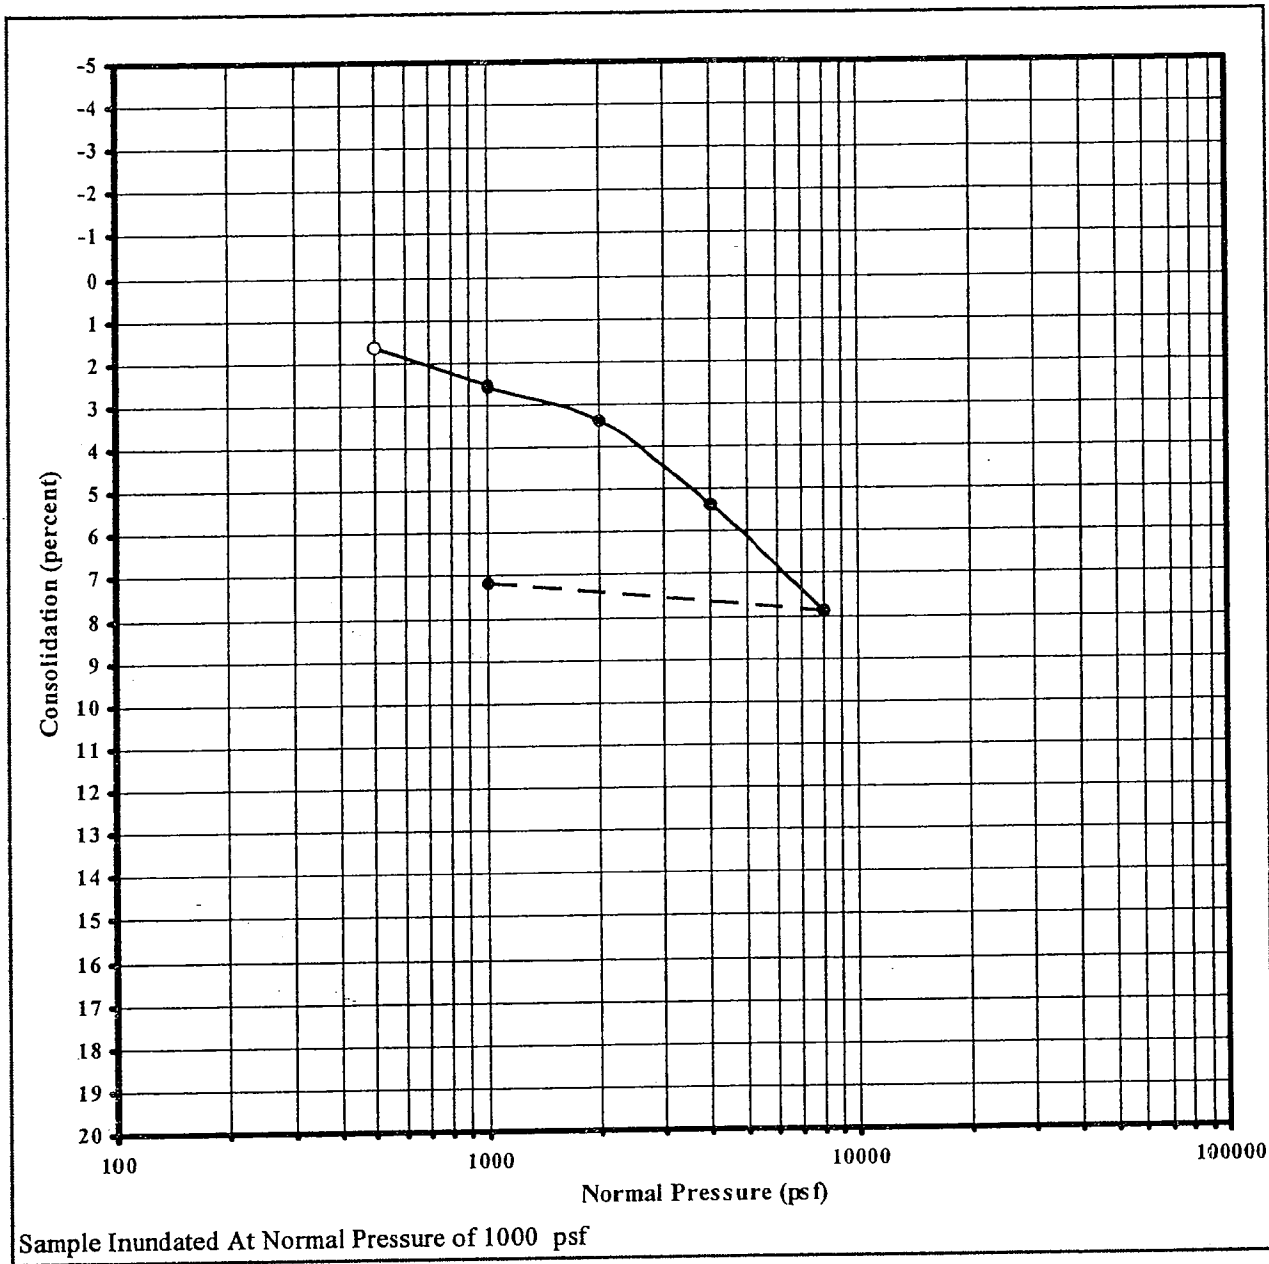
CONSOLIDATION RESULTS

Undisturbed Sample

Sample Location: GWV2

Sample Depth: 5 ft.

Initial Moisture: 17.9 %

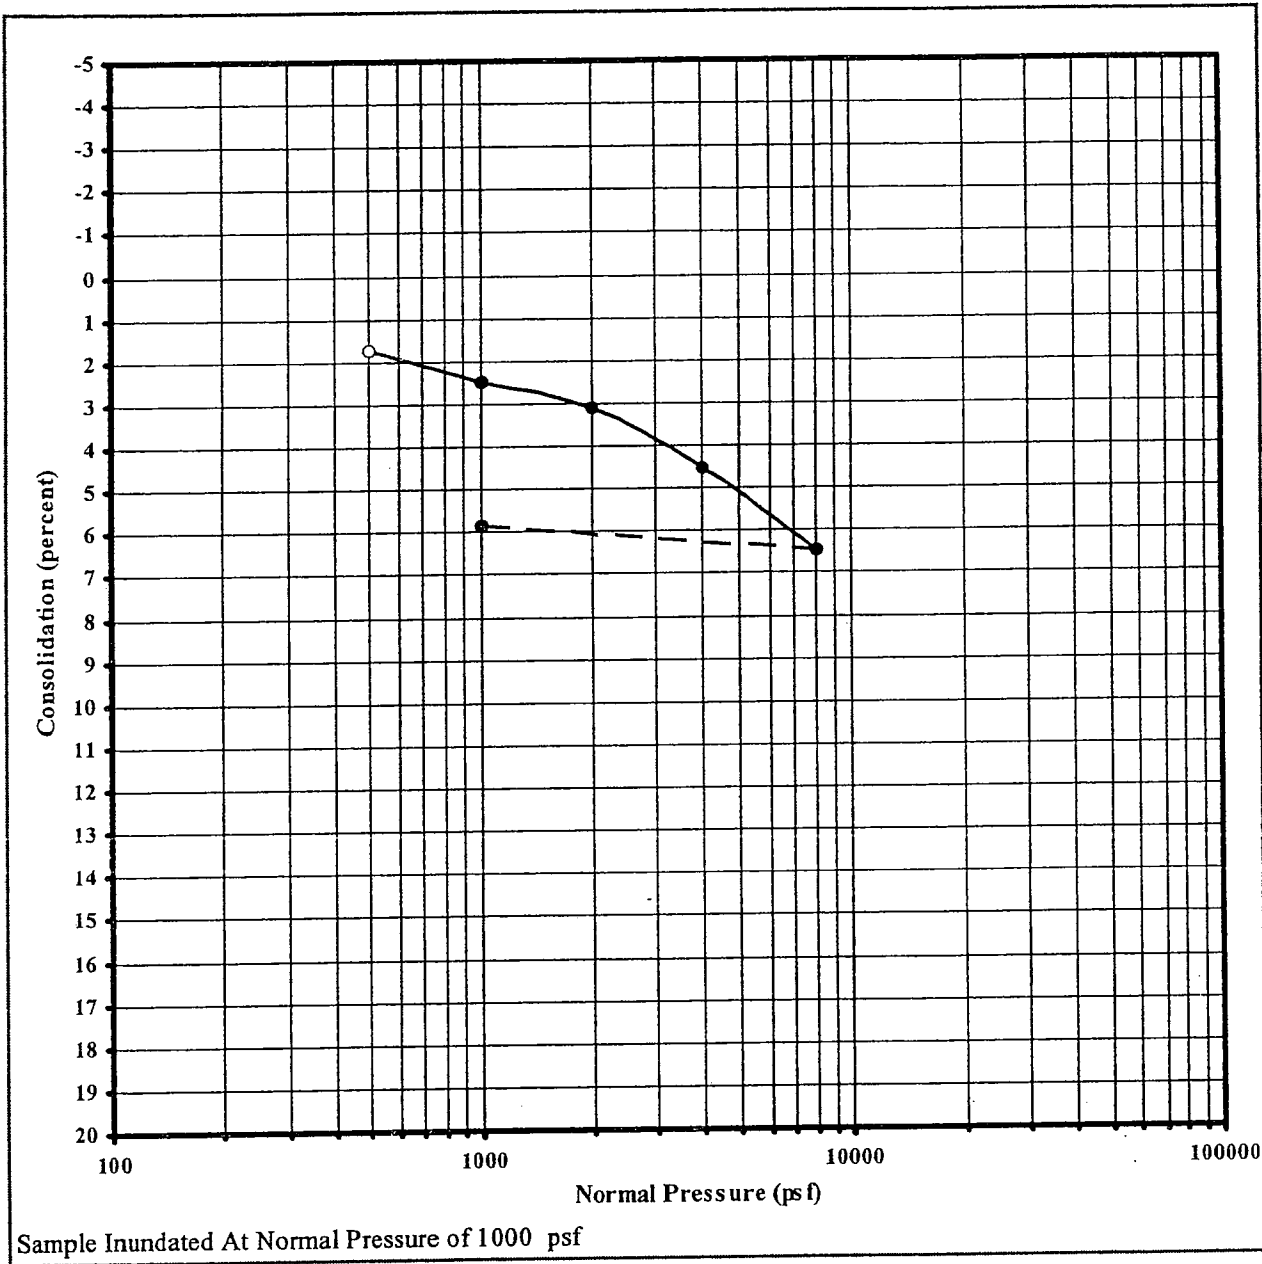
CONSOLIDATION RESULTS

Undisturbed Sample

Sample Location: GWV2

Sample Depth: 10 ft.

Initial Moisture: 20 %

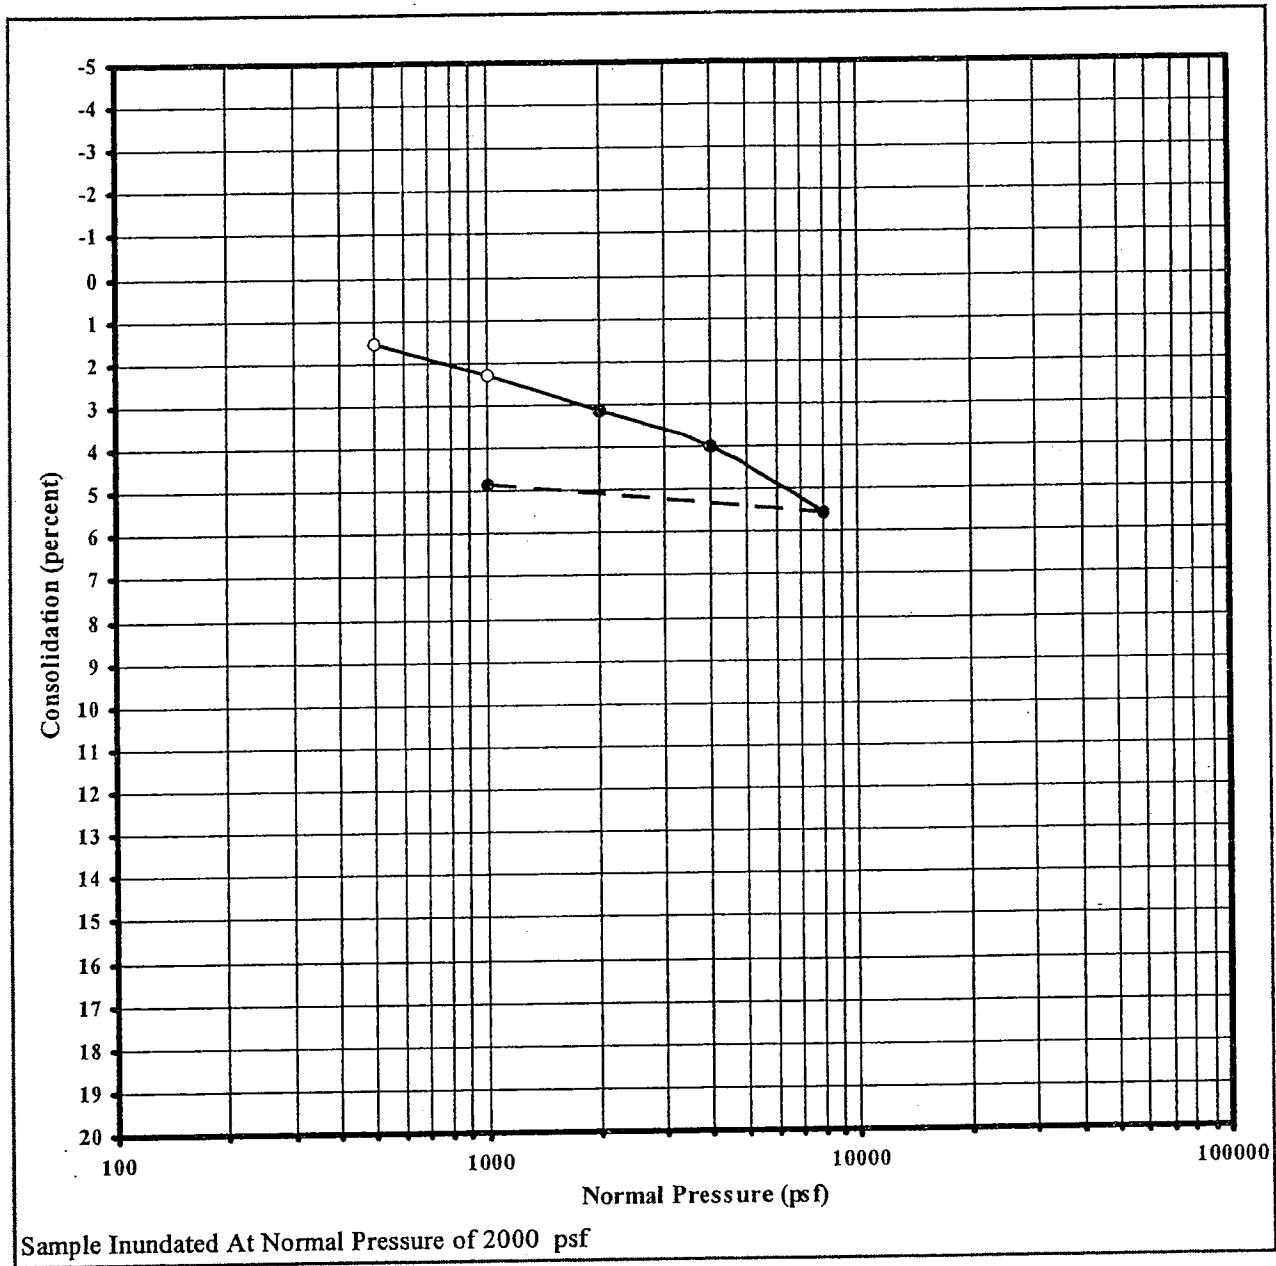
CONSOLIDATION RESULTS

Undisturbed Sample

Sample Location: GWV2

Sample Depth: 10 ft.

Initial Moisture: 20 %

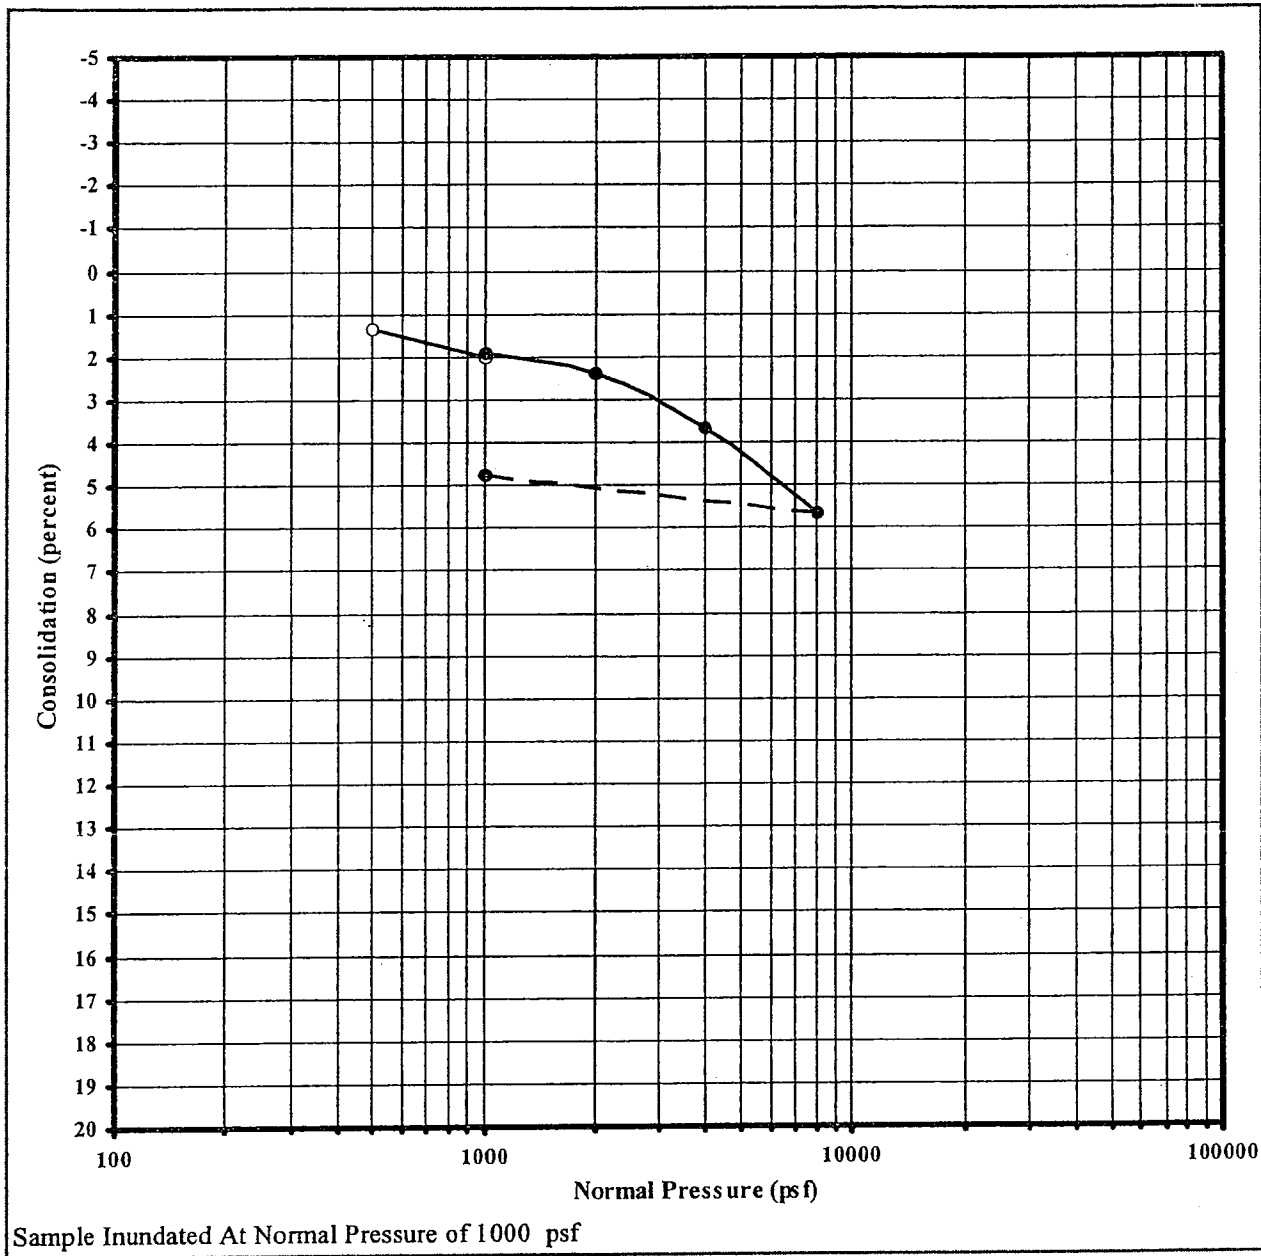
CONSOLIDATION RESULTS

Undisturbed Sample

Sample Location: GWV3

Sample Depth: 5 ft.

Initial Moisture: 18.1 %

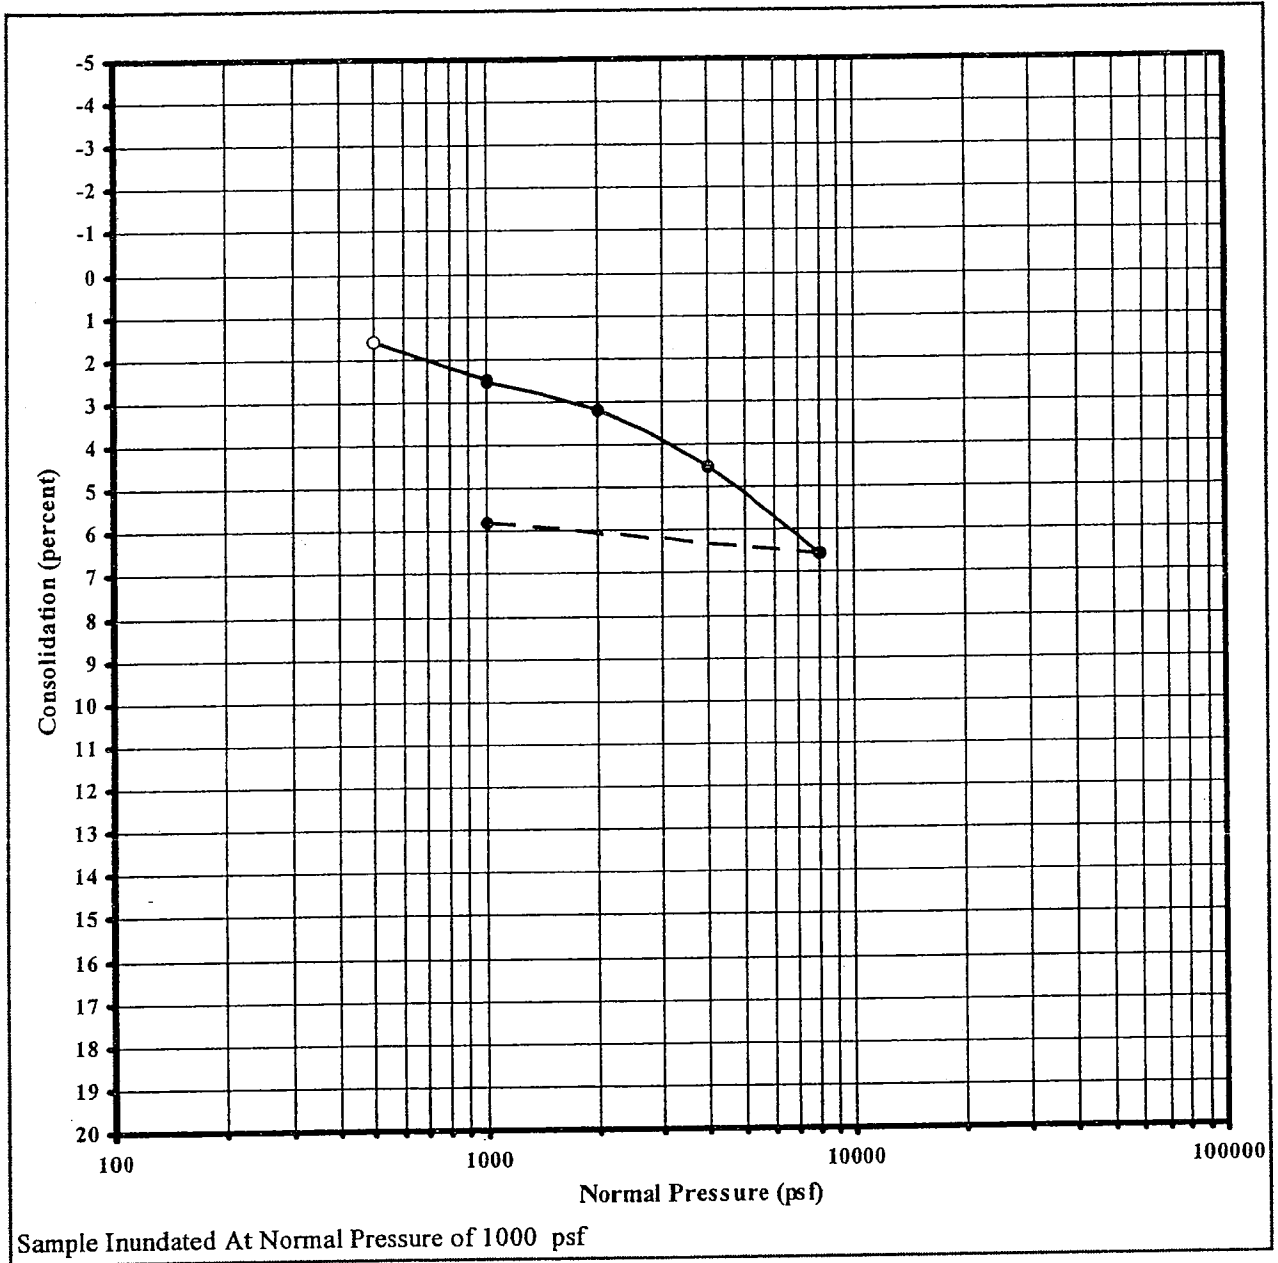
CONSOLIDATION RESULTS

Undisturbed Sample

Sample Location: GWV3

Sample Depth: 7.5 ft.

Initial Moisture: 17.6 %

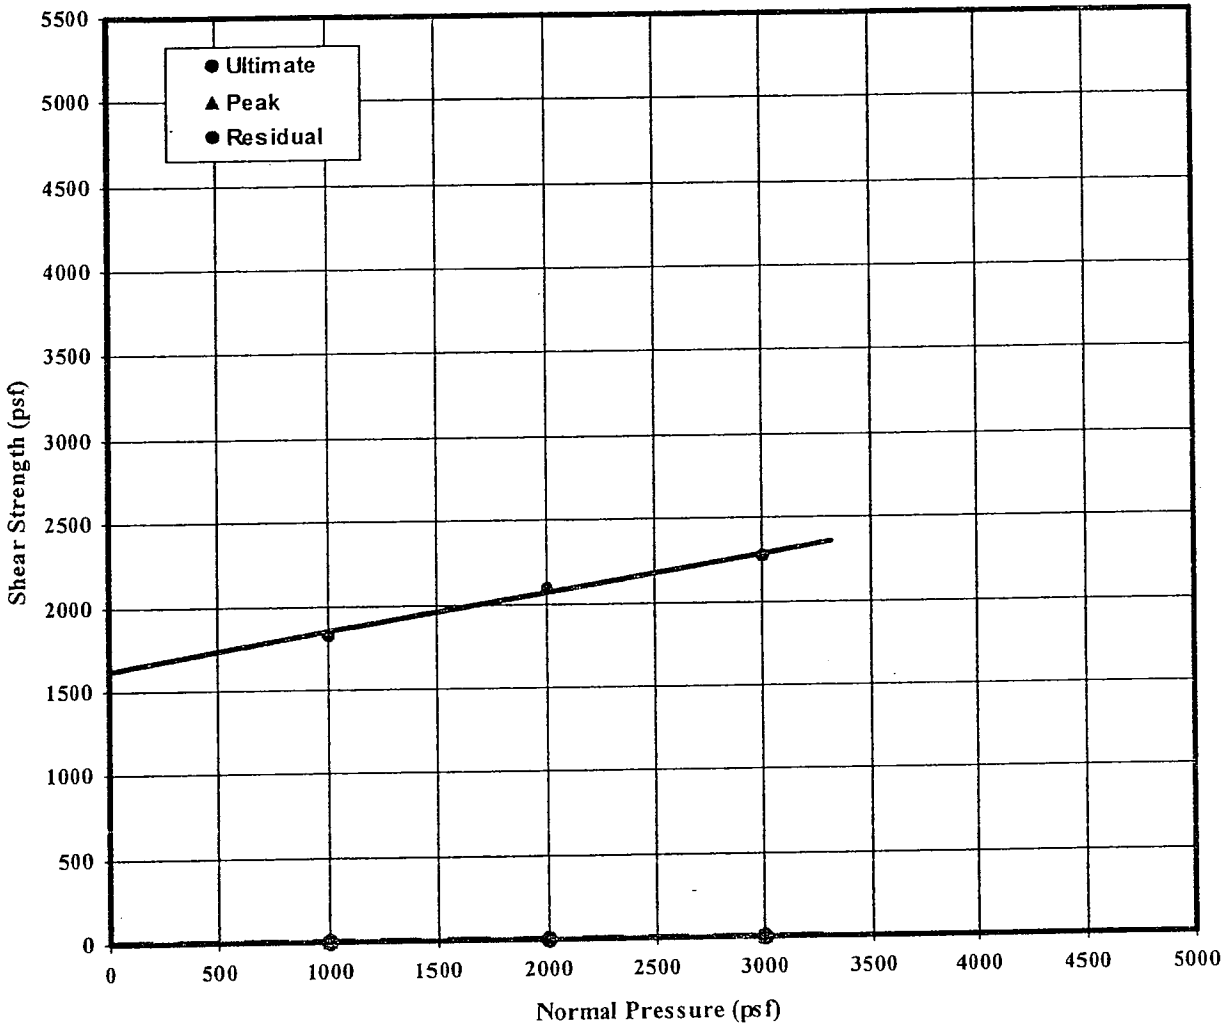
SHEAR TEST RESULTS

Undisturbed Sample

<u>Friction Angle</u>	<u>Cohesion</u>
Ultimate Shear Strength:	12 deg	1625 psf
Peak Shear Strength:		
Residual Shear Strength:

Displacement Rate: 0.01 in/min

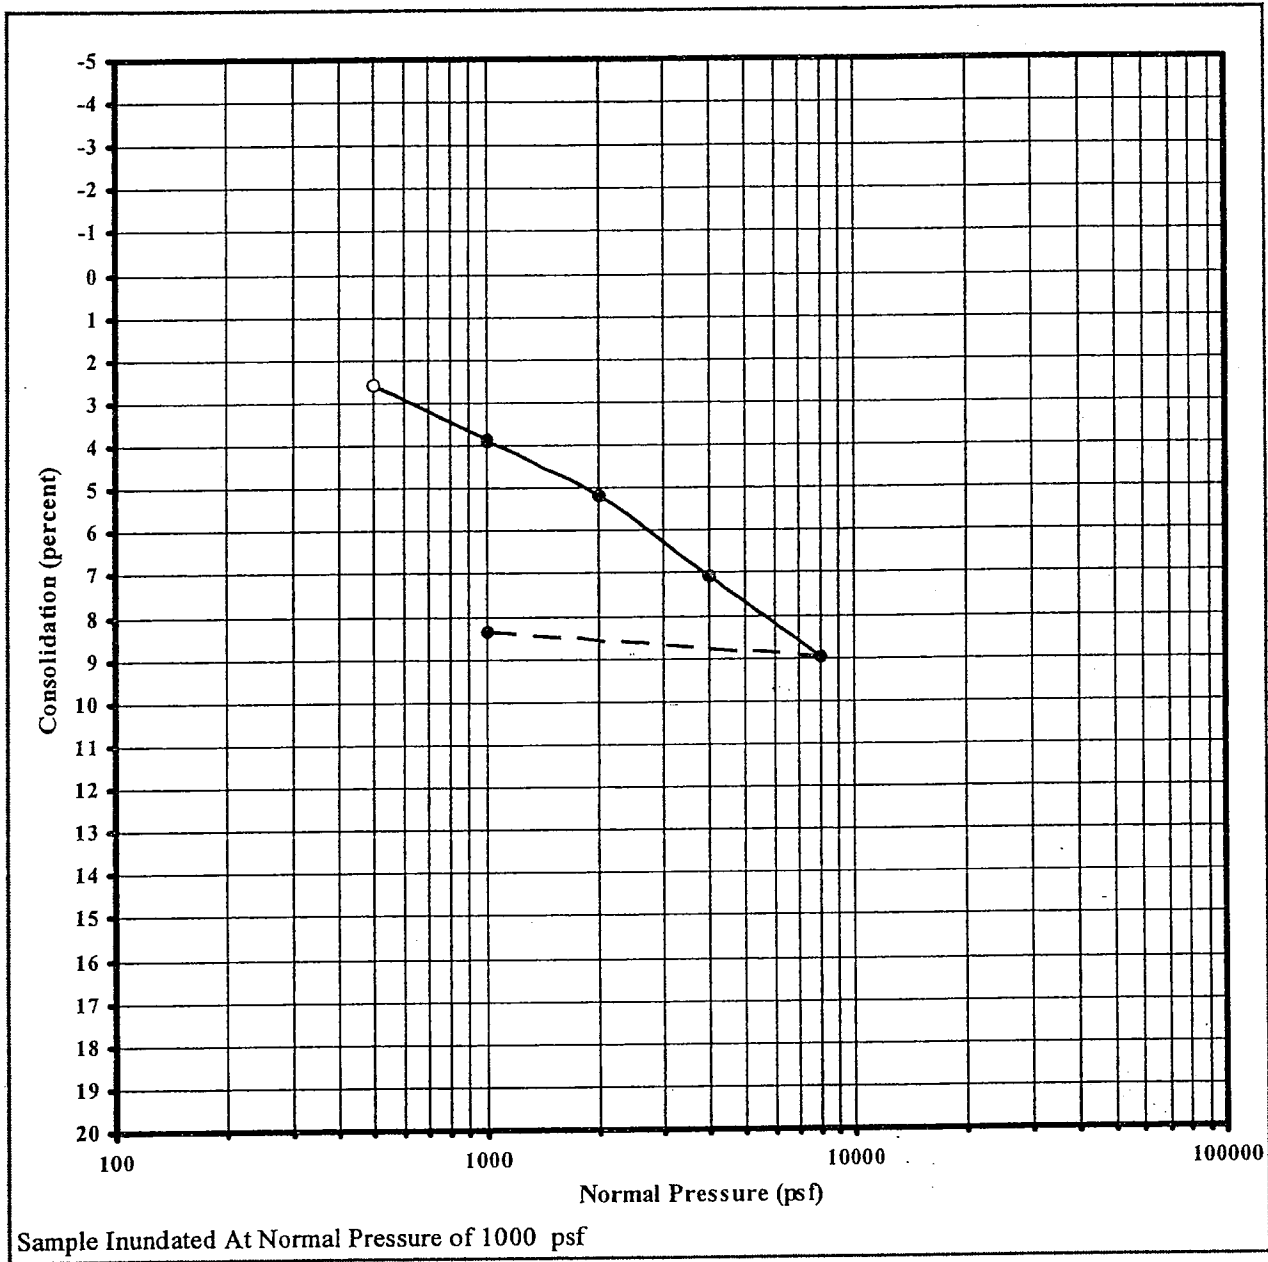
CONSOLIDATION RESULTS

Undisturbed Sample

Sample Location: GWV4

Sample Depth: 10 ft.

Initial Moisture: 19.3 %

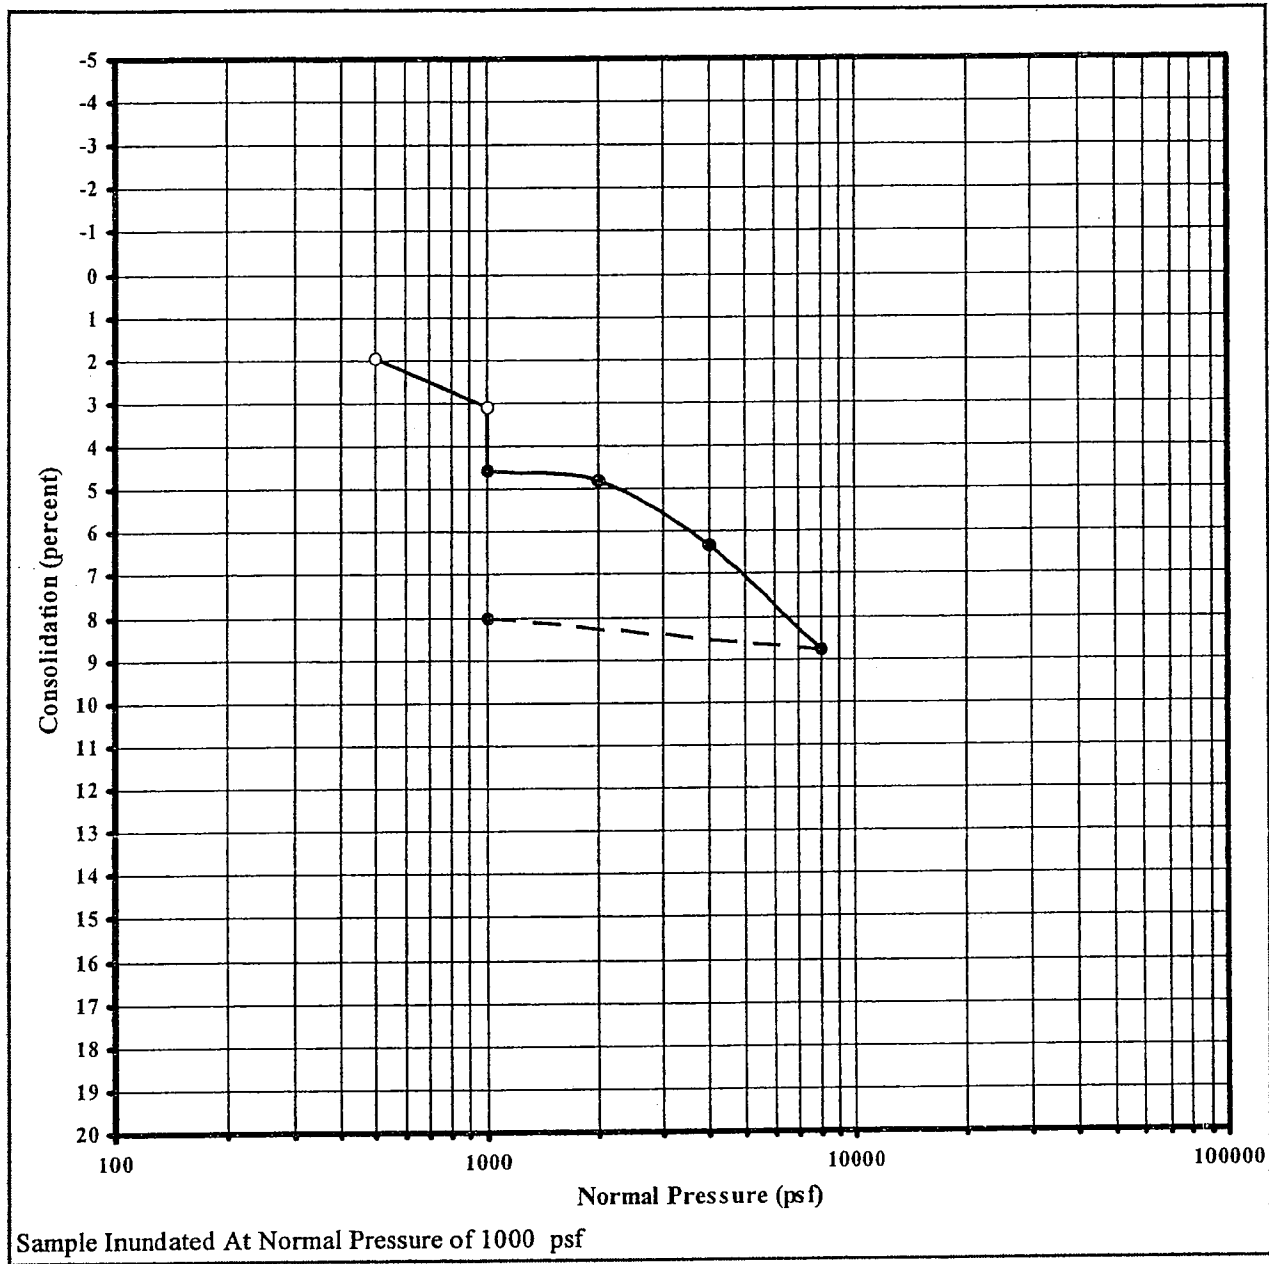
CONSOLIDATION RESULTS

Undisturbed Sample

Sample Location: GWV4

Sample Depth: 20 ft.

Initial Moisture: 21.4 %

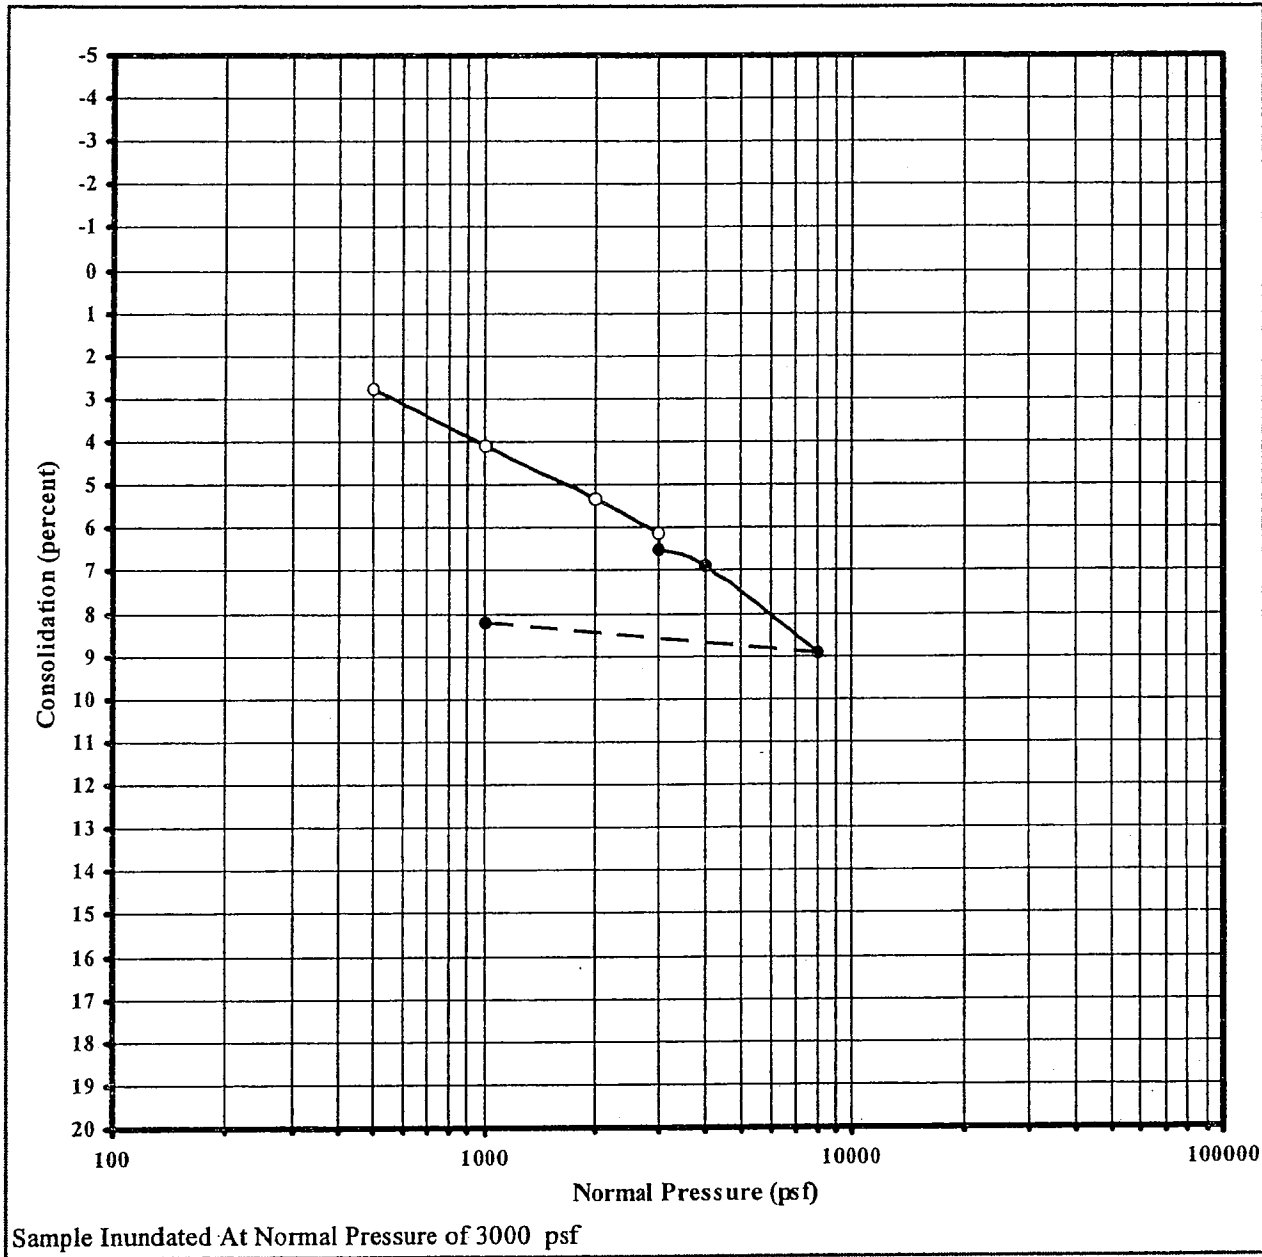
CONSOLIDATION RESULTS

Undisturbed Sample

Sample Location: GWV4

Sample Depth: 20 ft.

Initial Moisture: 21.4 %
