**SANTA PAULA GEOLOGIC HAZARD
ABATEMENT DISTRICT (GHAD)
PLAN OF CONTROL**

SANTA PAULA, CALIFORNIA

ENGEO INCORPORATED

MARCH 10, 2008

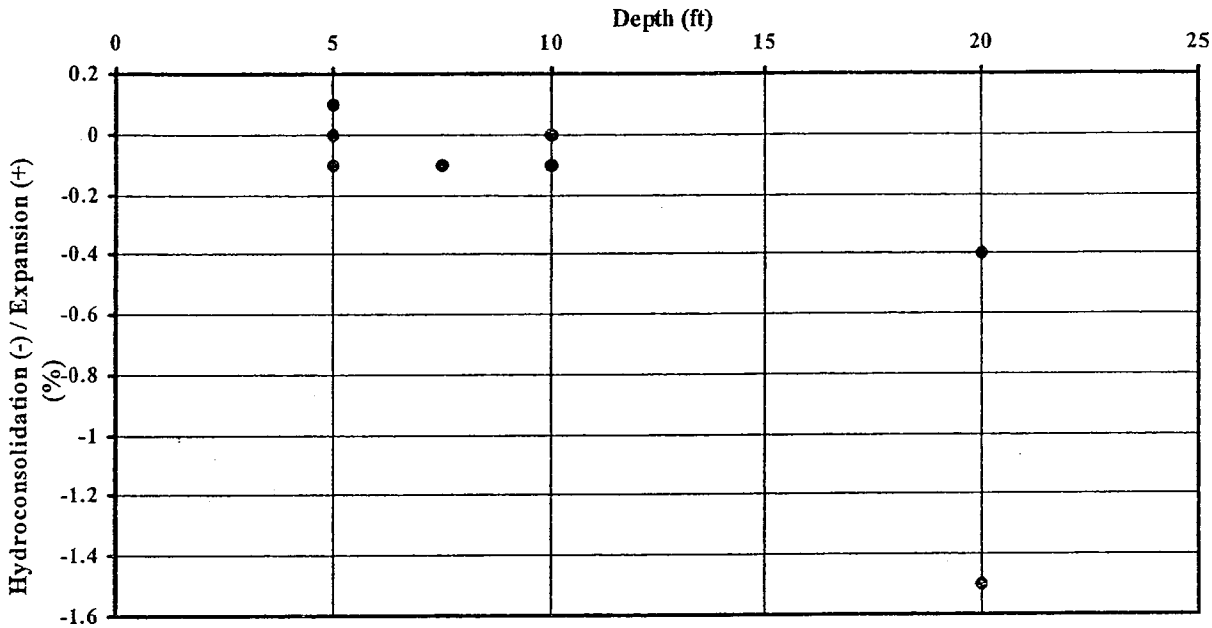
HYDROCONSOLIDATION/EXPANSION VS. DEPTH

Terrace Deposits

Excavation	Depth (ft)	Field DD (pcf)	M (%)	e	S (%)	Volume Change (%)	Terrace Deposits Material
GWV1	5	110.7	18.5	0.51	96.9	-0.1	SILT with clay
GWV1	5	110.7	18.5	0.51	96.9	-0.1	SILT with clay
GWV1	5	110.7	18.5	0.51	96.9	0.0	SILT with clay
GWV1	5	110.7	18.5	0.51	96.9	0.0	SILT with clay
GWV2	5	110.2	17.9	0.52	92.7	-0.1	SILT with clay
GWV3	5	112.9	18.1	0.48	101.1	0.1	silty CLAY
GWV3	7.5	111.5	17.6	0.50	94.1	-0.1	clayey SILT to silty CLAY
GWV2	10	109.4	20.0	0.53	101	0.0	SILT with clay
GWV2	10	109.4	20.0	0.53	101	0.0	SILT with clay
GWV2	10	109.4	20.0	0.53	101	0.0	SILT with clay
GWV2	10	109.4	20.0	0.53	101	0.0	SILT with clay
GWV4	10	105.7	19.3	0.58	88.9	-0.1	fine sandy SILT
GWV4	20	106.2	21.4	0.57	100	-1.5	Interbedded sandy SILT and silty SAND
GWV4	20	106.2	21.4	0.57	100	-1.5	Interbedded sandy SILT and silty SAND
GWV4	20	106.2	21.4	0.57	100	-0.4	Interbedded sandy SILT and silty SAND
GWV4	20	106.2	21.4	0.57	100	-0.4	Interbedded sandy SILT and silty SAND

DD = Field Dry Density, M = Field Moisture, e = initial void ratio, S = initial degree of saturation, Volume Change = percent of hydroconsolidation(-) or expansion (+)

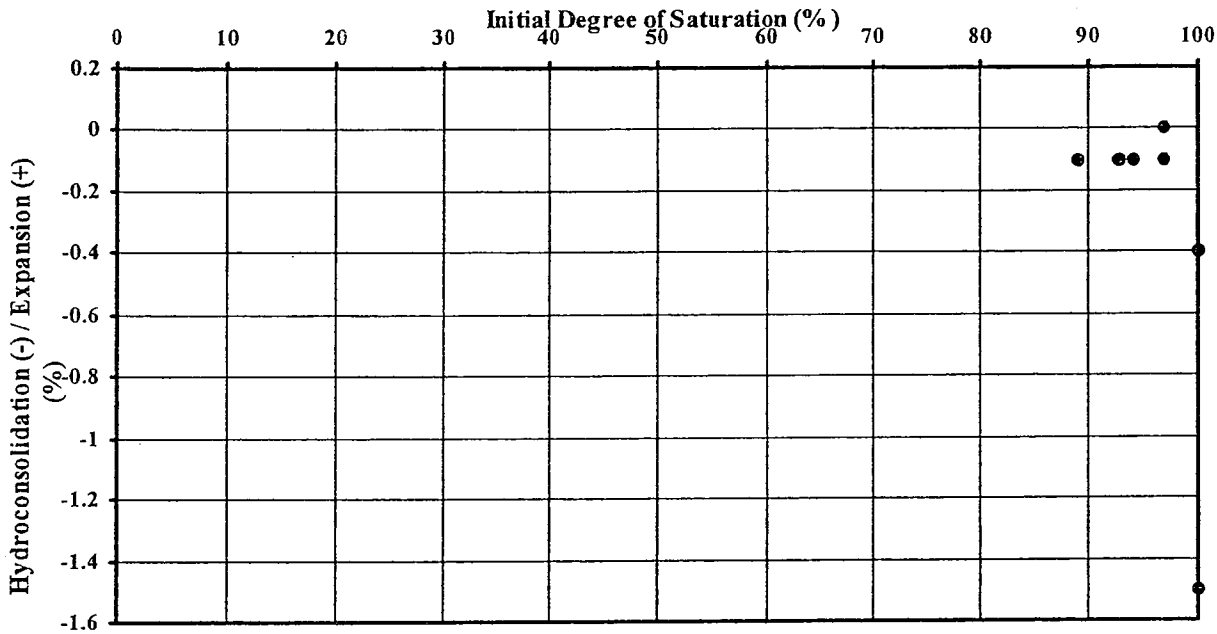
HYDROCONSOLIDATION/EXPANSION VS. SATURATION

Terrace Deposits

Excavation	Depth (ft)	Field DD (pcf)	M (%)	e	S (%)	Volume Change (%)	Terrace Deposits Material
GWV1	5	110.7	18.5	0.51	96.9	-0.1	SILT with clay
GWV1	5	110.7	18.5	0.51	96.9	-0.1	SILT with clay
GWV1	5	110.7	18.5	0.51	96.9	0.0	SILT with clay
GWV1	5	110.7	18.5	0.51	96.9	0.0	SILT with clay
GWV2	5	110.2	17.9	0.52	92.7	-0.1	SILT with clay
GWV3	5	112.9	18.1	0.48	101.1	0.1	silty CLAY
GWV3	7.5	111.5	17.6	0.50	94.1	-0.1	clayey SILT to silty CLAY
GWV2	10	109.4	20.0	0.53	101	0.0	SILT with clay
GWV2	10	109.4	20.0	0.53	101	0.0	SILT with clay
GWV2	10	109.4	20.0	0.53	101	0.0	SILT with clay
GWV2	10	109.4	20.0	0.53	101	0.0	SILT with clay
GWV4	10	105.7	19.3	0.58	88.9	-0.1	fine sandy SILT
GWV4	20	106.2	21.4	0.57	100	-1.5	Interbedded sandy SILT and silty SAND
GWV4	20	106.2	21.4	0.57	100	-1.5	Interbedded sandy SILT and silty SAND
GWV4	20	106.2	21.4	0.57	100	-0.4	Interbedded sandy SILT and silty SAND
GWV4	20	106.2	21.4	0.57	100	-0.4	Interbedded sandy SILT and silty SAND

DD = Field Dry Density, M = Field Moisture, e = initial void ratio, S = initial degree of saturation, Volume Change = percent of hydroconsolidation(-) or expansion (+)

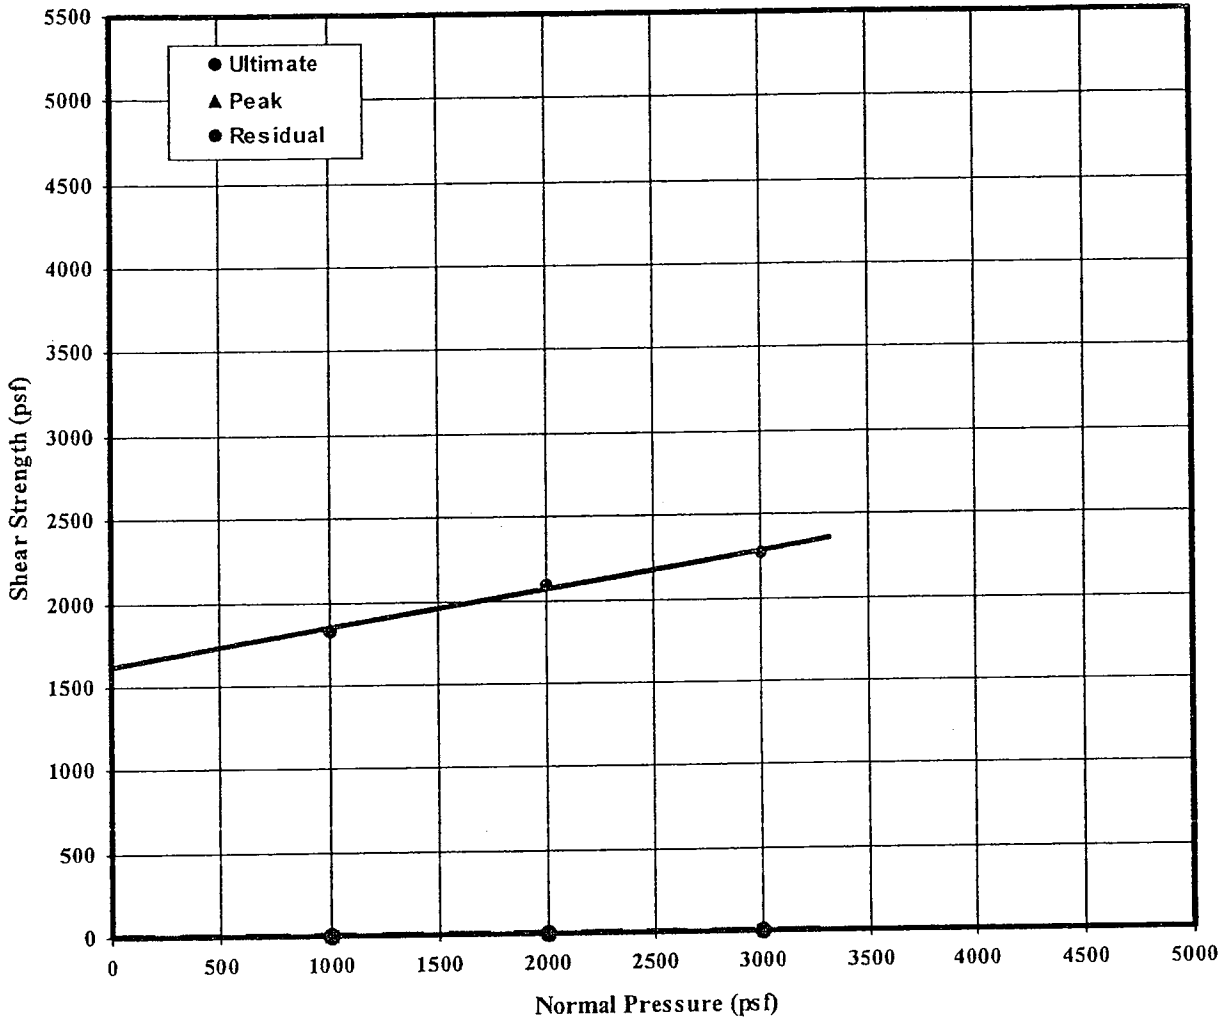
SHEAR TEST RESULTS

Undisturbed Sample

Friction Angle Cohesion
 Ultimate Shear Strength: 12 deg 1625 psf
 Peak Shear Strength:
 Residual Shear Strength:

Displacement Rate: 0.01 in/min

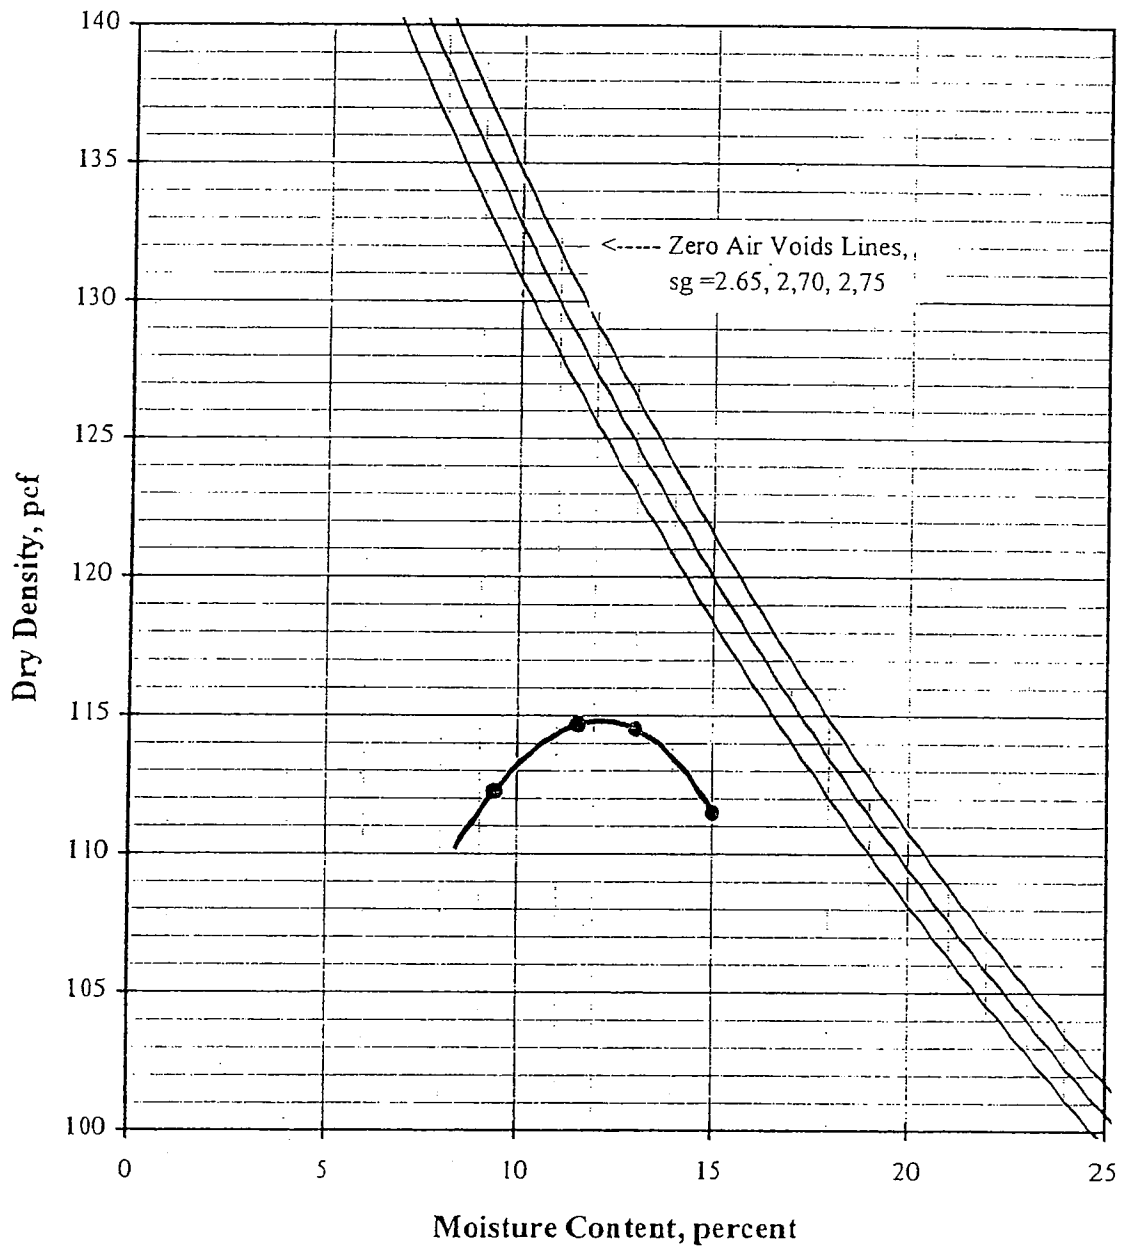
MAXIMUM DENSITY / OPTIMUM MOISTURE

Procedure Used: A
 Prep. Method: Moist
 Rammer Type: Manual

Maximum Density:	115 pcf	<u>Sieve Size % Retained</u>	
Optimum Moisture:	12%	3/4"	0.0
		3/8"	0.0
		#4	0.0

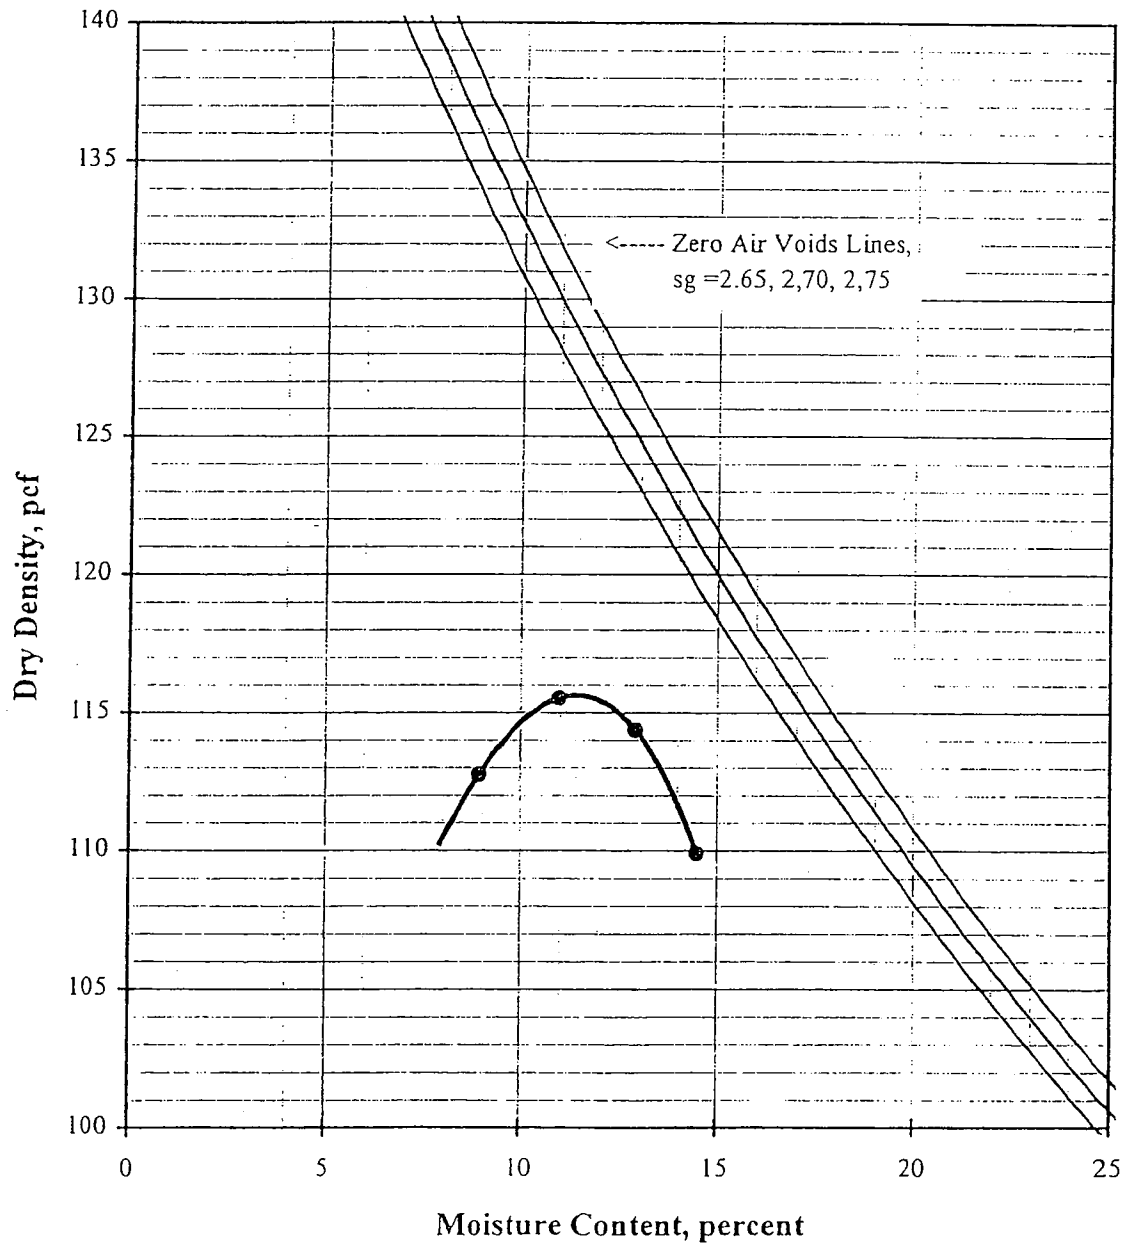
MAXIMUM DENSITY / OPTIMUM MOISTURE

ASTM D 1557-91 (Modified)

Procedure Used: A
 Prep. Method: Moist
 Rammer Type: Manual

Sieve Size % Retained	
Maximum Density:	115.5 pcf	3/4"	0.0
Optimum Moisture:	11.5%	3/8"	0.0
		#4	0.0

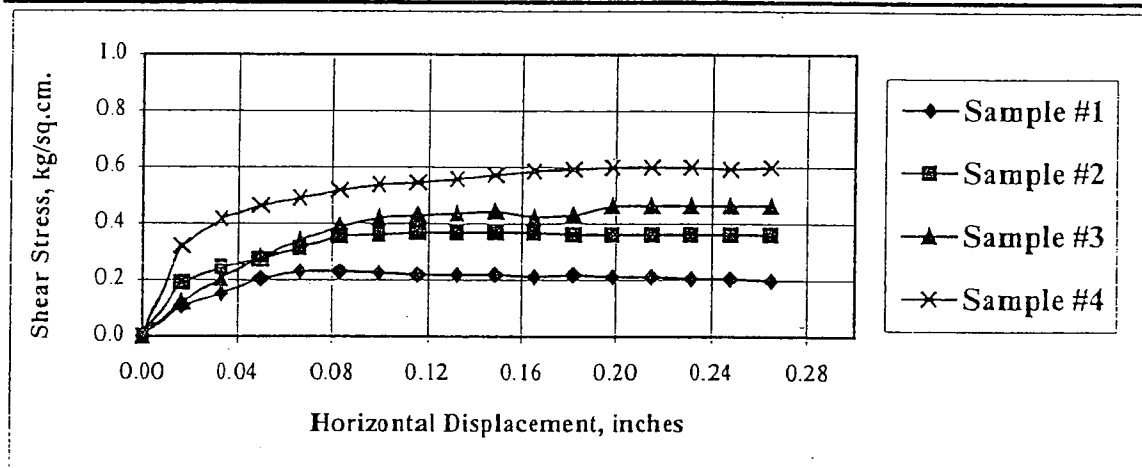
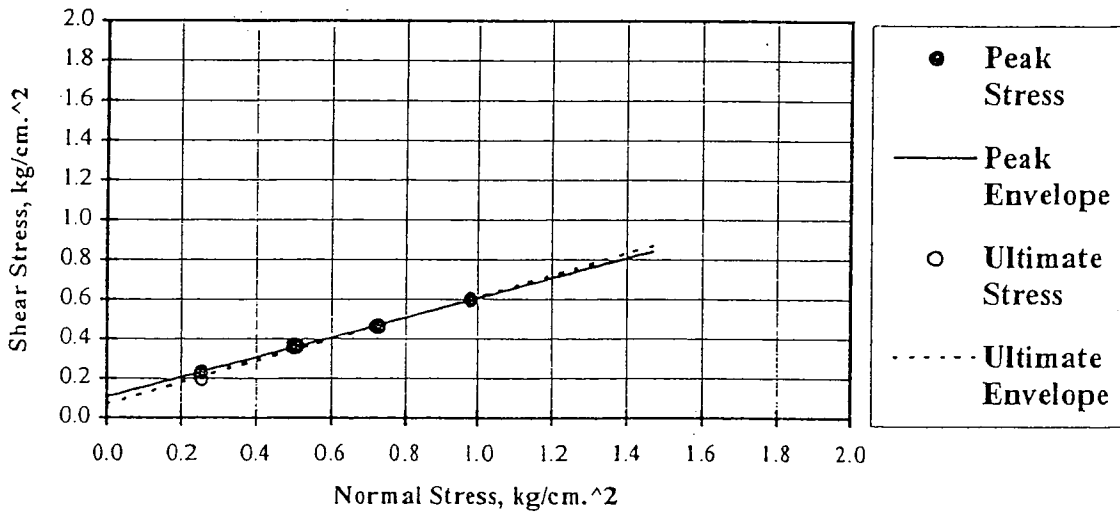
DIRECT SHEAR 080-90 (modified for unconsolidated, undrained conditions)

Santa Paula Memorial Hospital Assisted Living Facility Initial Dry Density: 104.5 pcf

Initial Moisture Content: 10.9 %

Cohesion (c): 0.107 kg/cm² (220 psf)

Sample No.	1	2	3	4	Average
Initial					
Dry Density, pcf	104.5	104.5	104.5	104.5	104.5
Moisture Content, %	10.9	10.9	10.9	10.9	10.9
Saturation, %	49	49	49	49	49
At Test					
Moisture Content, %	21.7	21.9	21.7	20.9	21.5
Saturation, %	97	98	97	94	97
Normal Stress, kg/cm ²	0.25	0.51	0.73	0.98	
Peak Stress, kg/cm ²	0.23	0.37	0.46	0.60	
Ultimate Stress, kg/cm ²	0.20	0.36	0.46	0.60

SHEAR vs. NORMAL STRESS DIAGRAM

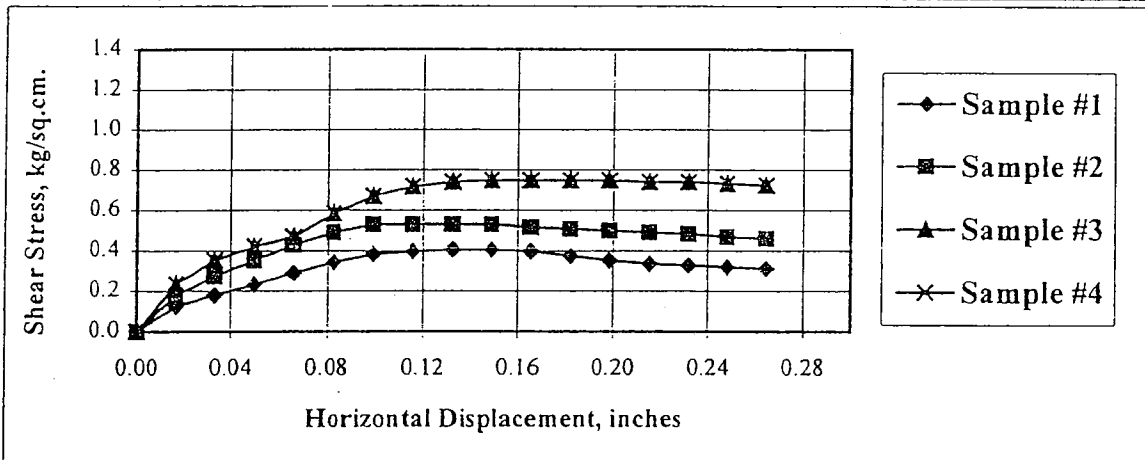
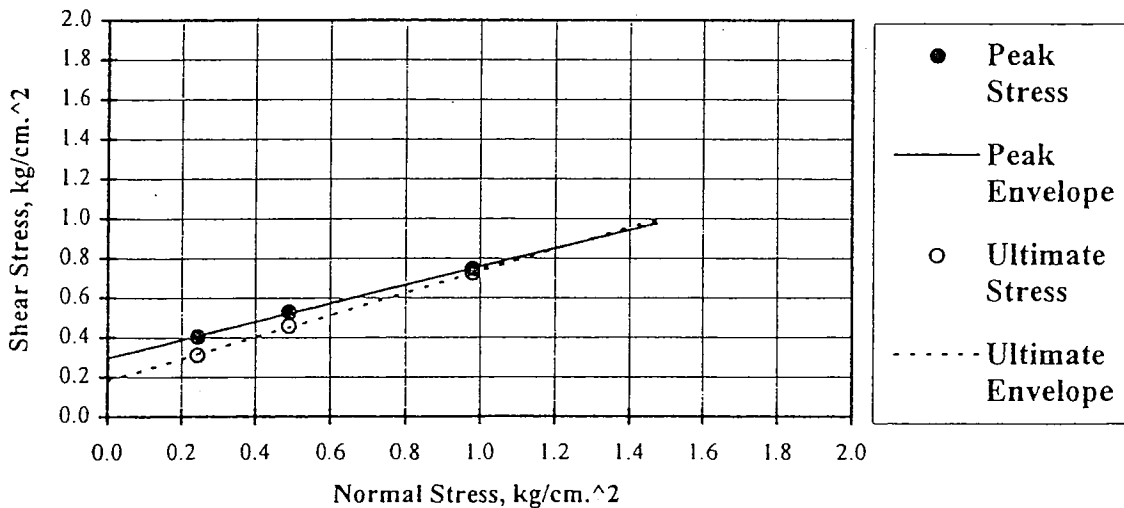
DIRECT SHEAR 080-90 (modified for unconsolidated, undrained conditions)

Santa Paula Memorial Hospital Assisted Living Facility Initial Dry Density: 107.2 pcf
 3 @ 10 Initial Moisture Content: 19.1 %
 Clay Peak Friction Angle (ϕ): 25°
 Undisturbed Cohesion (c): 0.296 kg/cm² (610 psf)

Sample No.	1	2	3	4	Average
Initial					
Dry Density, pcf	106.4	107.4	107.5	107.5	107.2
Moisture Content, %	19.1	19.1	19.1	19.1	19.1
Saturation, %	90	93	93	93	92
At Test					
Moisture Content, %	21.0	20.4	20.3	20.3	20.5
Saturation, %	99	99	99	99	99
Normal Stress, kg/cm ²	0.24	0.49	0.98	0.98	
Peak Stress, kg/cm ²	0.40	0.53	0.75	0.75	
Ultimate Stress, kg/cm ²	0.31	0.46	0.72	0.72

SHEAR vs. NORMAL STRESS DIAGRAM

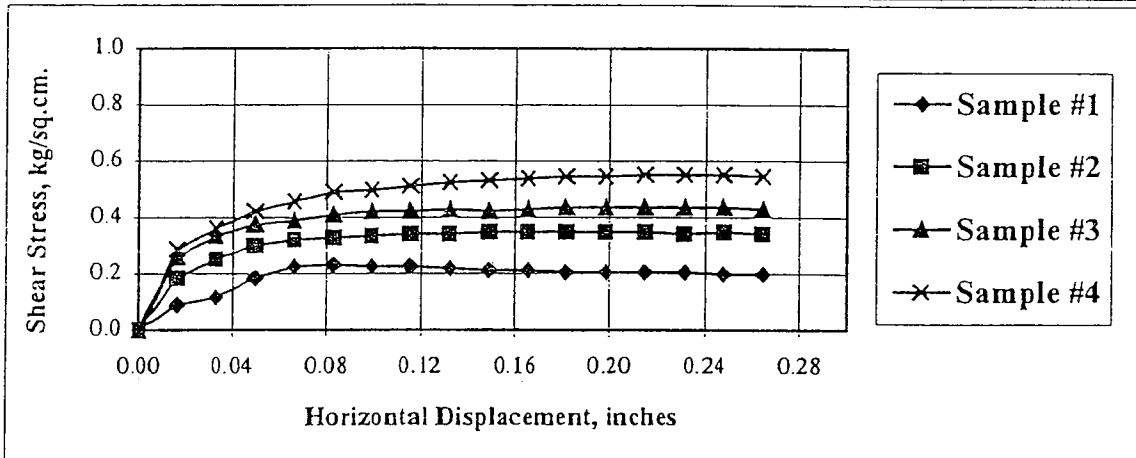
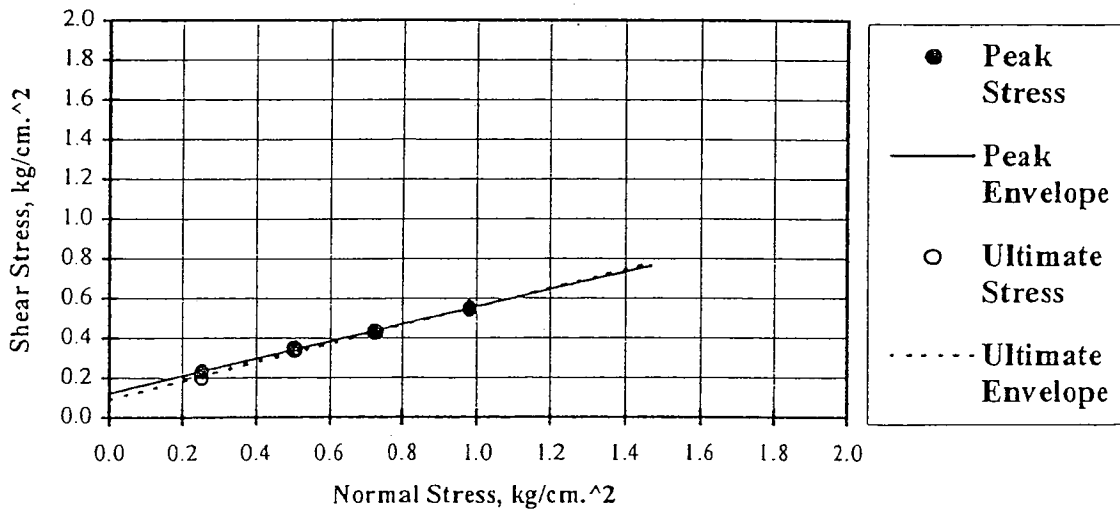
DIRECT SHEAR 080-90 (modified for unconsolidated, undrained conditions)

Santa Paula Memorial Hospital Assisted Living Facility Initial Dry Density: 103.8 pcf
 1 @ 0 - 5 Initial Moisture Content: 11.5 %
 Silt Peak Friction Angle (ϕ): 24°
 Remolded Cohesion (c): 0.122 kg/cm² (250 psf)

Sample No.	1	2	3	4	Average
Initial					
Dry Density, pcf	103.8	103.8	103.8	103.8	103.8
Moisture Content, %	11.5	11.5	11.5	11.5	11.5
Saturation, %	51	51	51	51	51
At Test					
Moisture Content, %	22.4	21.7	22.3	22.3	22.2
Saturation, %	99	96	98	98	98
Normal Stress, kg/cm ²	0.25	0.51	0.73	0.98	
Peak Stress, kg/cm ²	0.23	0.35	0.44	0.55	
Ultimate Stress, kg/cm ²	0.20	0.34	0.43	0.54

SHEAR vs. NORMAL STRESS DIAGRAM

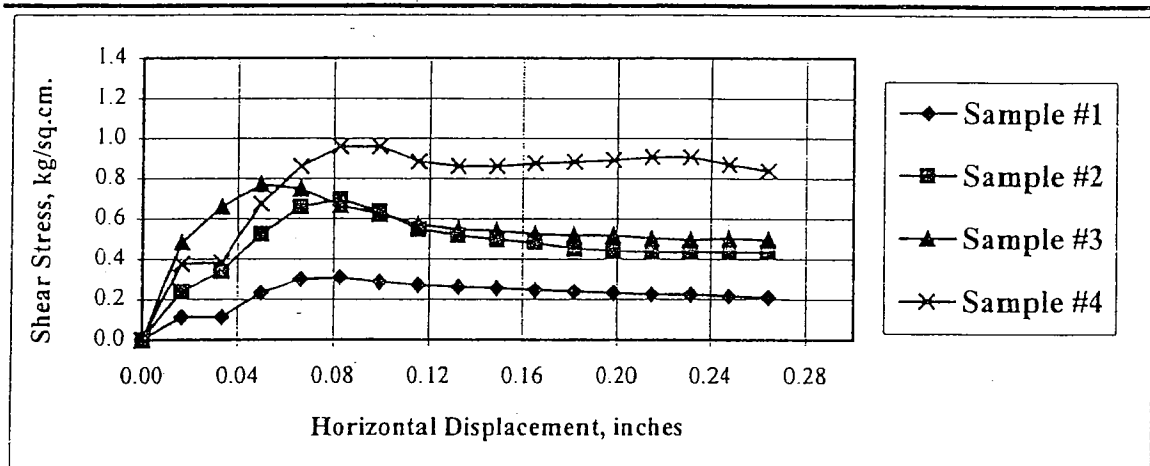
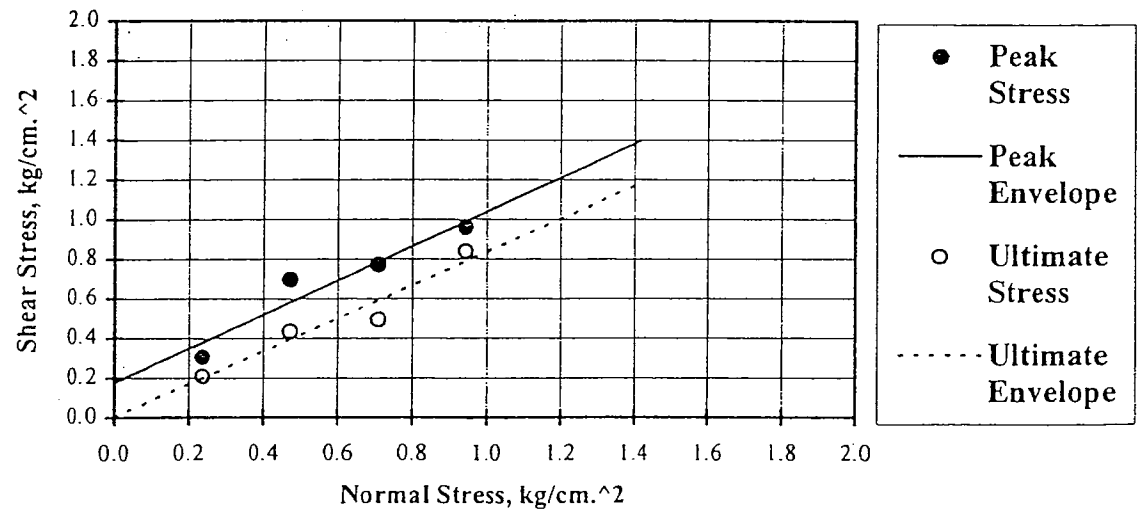
DIRECT SHEAR 080-90 (modified for unconsolidated, undrained conditions)

Santa Paula Memorial Hospital Assisted Living Facility Initial Dry Density: 108.0 pcf
 3 @ 35 Initial Moisture Content: 19.1 %
 Clayey Silt Peak Friction Angle (ϕ): 41°
 Undisturbed Cohesion (c): 0.176 kg/cm² (360 psf)

Sample No.	1	2	3	4	Average
Initial					
Dry Density, pcf	107.9	108.6	107.4	108.1	108.0
Moisture Content, %	19.1	19.1	19.1	19.1	19.1
Saturation, %	94	96	92	94	94
At Test					
Moisture Content, %	19.9	19.8	19.4	19.9	19.7
Saturation, %	97	99	94	98	97
Normal Stress, kg/cm ²	0.24	0.47	0.71	0.94	
Peak Stress, kg/cm ²	0.31	0.70	0.77	0.96	
Ultimate Stress, kg/cm ²	0.21	0.43	0.49	0.84

SHEAR vs. NORMAL STRESS DIAGRAM

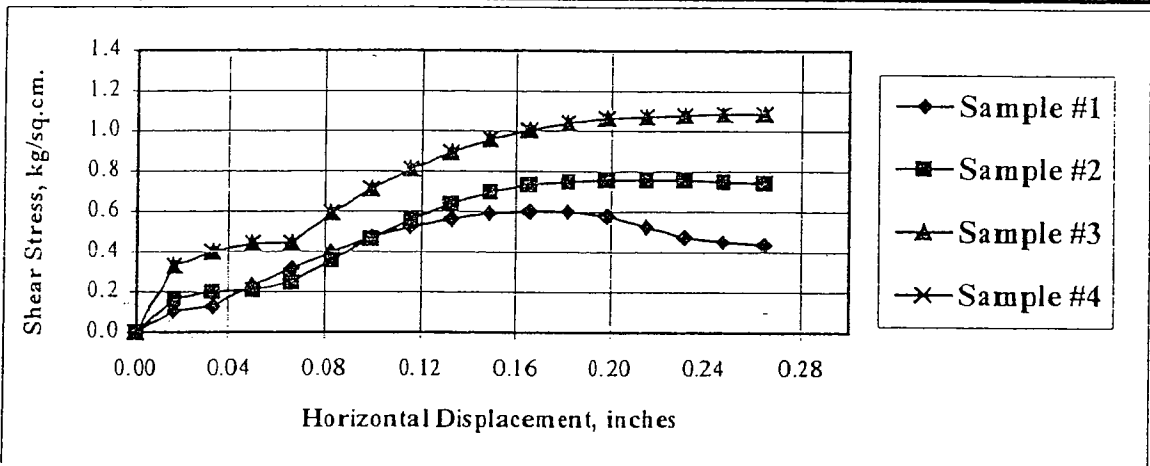
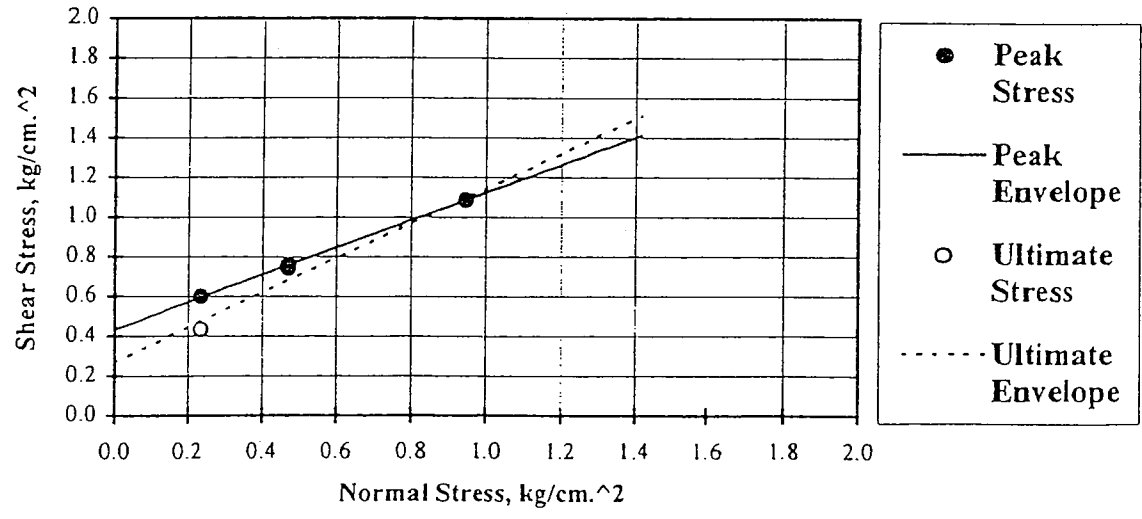
DIRECT SHEAR 080-90 (modified for unconsolidated, undrained conditions)

Santa Paula Memorial Hospital Assisted Living Facility Initial Dry Density: 105.2 pcf
 3 @ 2 Initial Moisture Content: 16.8 %
 Clay Peak Friction Angle (ϕ): 35°
 Undisturbed Cohesion (c): 0.434 kg/cm² (890 psf)

Sample No.	1	2	3	4	Average
Initial					
Dry Density, pcf	106.9	109.9	102.0	102.0	105.2
Moisture Content, %	16.8	16.8	16.8	16.8	16.8
Saturation, %	80	87	71	71	77
At Test					
Moisture Content, %	20.3	18.7	21.6	21.6	20.5
Saturation, %	97	97	91	91	94
Normal Stress, kg/cm ²	0.24	0.47	0.94	0.94	
Peak Stress, kg/cm ²	0.60	0.76	1.09	1.09	
Ultimate Stress, kg/cm ²	0.43	0.74	1.09	1.09

SHEAR vs. NORMAL STRESS DIAGRAM

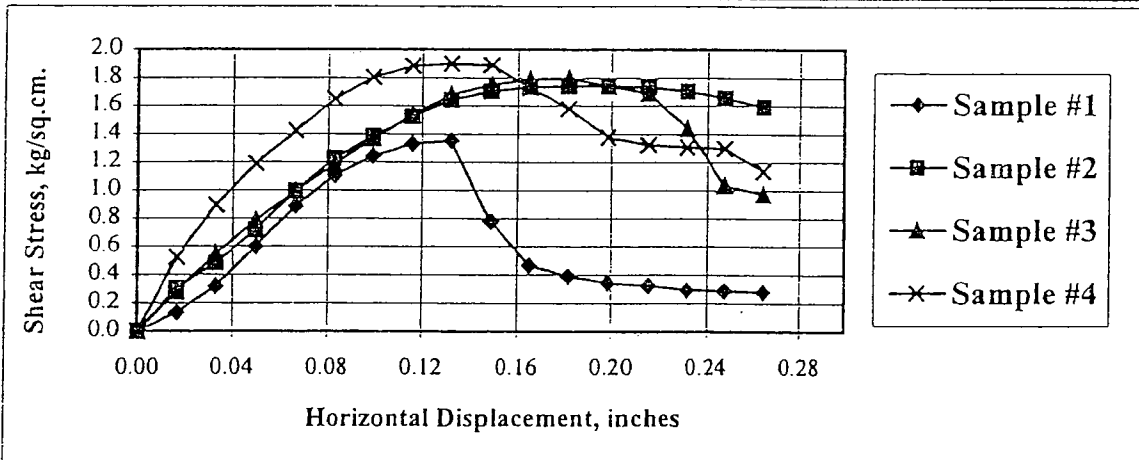
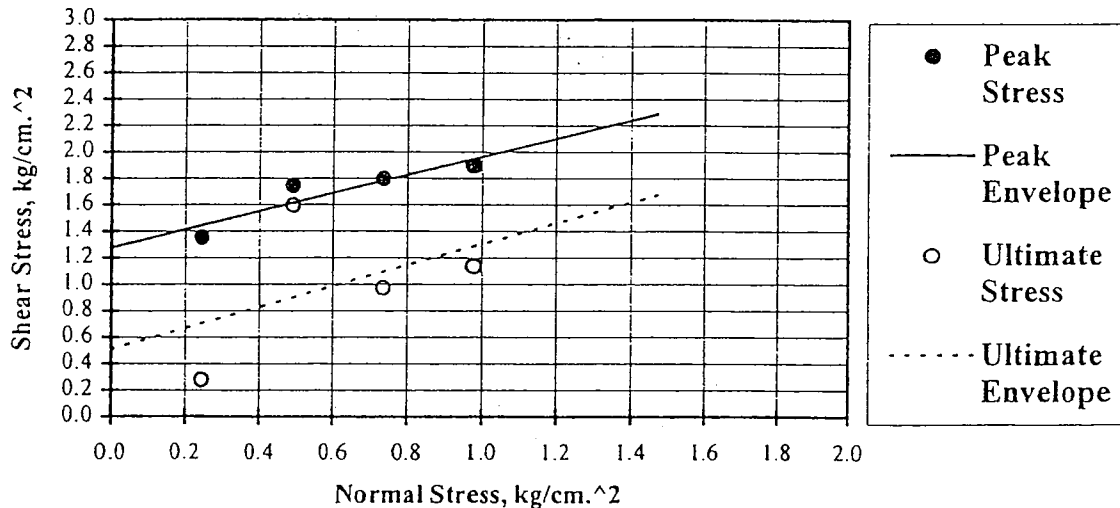
DIRECT SHEAR 080-90 (modified for unconsolidated, undrained conditions)

Santa Paula Memorial Hospital Assisted Living Facility Initial Dry Density: 116.9 pcf
 3 @ 25 Initial Moisture Content: 16.2 %
 Clay Peak Friction Angle (ϕ): 35°
 Undisturbed Cohesion (c): 1.276 kg/cm² (2610 psf)

Sample No.	1	2	3	4	Average
Initial					
Dry Density, pcf	116.1	116.3	117.3	117.8	116.9
Moisture Content, %	16.2	16.2	16.2	16.2	16.2
Saturation, %	99	100	100	100	102
At Test					
Moisture Content, %	19.0	18.9	19.0	18.7	18.9
Saturation, %	117	116	121	120	119
Normal Stress, kg/cm ²	0.24	0.49	0.73	0.98	
Peak Stress, kg/cm ²	1.35	1.74	1.80	1.90	
Ultimate Stress, kg/cm ²	0.28	1.59	0.97	1.14

SHEAR vs. NORMAL STRESS DIAGRAM

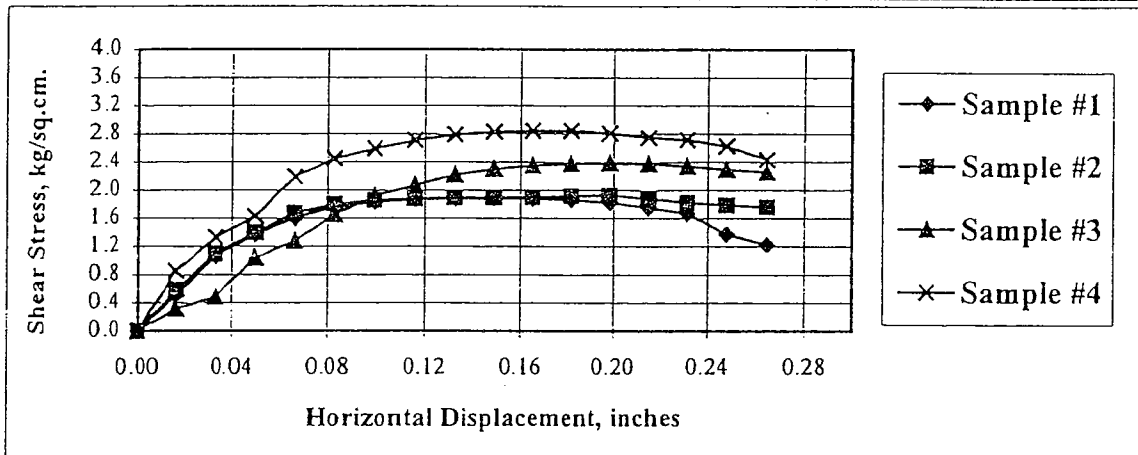
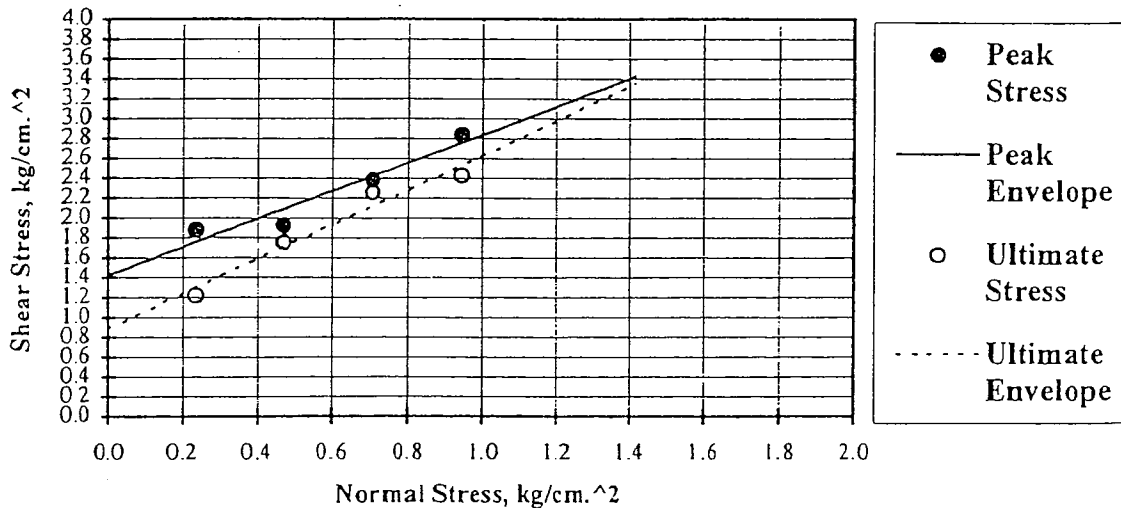
DIRECT SHEAR 080-90 (modified for unconsolidated, undrained conditions)

Santa Paula Memorial Hospital Assisted Living Facility Initial Dry Density: 118.3 pcf
 3 @ 40 Initial Moisture Content: 14.0 %
 Silty Clay Peak Friction Angle (ϕ): 55°
 Undisturbed Cohesion (c): 1.424 kg/cm² (2920 psf)

Sample No.	1	2	3	4	Average
Initial					
Dry Density, pcf	119.5	117.4	116.9	119.2	118.3
Moisture Content, %	14.0	14.0	14.0	14.0	14.0
Saturation, %	95	89	88	94	91
At Test					
Moisture Content, %	14.0	14.7	15.4	14.7	14.7
Saturation, %	95	94	97	99	96
Normal Stress, kg/cm ²	0.24	0.47	0.71	0.94	
Peak Stress, kg/cm ²	1.88	1.93	2.38	2.84	
Ultimate Stress, kg/cm ²	1.22	1.75	2.26	2.43

SHEAR vs. NORMAL STRESS DIAGRAM

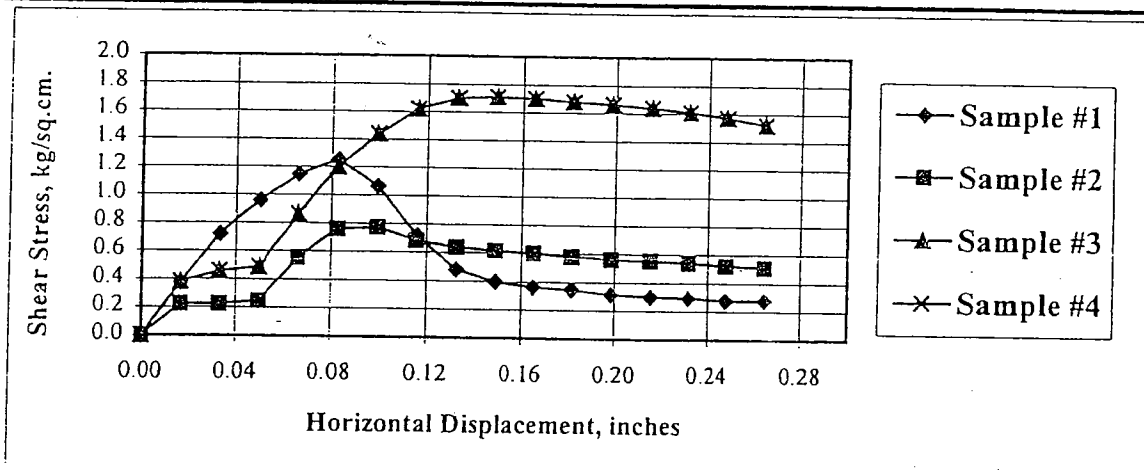
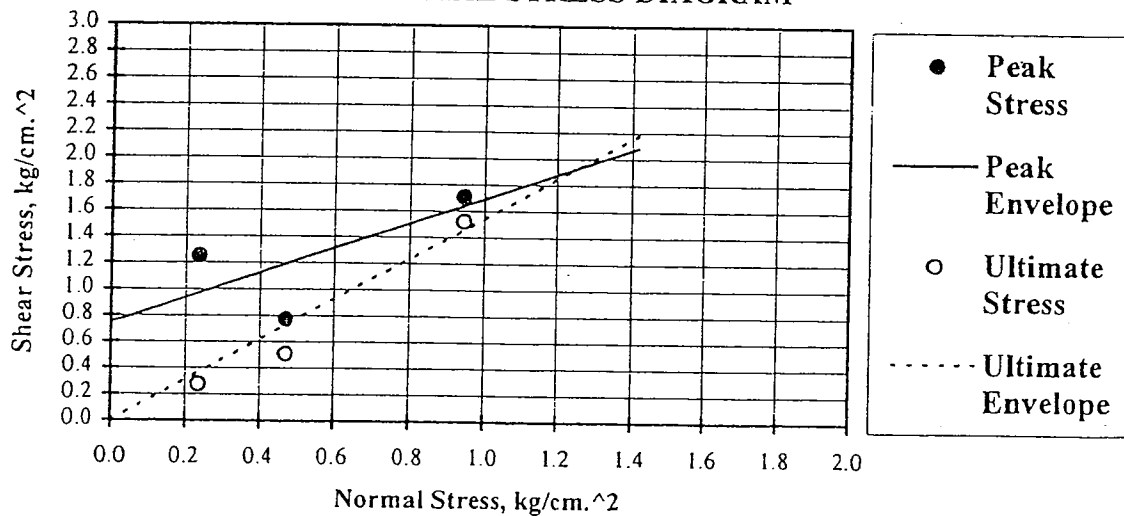
DIRECT SHEAR 080-90 (modified for unconsolidated, undrained conditions)

Santa Paula Memorial Hospital Assisted Living Facility Initial Dry Density: 107.7 pcf
 3 @ 50 Initial Moisture Content: 19.0 %
 Silty Clay Peak Friction Angle (ϕ): 43°
 Undisturbed Cohesion (c): 0.748 kg/cm² (1530 psf)

Sample No.	1	2	3	4	Average
Initial					
Dry Density, pcf	108.4	108.0	107.3	107.3	107.7
Moisture Content, %	19.0	19.0	19.0	19.0	19.0
Saturation, %	95	94	92	92	93
At Test					
Moisture Content, %	19.7	20.2	19.8	19.8	19.9
Saturation, %	98	100	95	95	97
Normal Stress, kg/cm ²	0.24	0.47	0.94	0.94	
Peak Stress, kg/cm ²	1.25	0.77	1.71	1.71	
Ultimate Stress, kg/cm ²	0.28	0.51	1.52	1.52

SHEAR vs. NORMAL STRESS DIAGRAM

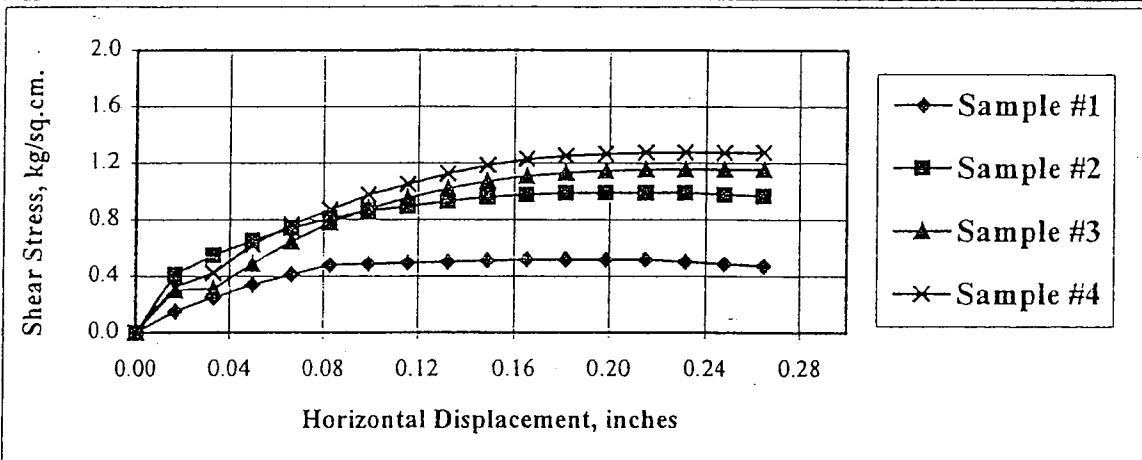
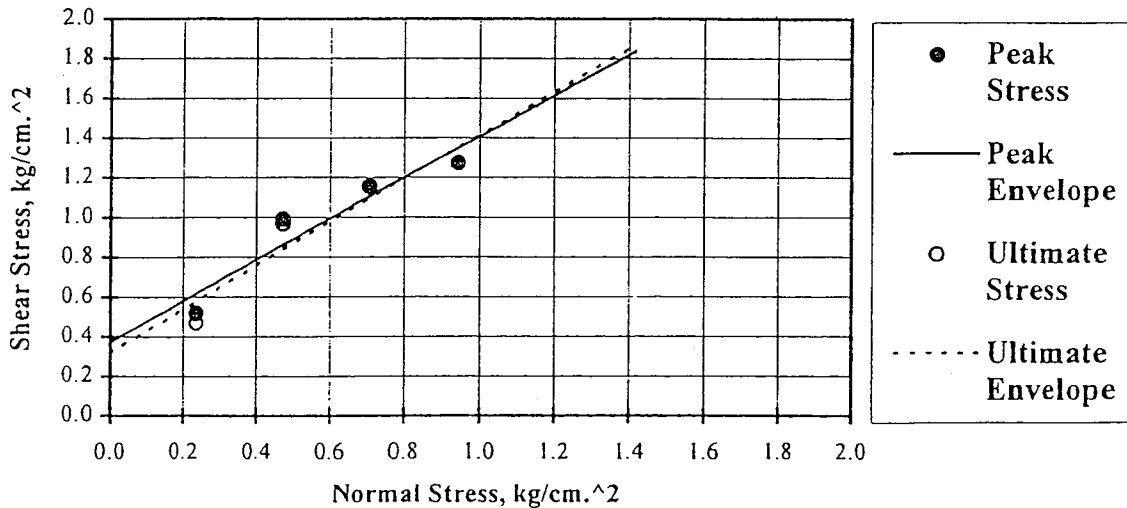
DIRECT SHEAR 080-90 (modified for unconsolidated, undrained conditions)

Santa Paula Memorial Hospital Assisted Living Facility Initial Dry Density: 110.2 pcf
 4 @ 2 Initial Moisture Content: 16.6 %
 Silt Peak Friction Angle (ϕ): 46°
 Undisturbed Cohesion (c): 0.375 kg/cm² (770 psf)

Sample No.	1	2	3	4	Average
Initial					
Dry Density, pcf	109.7	109.7	110.7	110.9	110.2
Moisture Content, %	16.6	16.6	16.6	16.6	16.6
Saturation, %	85	85	88	88	87
At Test					
Moisture Content, %	19.1	18.9	18.3	18.6	18.7
Saturation, %	98	97	97	99	98
Normal Stress, kg/cm ²	0.24	0.47	0.71	0.94	
Peak Stress, kg/cm ²	0.52	0.99	1.15	1.27	
Ultimate Stress, kg/cm ²	0.47	0.97	1.15	1.27

SHEAR vs. NORMAL STRESS DIAGRAM

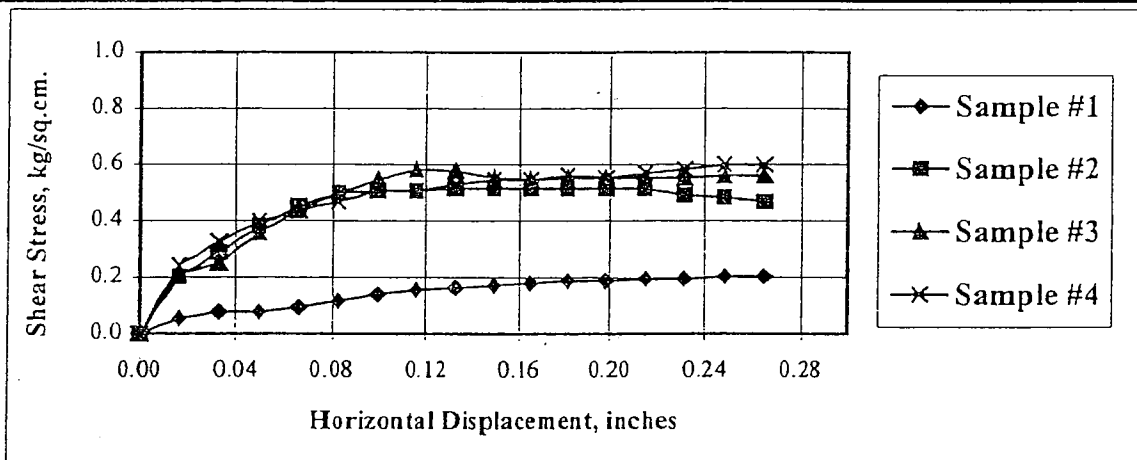
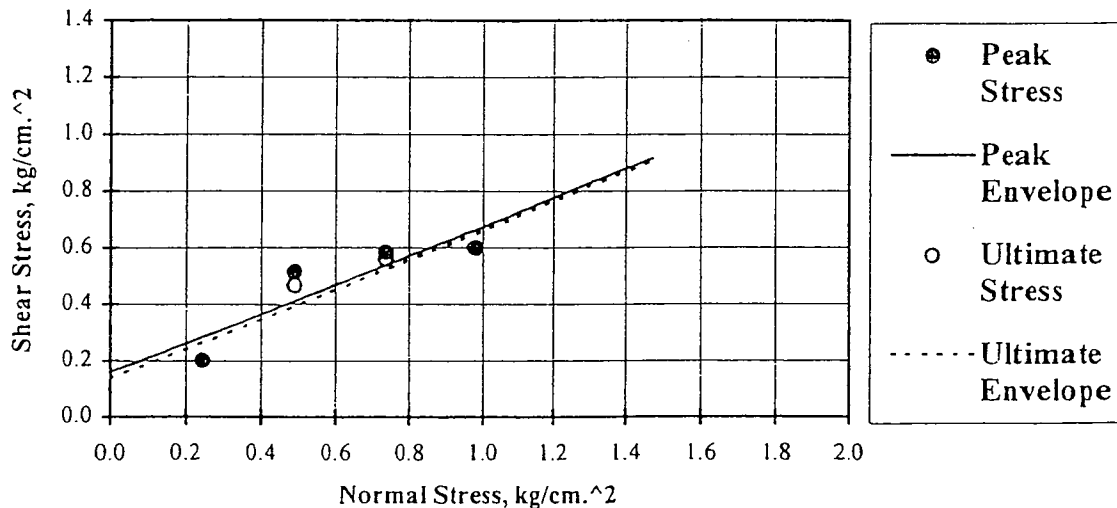
DIRECT SHEAR 080-90 (modified for unconsolidated, undrained conditions)

Santa Paula Memorial Hospital Assisted Living Facility Initial Dry Density: 105.8 pcf

Initial Moisture Content: 16.3 %

Cohesion (c): 0.160 kg/cm² (330 psf)

Sample No.	1	2	3	4	Average
Initial					
Dry Density, pcf	103.8	105.9	105.9	107.5	105.8
Moisture Content, %	16.3	16.3	16.3	16.3	16.3
Saturation, %	72	76	76	79	76
At Test					
Moisture Content, %	21.4	19.5	20.1	20.5	20.4
Saturation, %	95	91	94	100	95
Normal Stress, kg/cm ²	0.24	0.49	0.73	0.98	
Peak Stress, kg/cm ²	0.20	0.51	0.58	0.60	
Ultimate Stress, kg/cm ²	0.20	0.47	0.56	0.60

SHEAR vs. NORMAL STRESS DIAGRAM

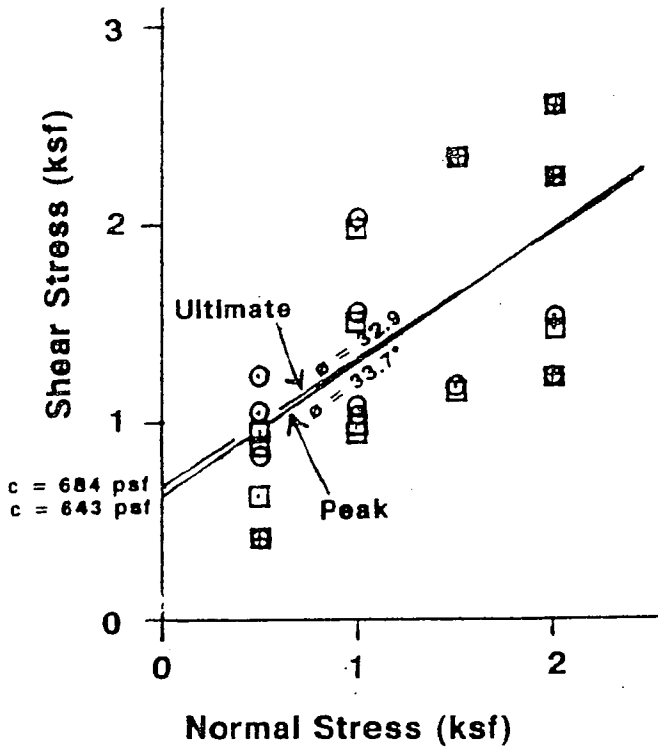
SCATTER DIAGRAM OF DIRECT SHEAR DATA FOR TERRACE DEPOSITS

- PEAK VALUES
- ULTIMATE VALUES

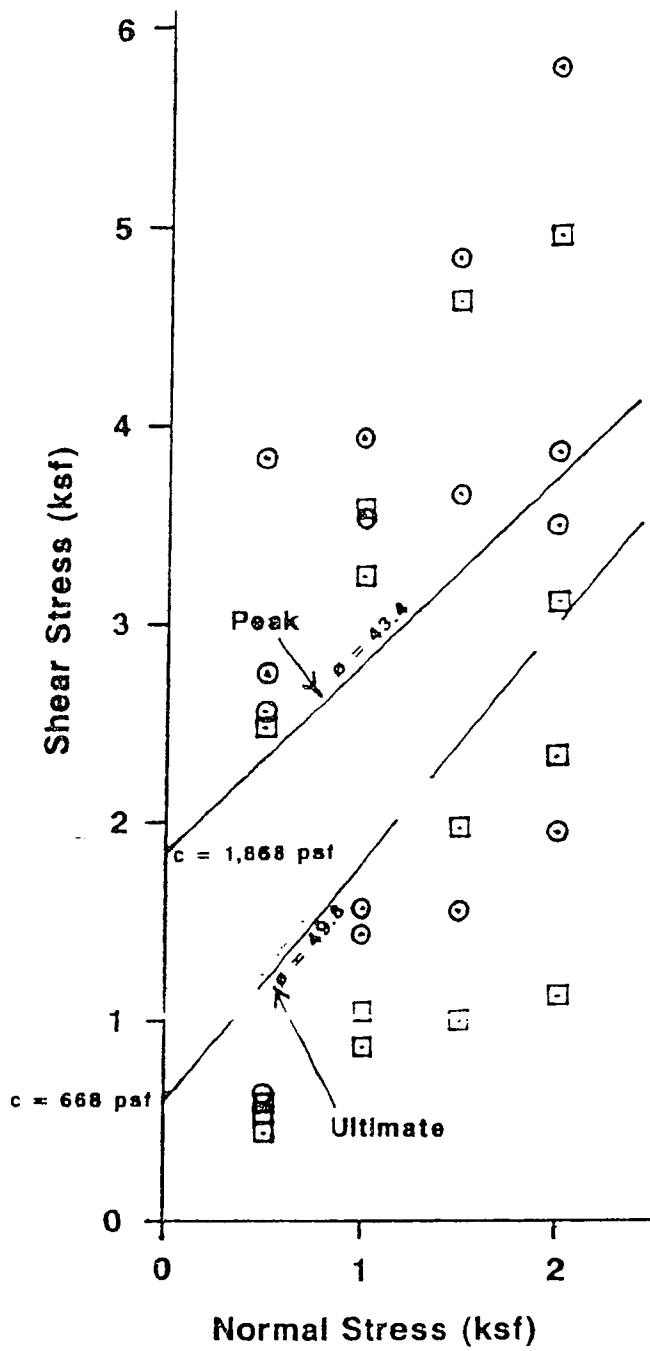
SCATTER DIAGRAM OF DIRECT SHEAR DATA FOR SAUGUS FORMATION

- PEAK VALUES
- ULTIMATE VALUES

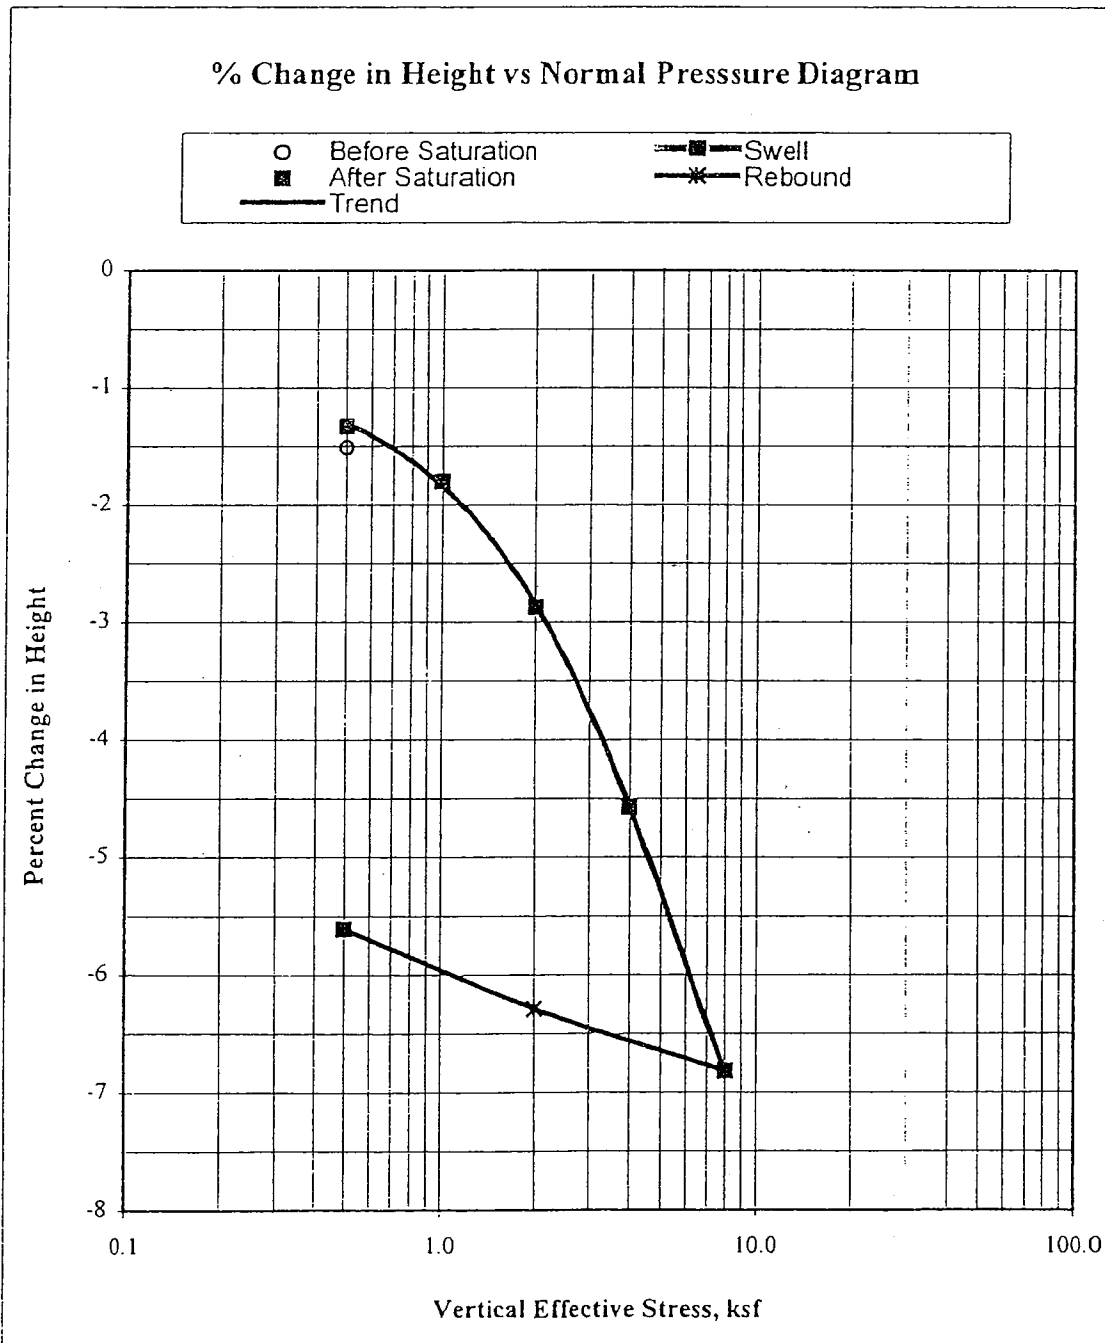
Santa Paula Memorial Hospital Assisted Living Facility
 1 @ 5
 Clay
 Ring Sample

Initial Dry Density: 103.7 pcf
 Initial Moisture, %: 16.6%
 Specific Gravity: 2.67 (assumed)
 Initial Void Ratio: 0.607
