**SANTA PAULA GEOLOGIC HAZARD
ABATEMENT DISTRICT (GHAD)
PLAN OF CONTROL**

SANTA PAULA, CALIFORNIA

ENGEO INCORPORATED

MARCH 10, 2008

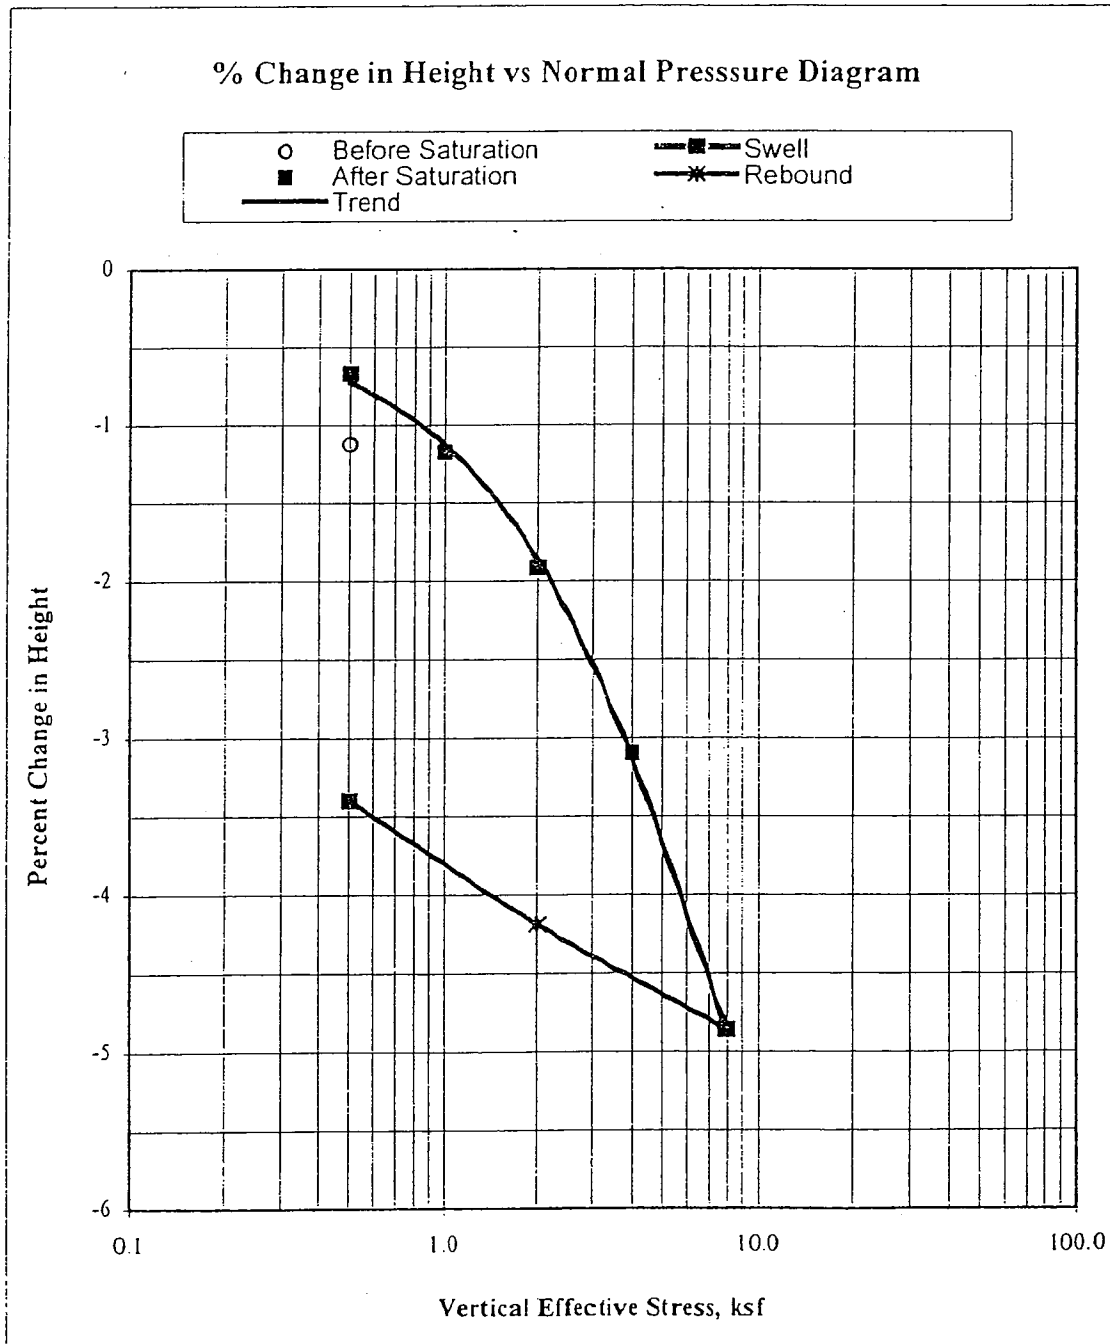
CONSOLIDATION TEST

ASTM D 2435-90

Santa Paula Memorial Hospital Assisted Living Facility
 2 @ 5
 Clay
 Ring Sample

Initial Dry Density: 113.8 pcf
 Initial Moisture, %: 15.6%
 Specific Gravity: 2.67 (assumed)
 Initial Void Ratio: 0.465

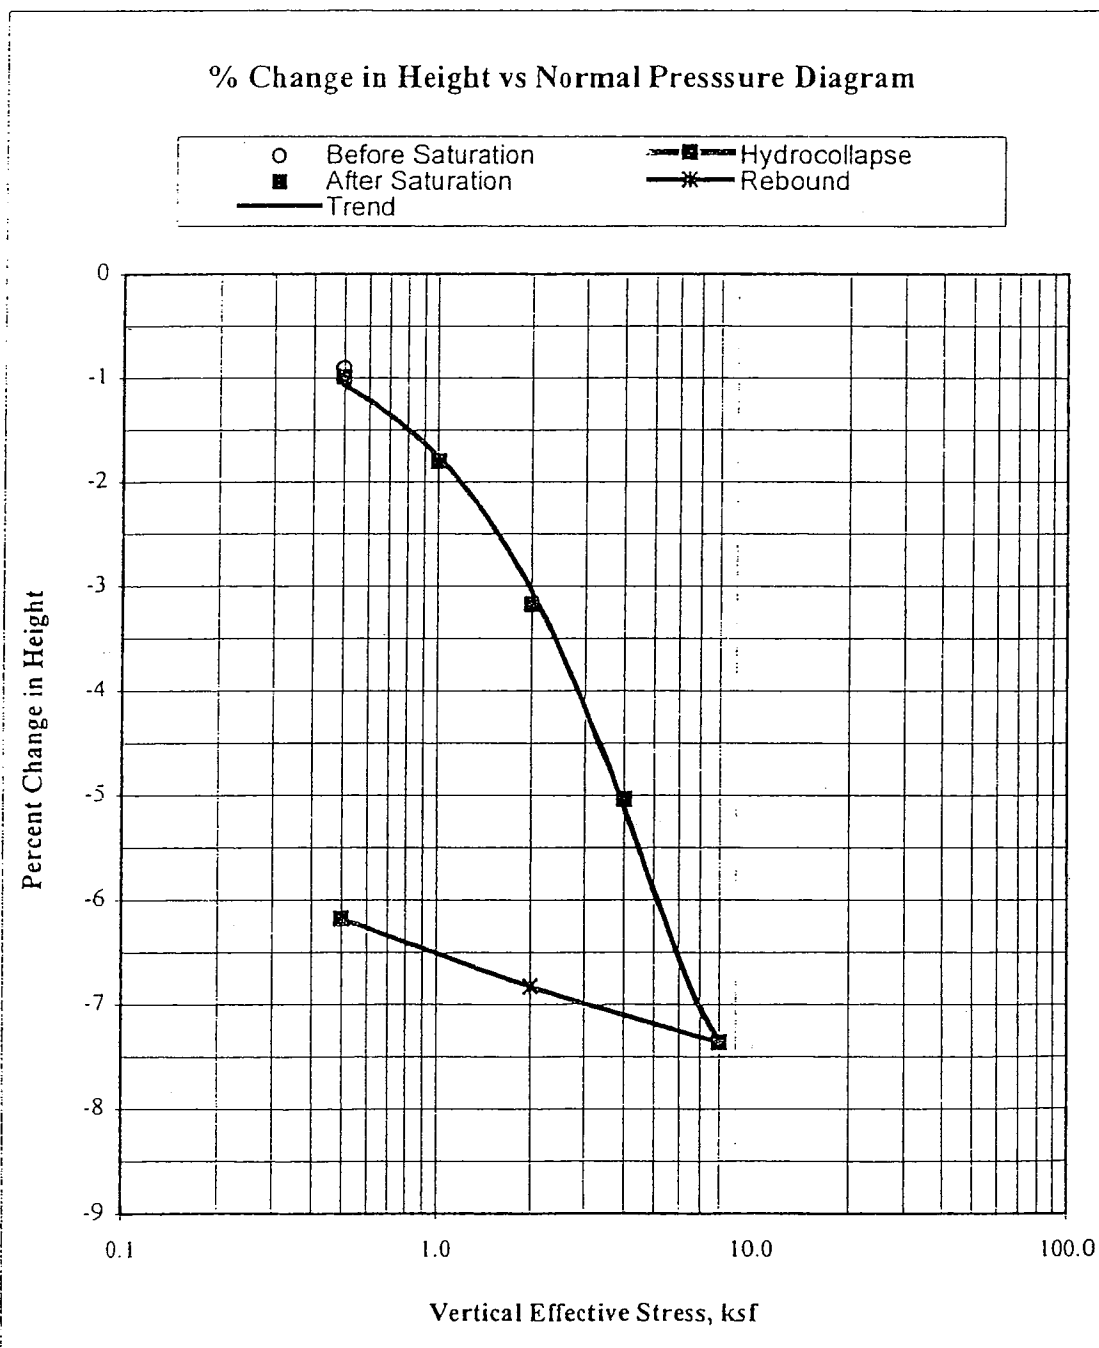
CONSOLIDATION TEST

ASTM D 2435-90

Santa Paula Memorial Hospital Assisted Living Facility
4 @ 5
Clay
Ring Sample

Initial Dry Density: 108.8 pcf
Initial Moisture, %: 15.5%
Specific Gravity: 2.67 (assumed)
Initial Void Ratio: 0.533

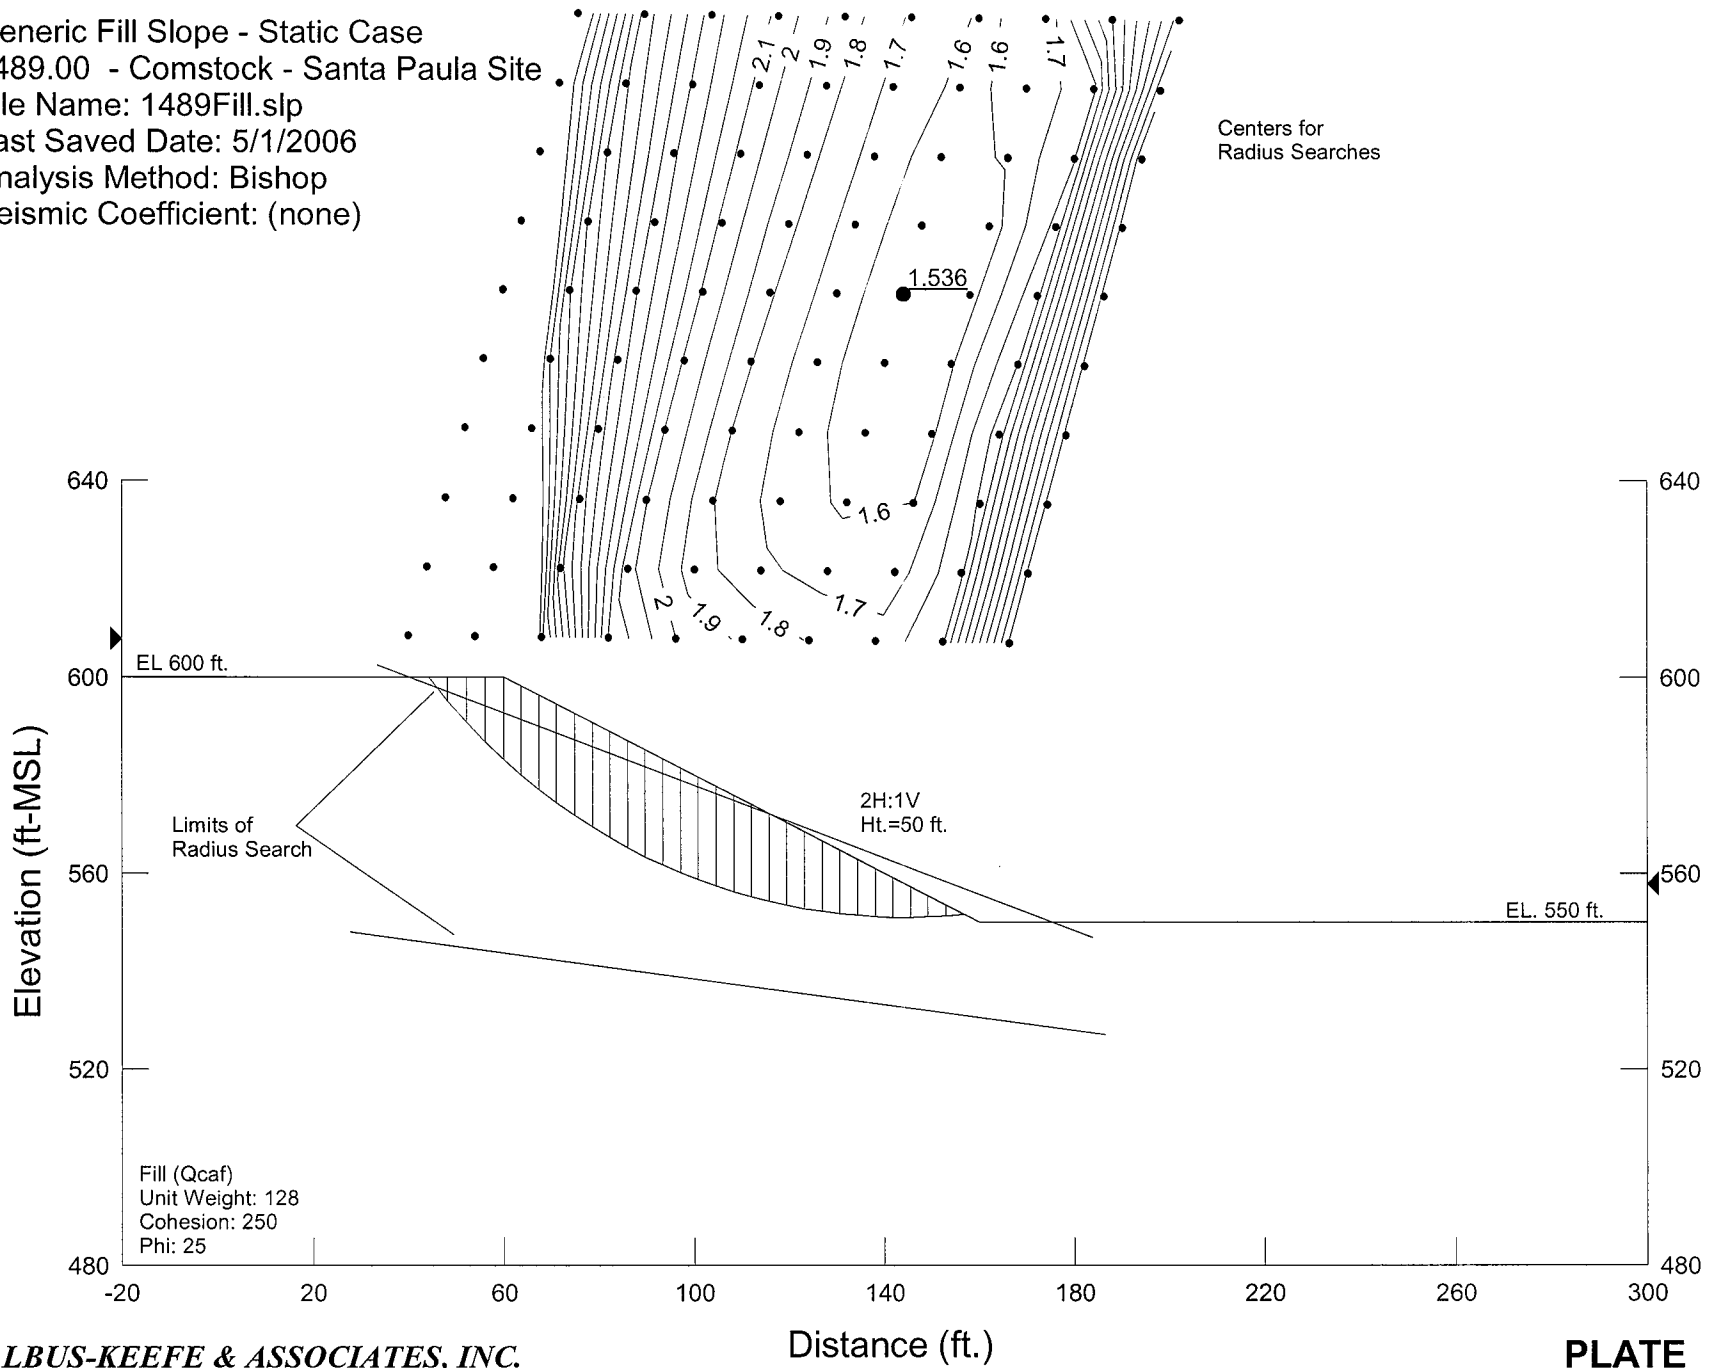
Generic Fill Slope - Static Case
 1489.00 - Comstock - Santa Paula Site
 File Name: 1489Fill.slp
 Last Saved Date: 5/1/2006
 Analysis Method: Bishop
 Seismic Coefficient: (none)

Section	Search Type	Analysis Method	Plates	Static Factor of Safety	Seismic Factor of Safety
50' Fill Slope 2H:1V	Circular	Bishop	D-1 & D-2	1.54	1.11
C-C'	Circular	Bishop	D-3 & D-4	1.63	1.24
C-C' Detail	Circular	Bishop	D-5 & D-6	1.81	1.38
D-D'	Circular	Bishop	D-7 & D-8	1.81	1.34
F-F'	Circular	Bishop	D-9 & D-10	1.54	1.26
G-G'	Circular	Bishop	D-11 & D-12	1.51	1.10
G-G' Temp. Cut	Circular	Bishop	D-13	1.25	-

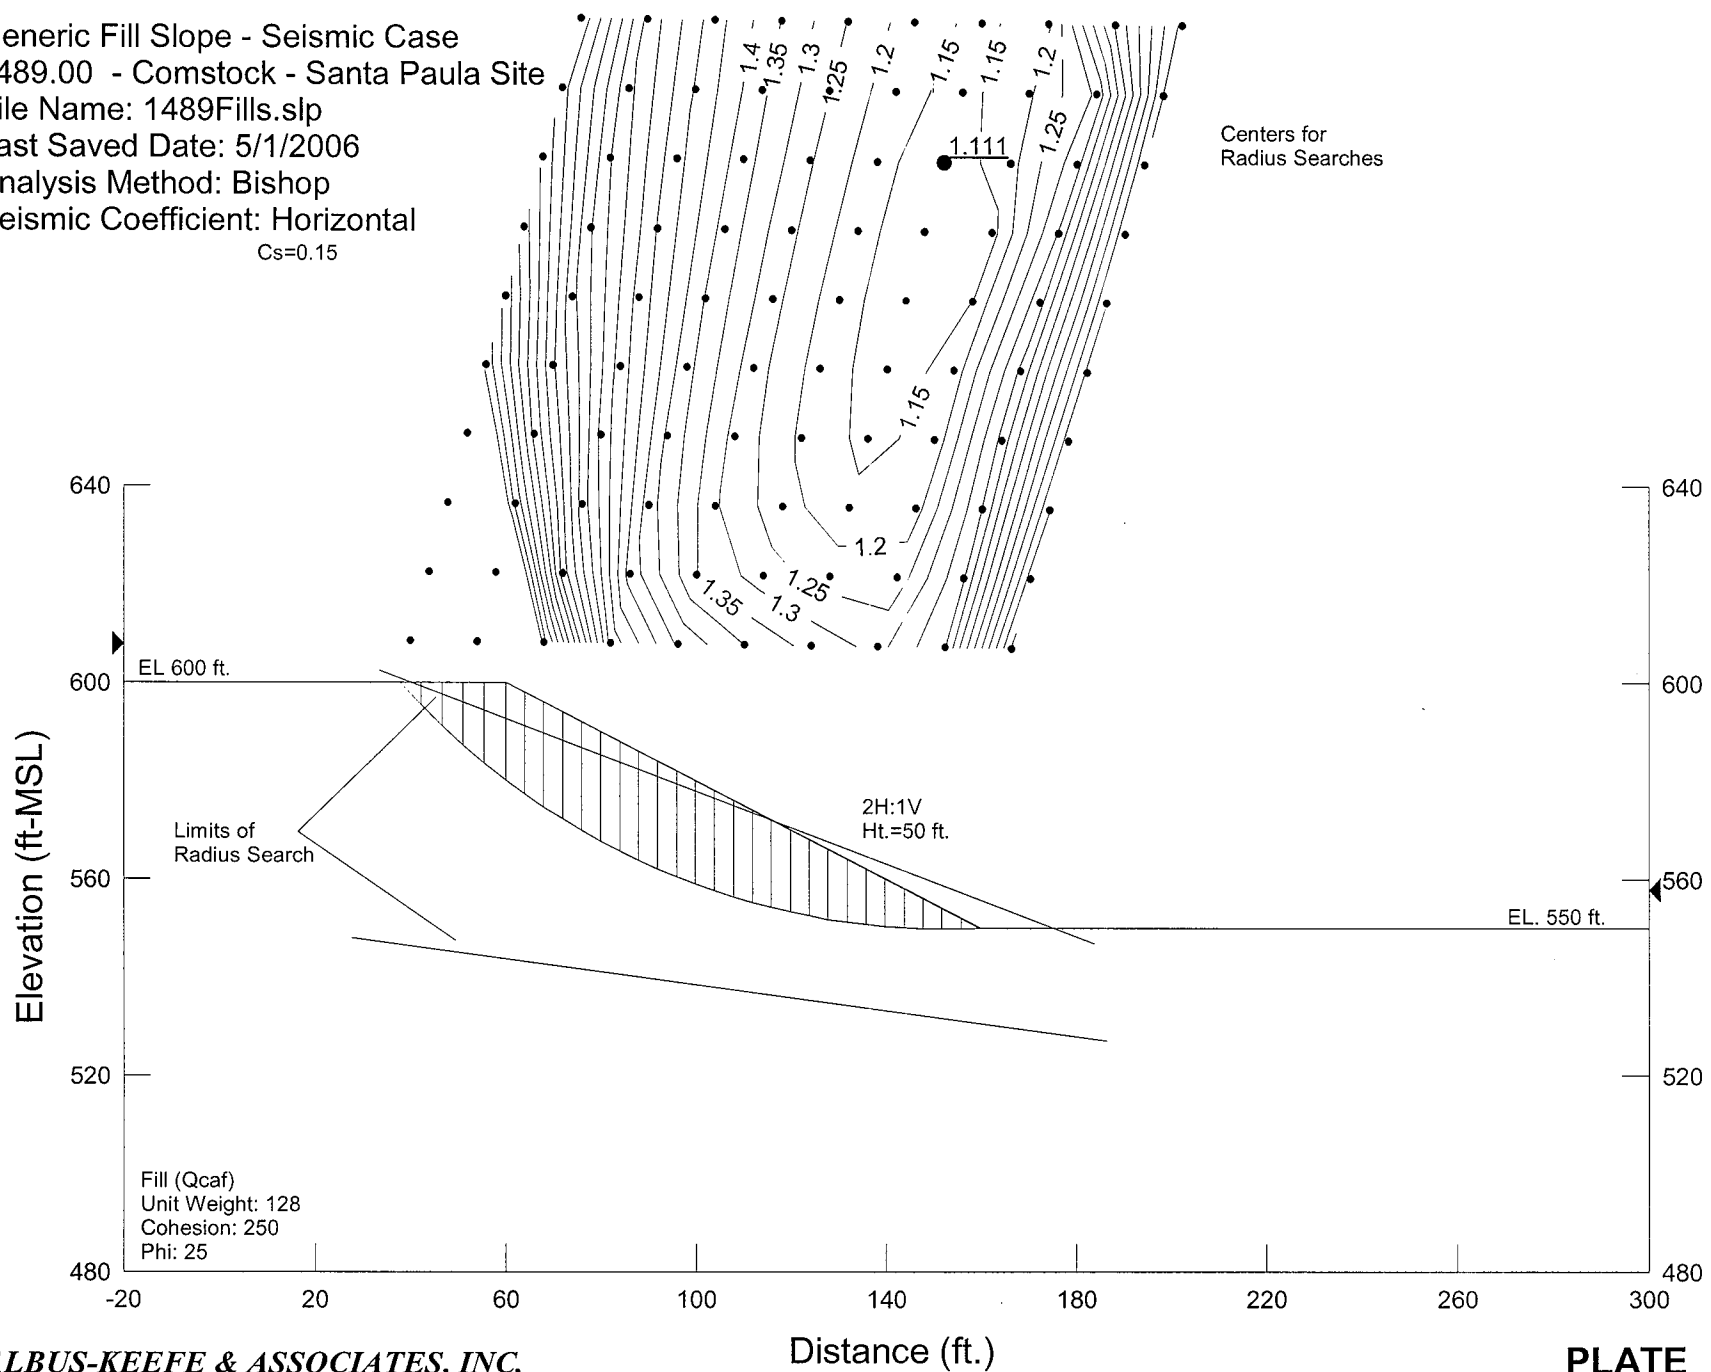
Generic Fill Slope - Seismic Case
 1489.00 - Comstock - Santa Paula Site
 File Name: 1489Fills.sl
 Last Saved Date: 5/1/2006
 Analysis Method: Bishop
 Seismic Coefficient: Horizontal
 Cs=0.15

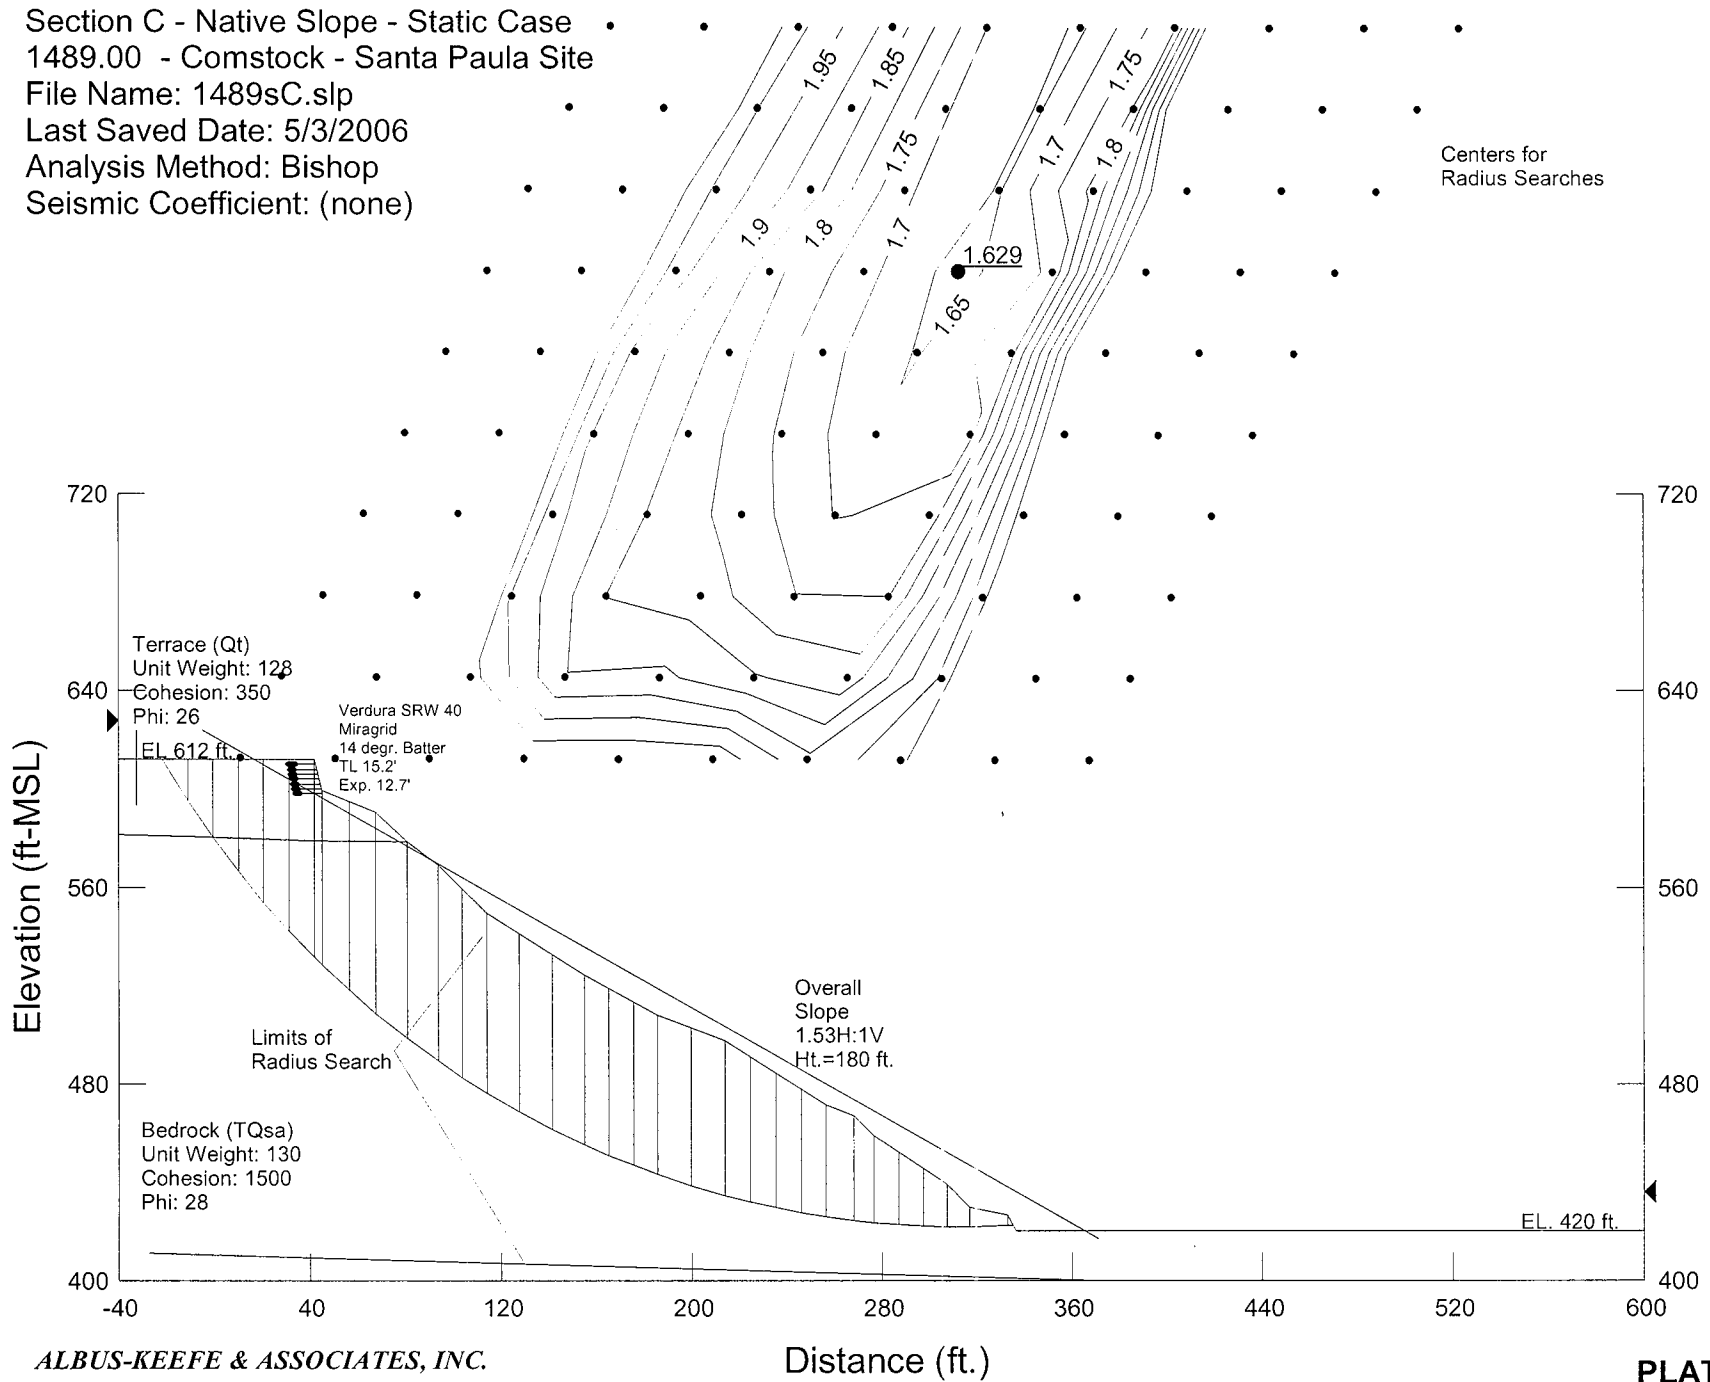
Section C - Native Slope - Static Case
 1489.00 - Comstock - Santa Paula Site
 File Name: 1489sC.slp
 Last Saved Date: 5/3/2006
 Analysis Method: Bishop
 Seismic Coefficient: (none)

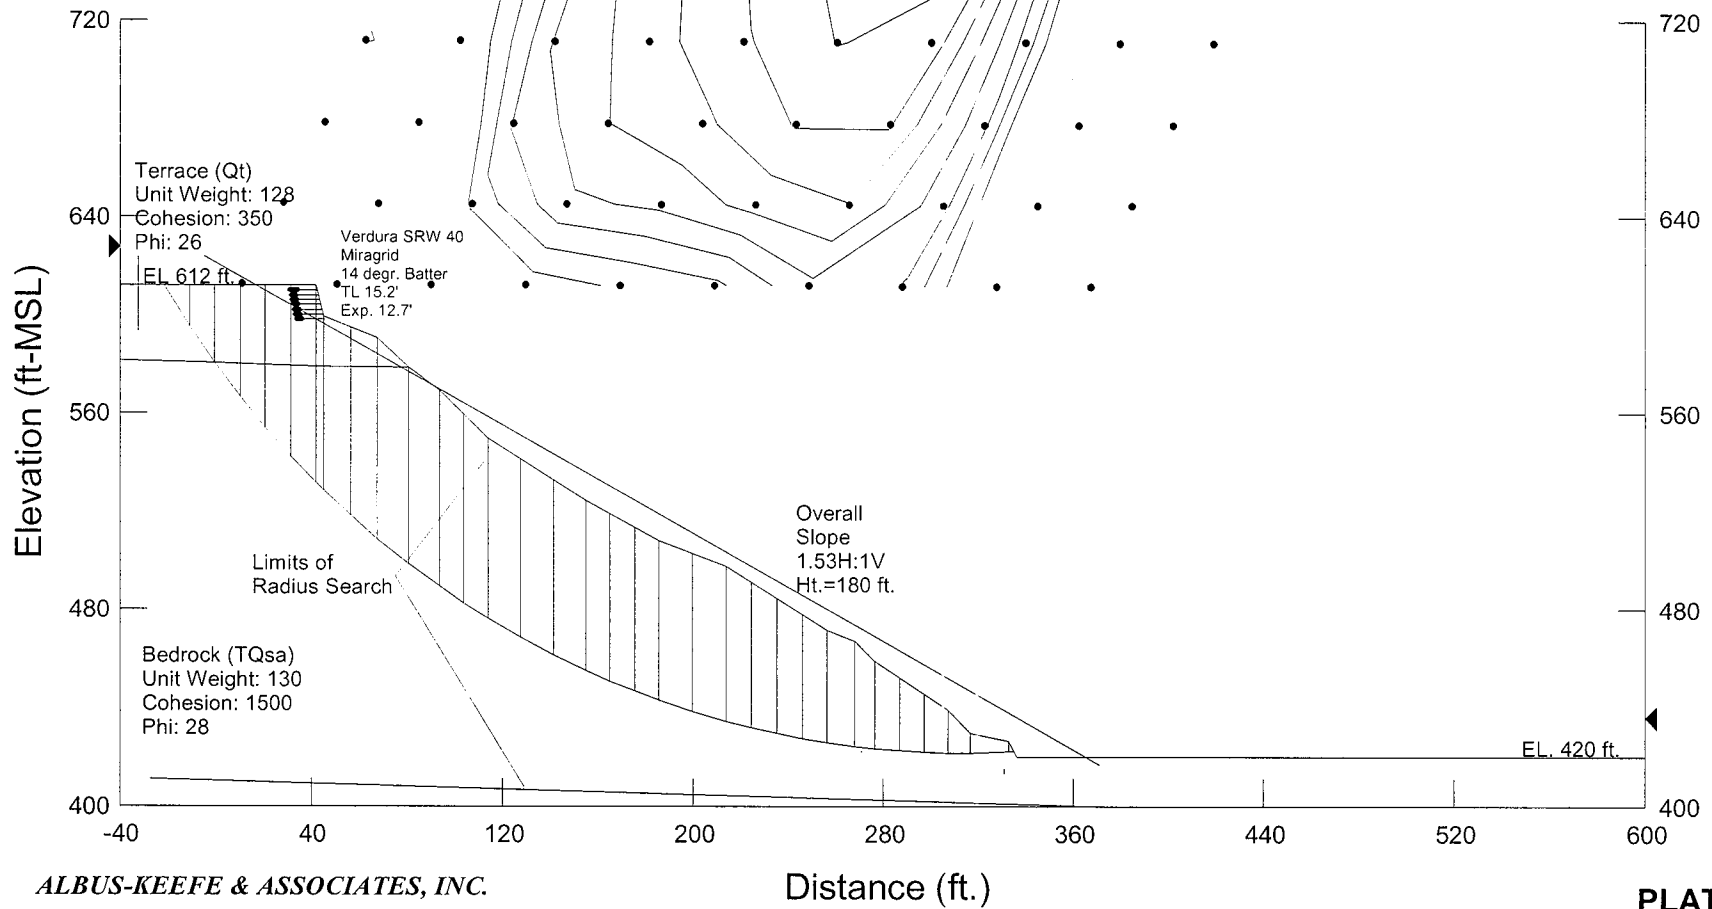
Section C - Native Slope - Seismic Case
 1489.00 - Comstock - Santa Paula Site
 File Name: 1489sCs.slp
 Last Saved Date: 5/3/2006
 Analysis Method: Bishop
 Seismic Coefficient: Horizontal

Cs=0.15

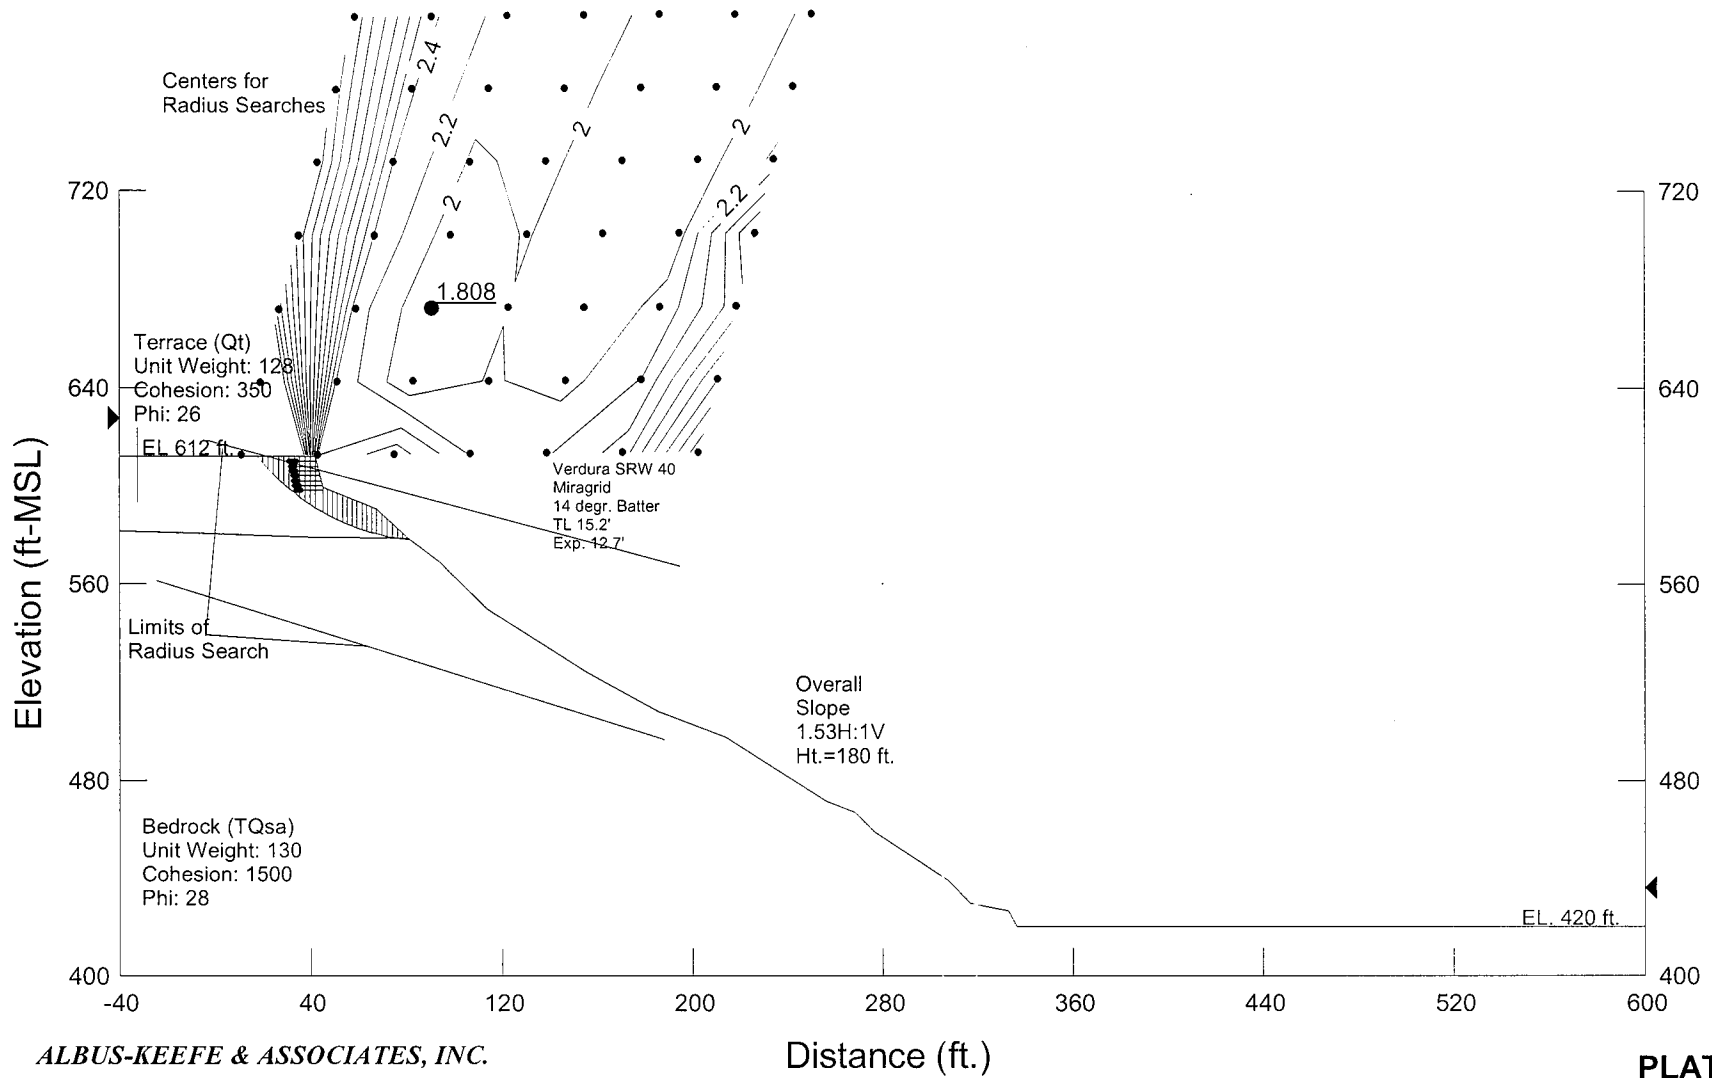
Section C - Global Segmental Wall - Static Case
 1489.00 - Comstock - Santa Paula Site
 File Name: 1489sC1.slp
 Last Saved Date: 5/3/2006
 Analysis Method: Bishop
 Seismic Coefficient: (none)

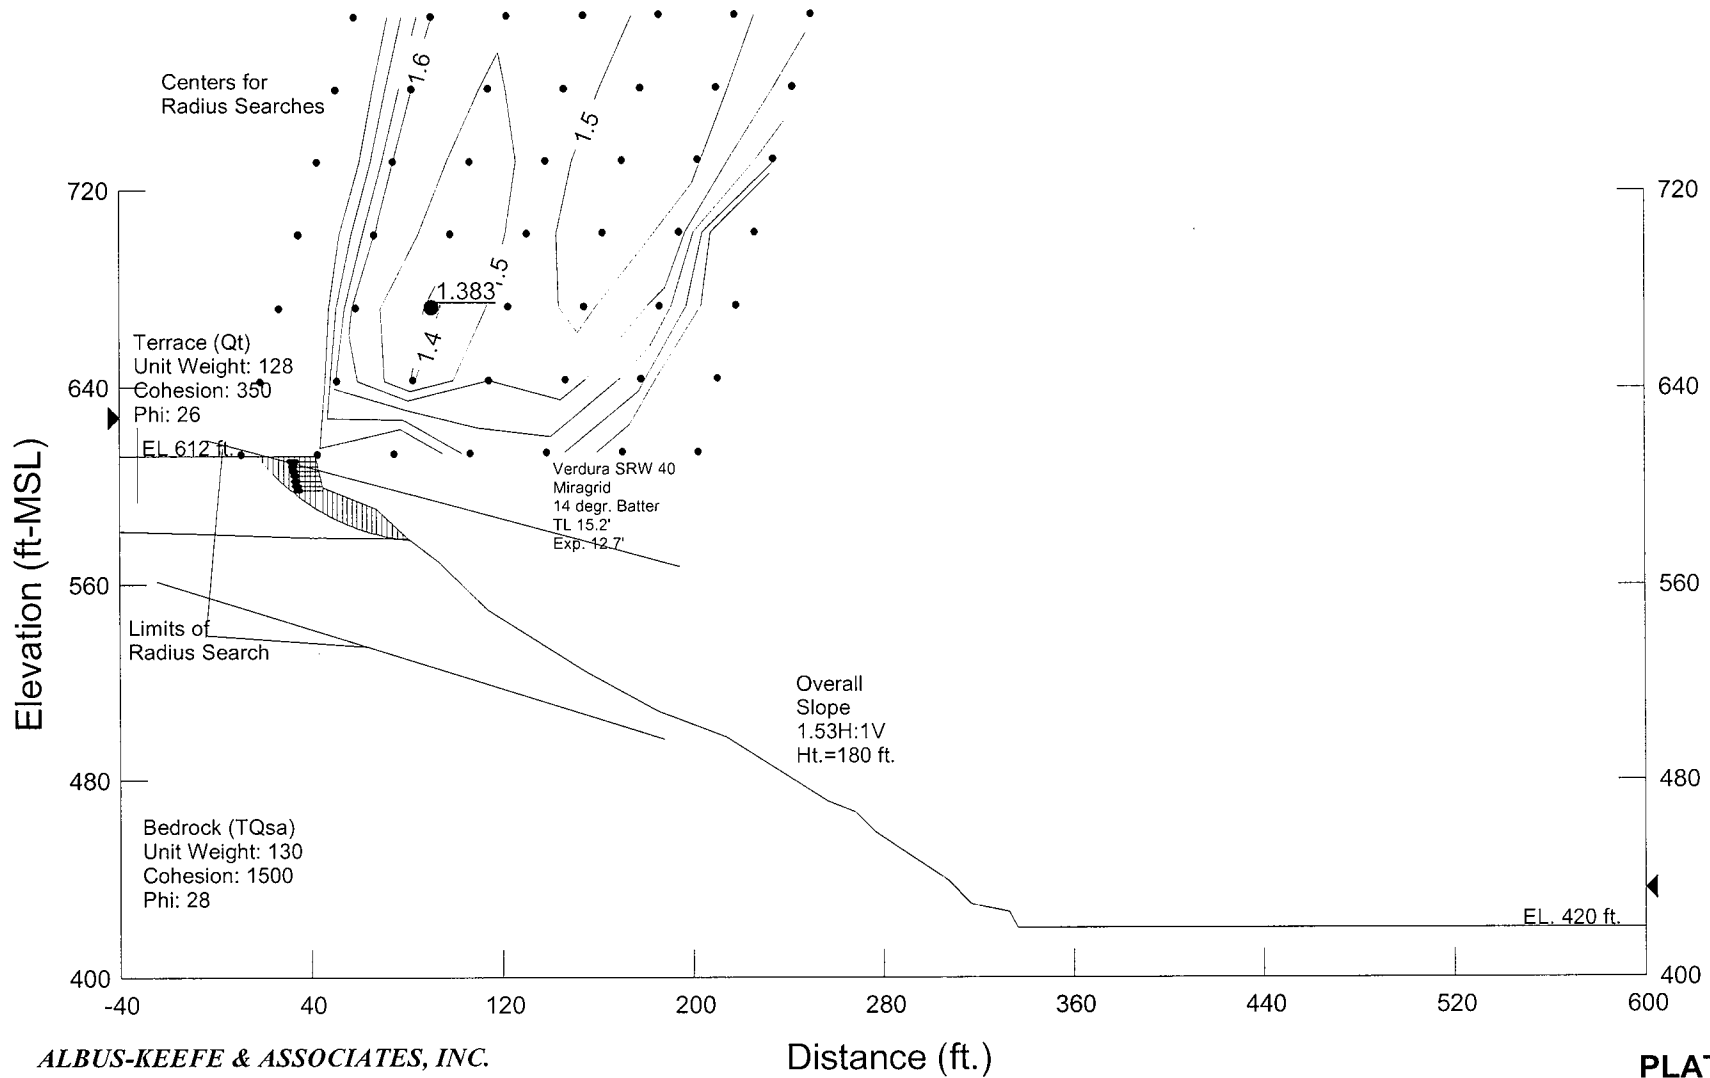
Section C - Global Segmental Wall - Seismic Case
 1489.00 - Comstock - Santa Paula Site
 File Name: 1489sC1s.slp
 Last Saved Date: 5/3/2006
 Analysis Method: Bishop
 Seismic Coefficient: Horizontal

Cs=0.15

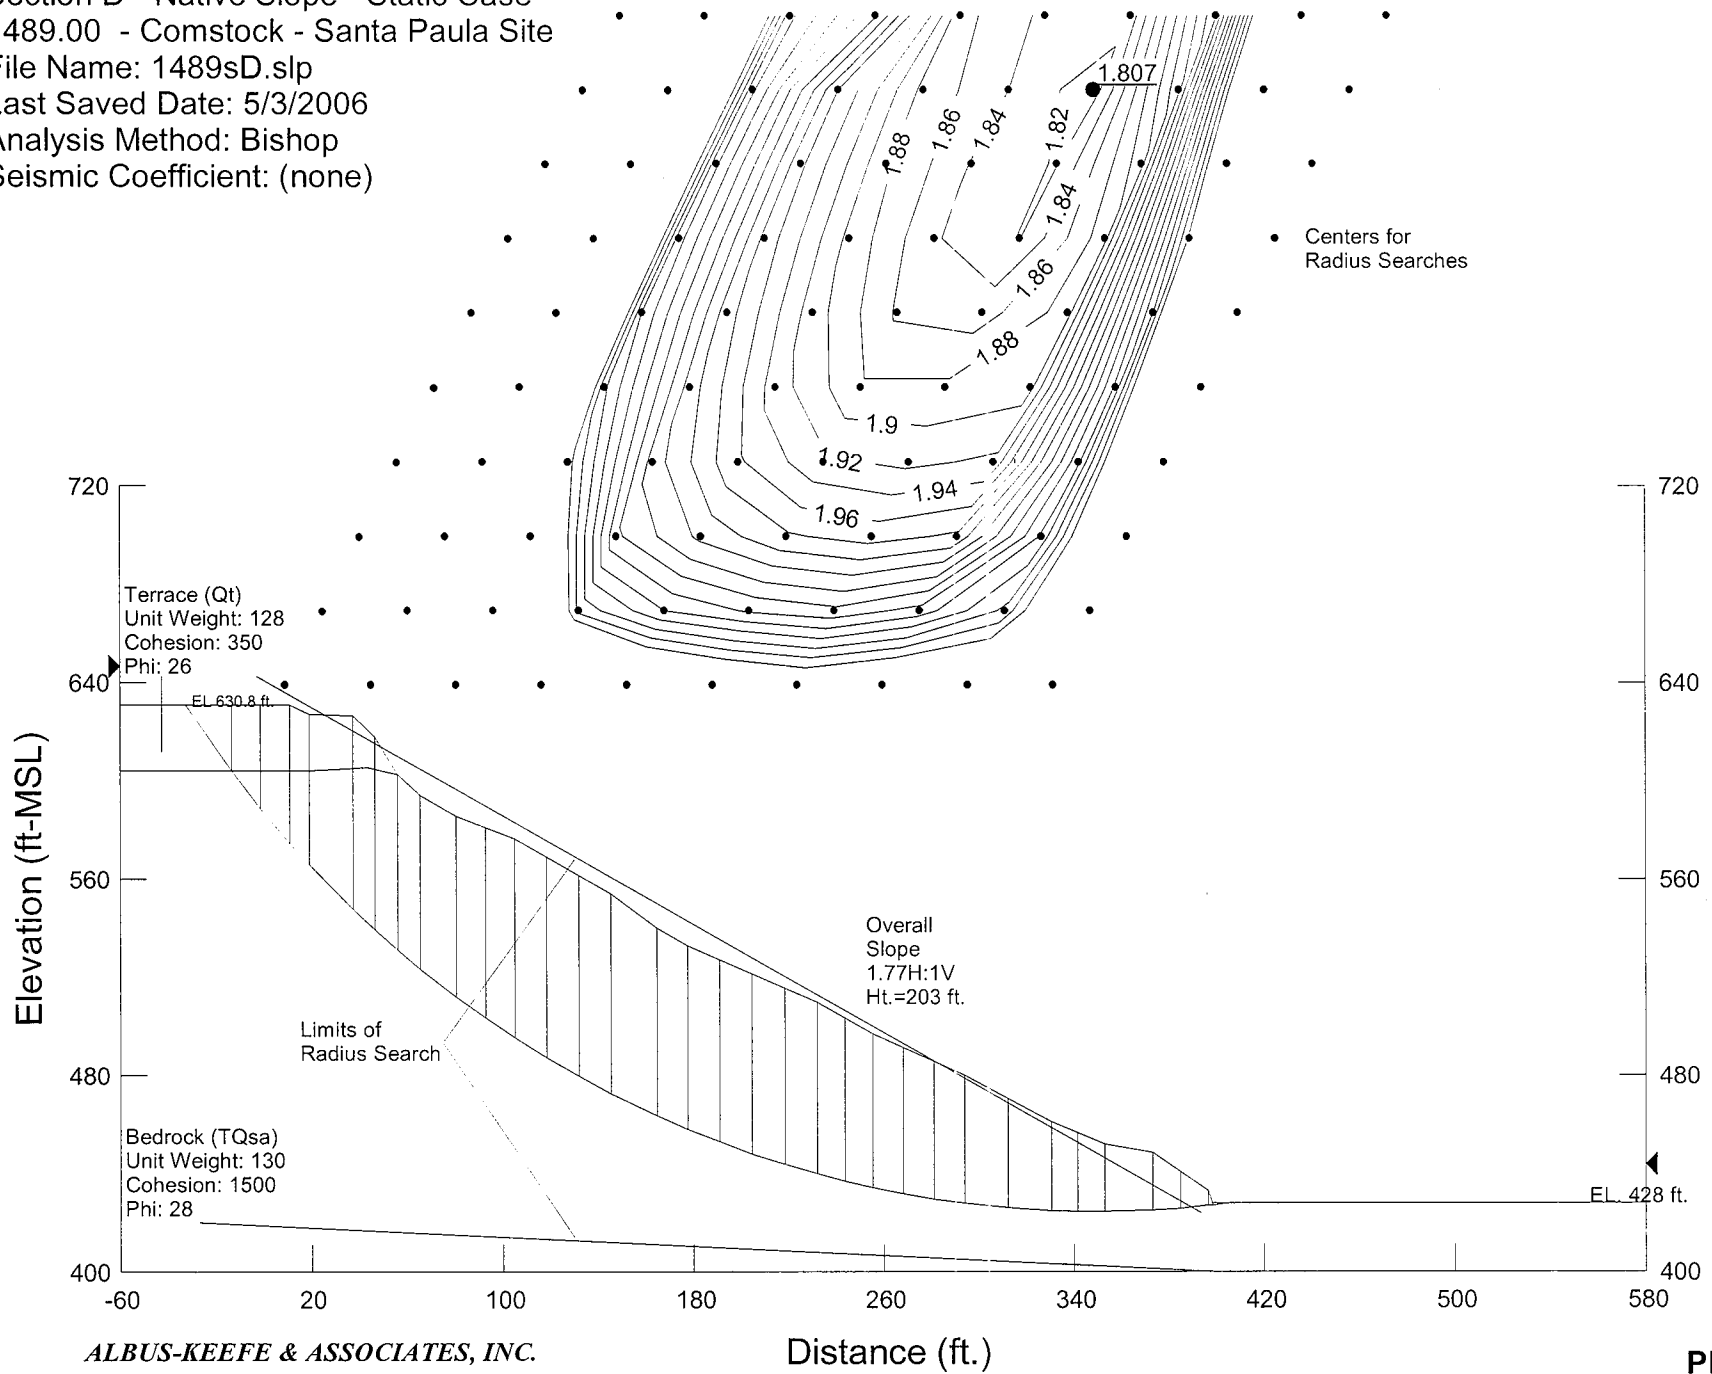
Section D - Native Slope - Static Case
 1489.00 - Comstock - Santa Paula Site
 File Name: 1489sD.slp
 Last Saved Date: 5/3/2006
 Analysis Method: Bishop
 Seismic Coefficient: (none)

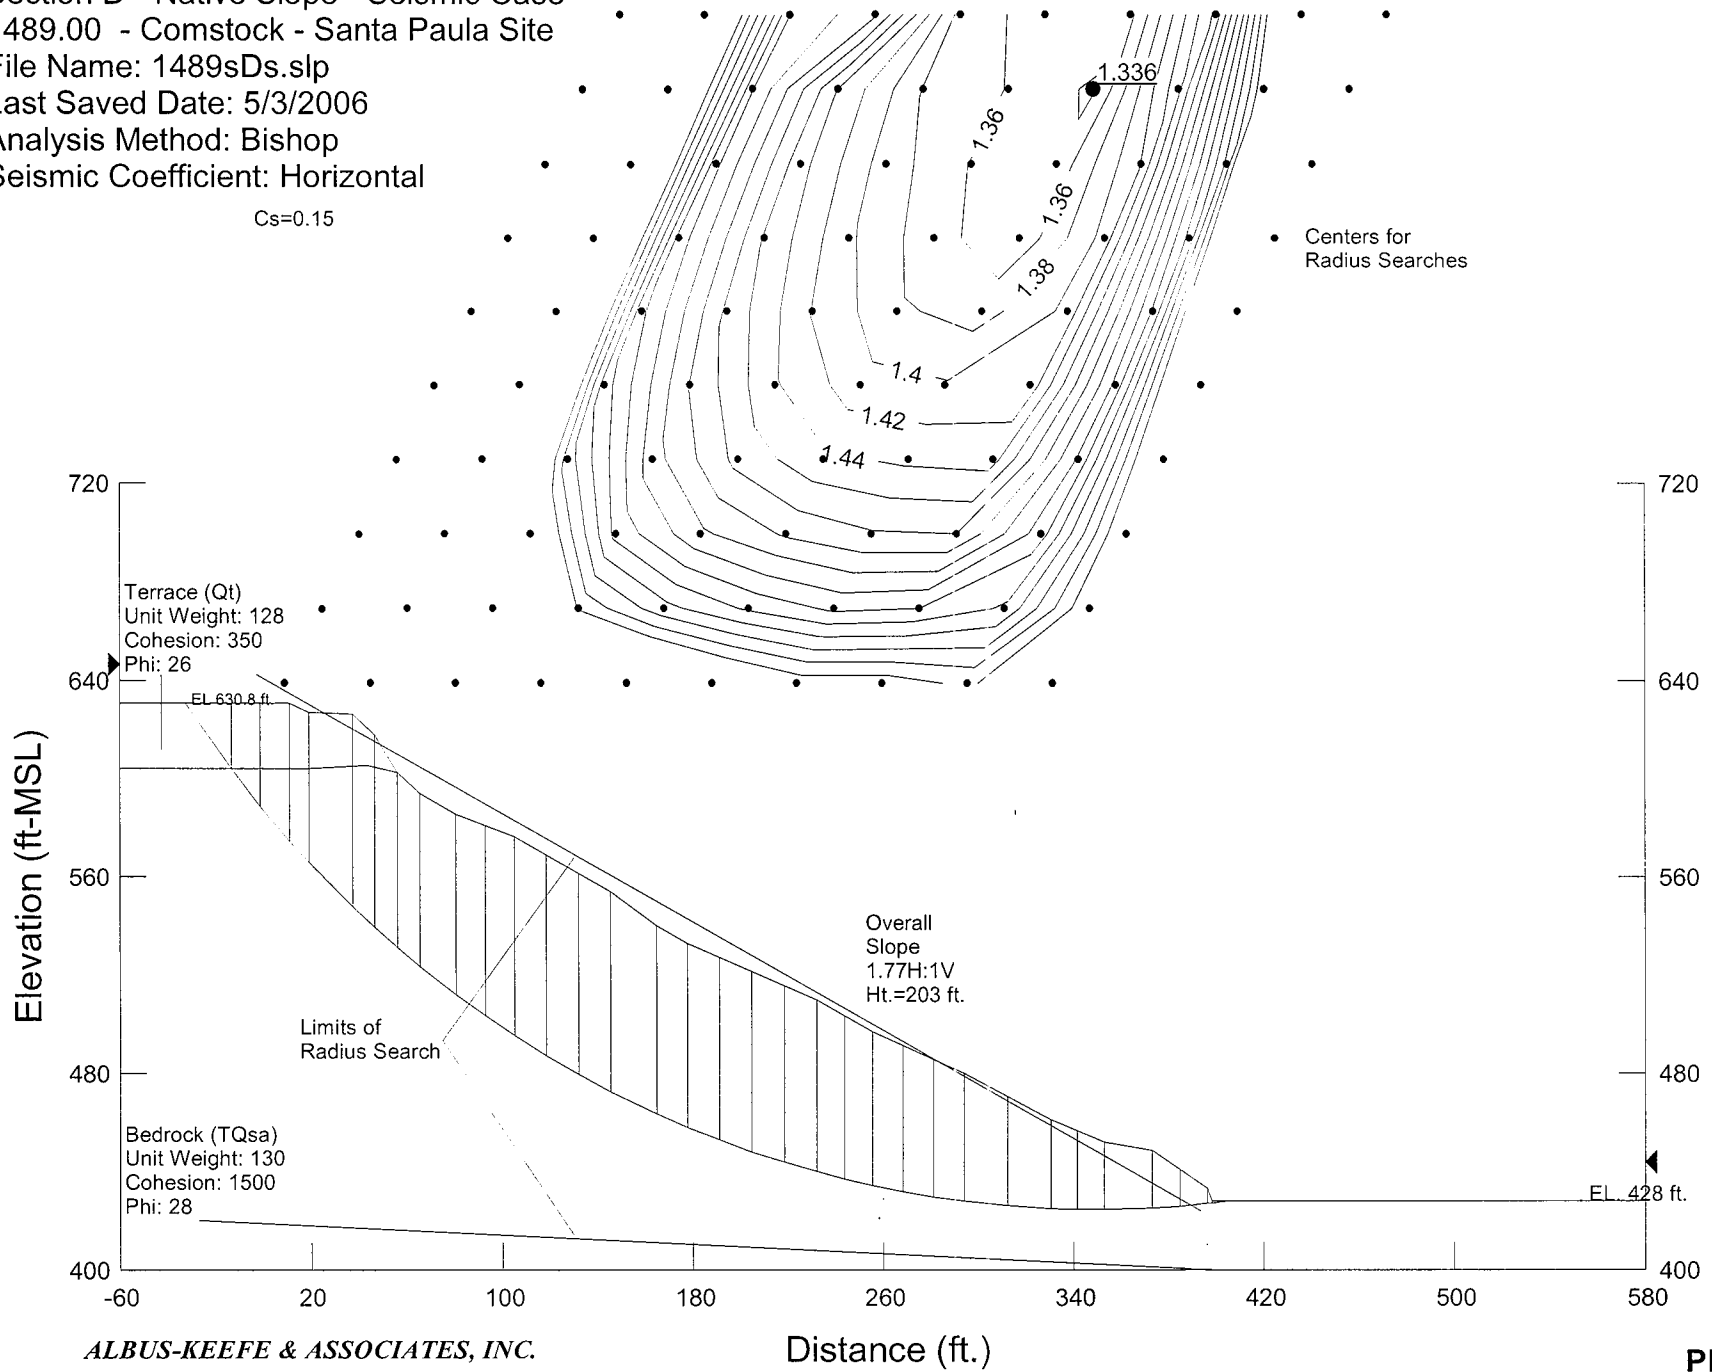
Section D - Native Slope - Seismic Case
 1489.00 - Comstock - Santa Paula Site
 File Name: 1489sDs.slp
 Last Saved Date: 5/3/2006
 Analysis Method: Bishop
 Seismic Coefficient: Horizontal

Cs=0.15

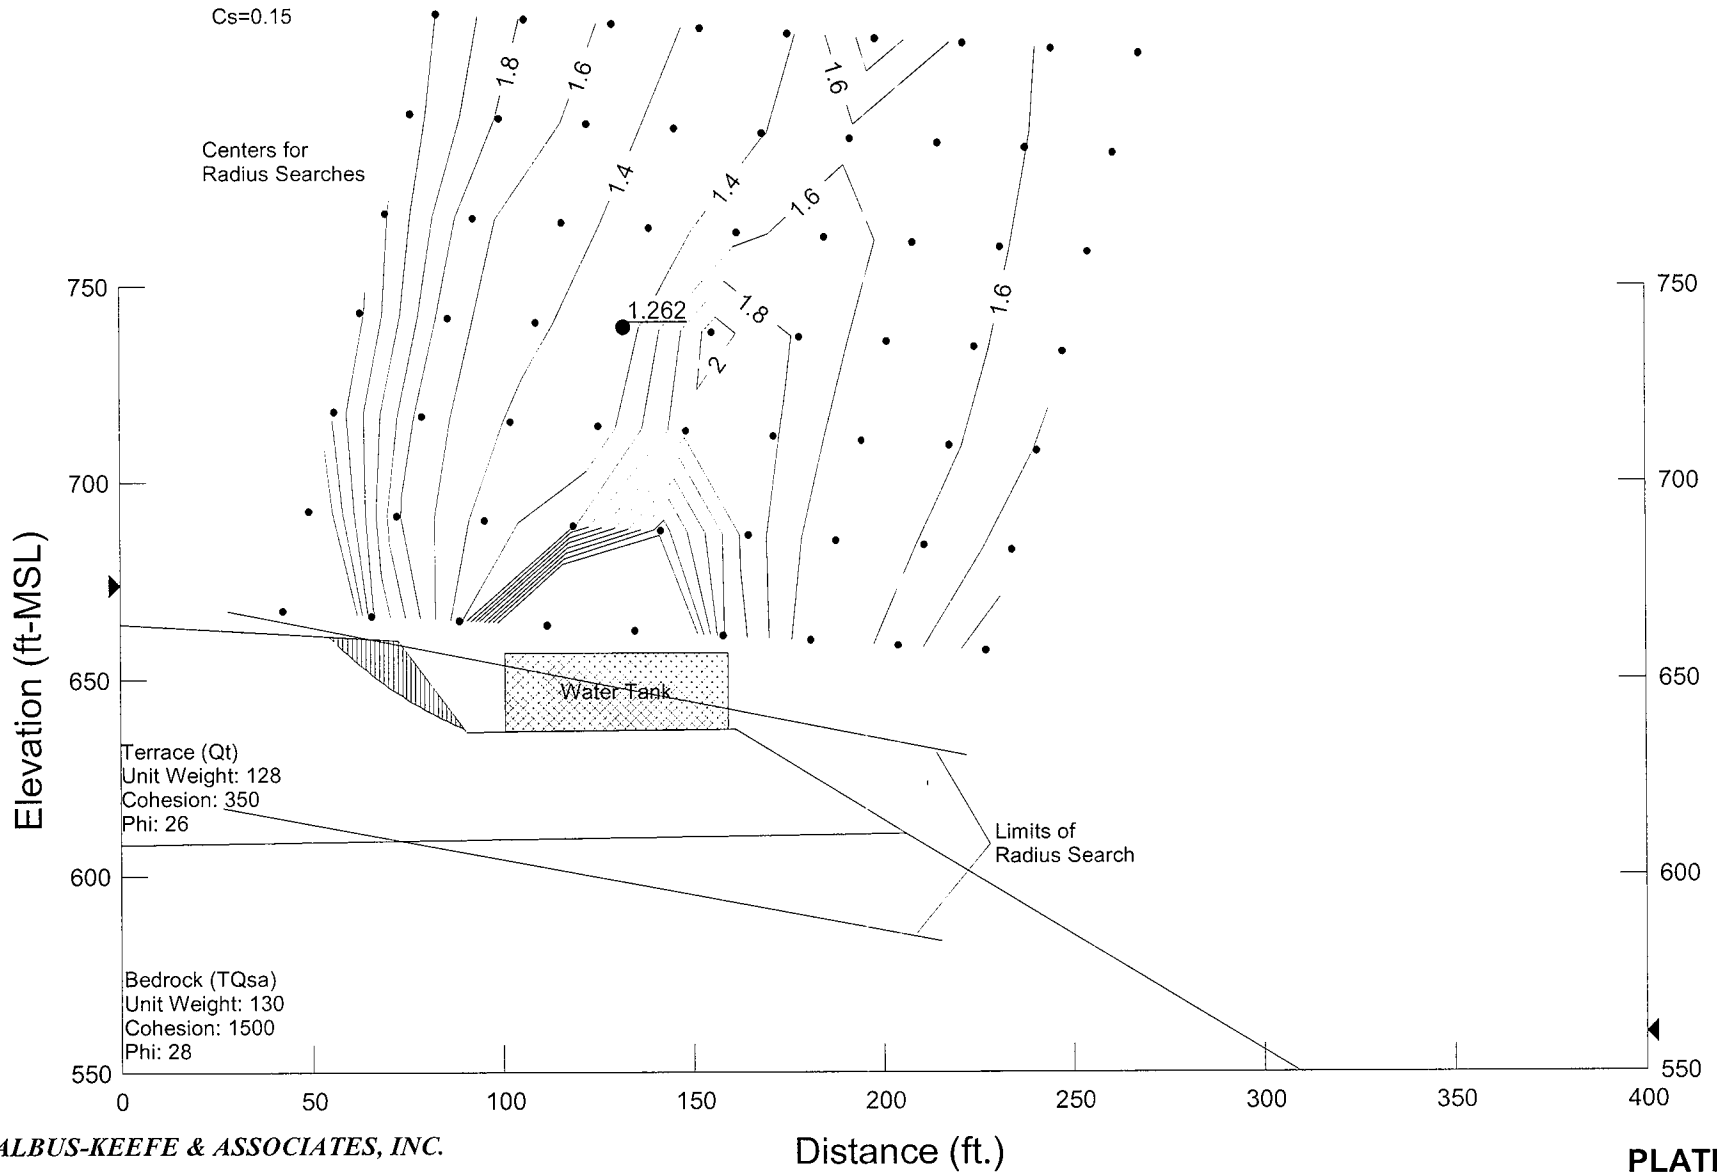
Section F - Tank Slope - Seismic Case
 1489.00 - Comstock - Santa Paula Site
 File Name: 1489_Fs.slp
 Last Saved Date: 5/3/2006
 Analysis Method: Bishop
 Seismic Coefficient: Horizontal
