**SANTA PAULA GEOLOGIC HAZARD
ABATEMENT DISTRICT (GHAD)
PLAN OF CONTROL**

SANTA PAULA, CALIFORNIA

ENGEO INCORPORATED

MARCH 10, 2008

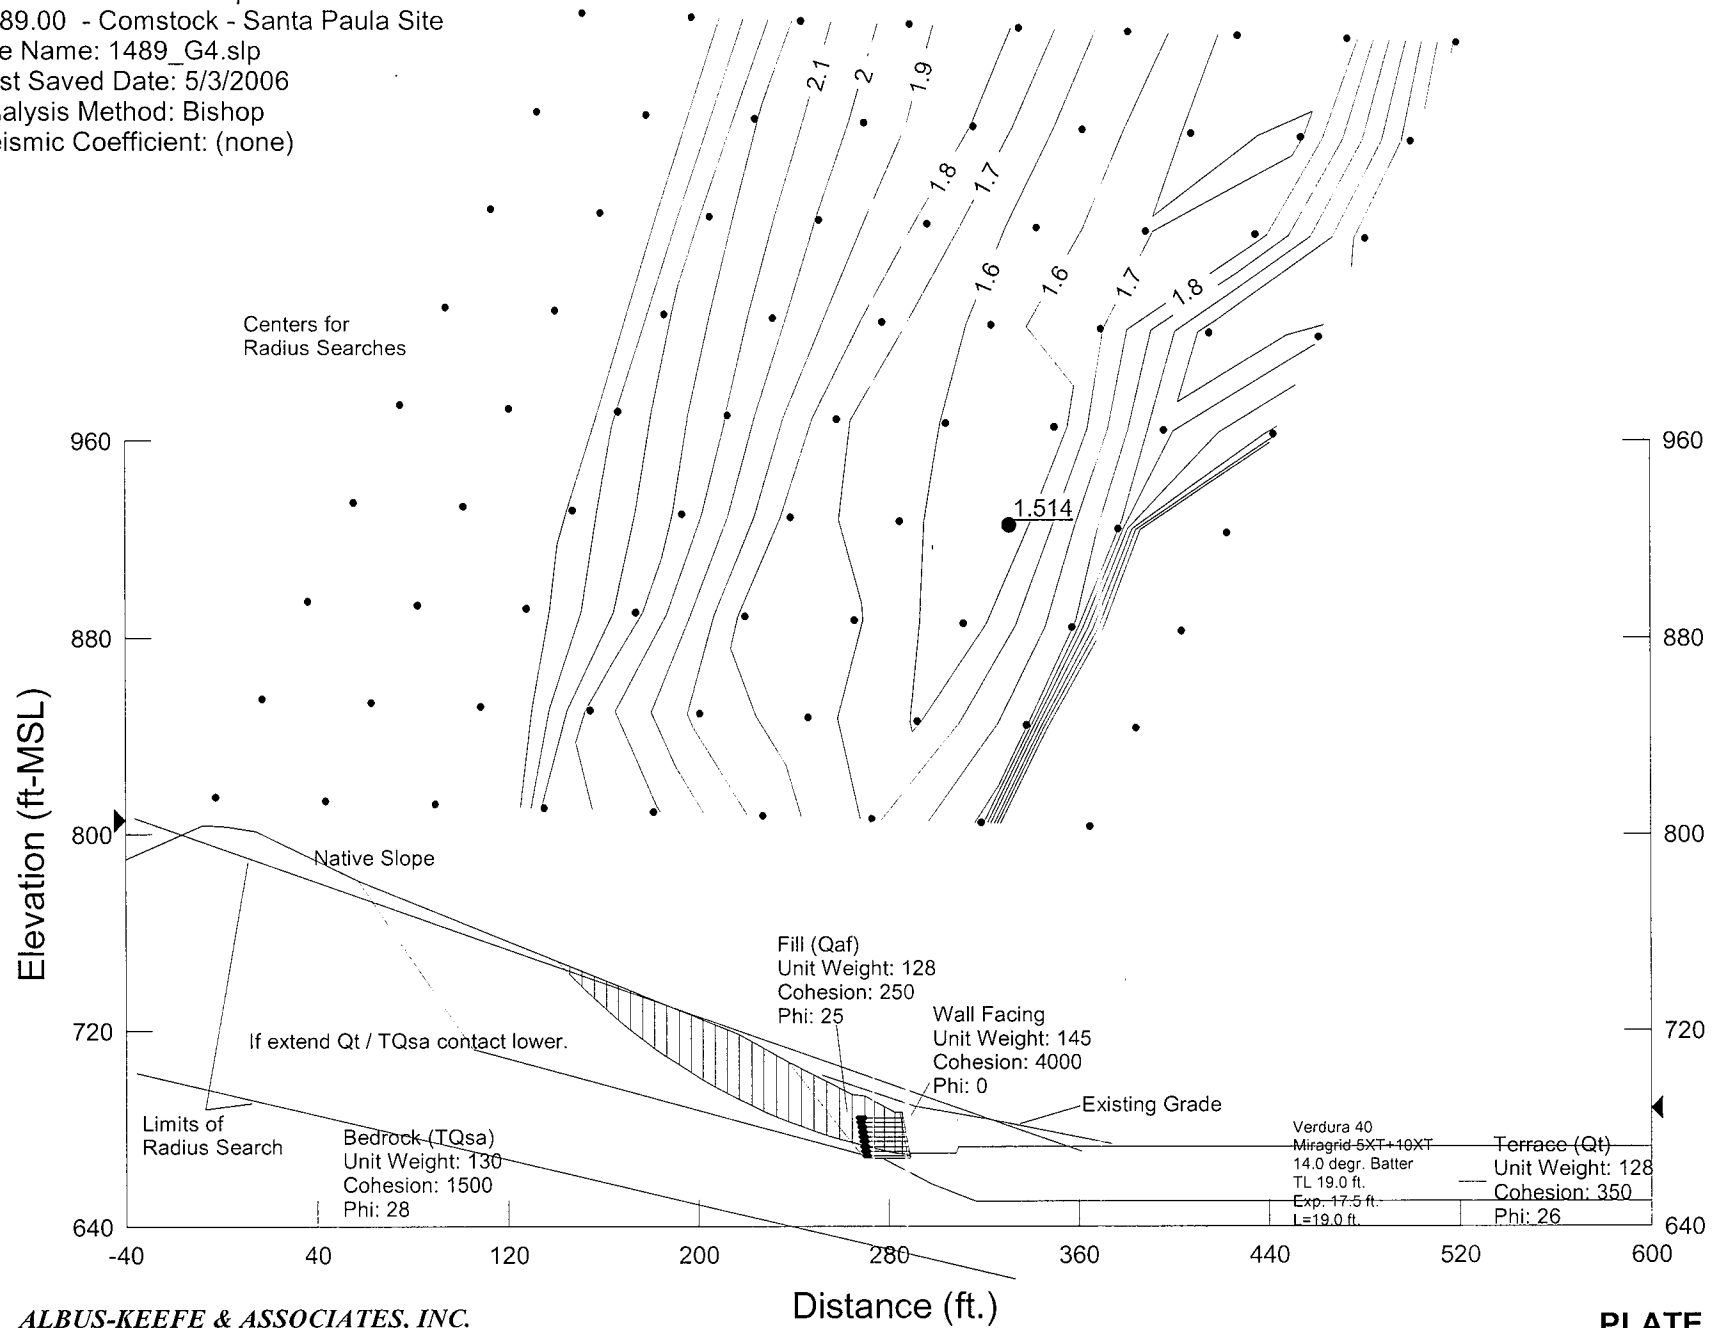
Section G - Native Slope - Static Case
 1489.00 - Comstock - Santa Paula Site
 File Name: 1489_G4.slp
 Last Saved Date: 5/3/2006
 Analysis Method: Bishop
 Seismic Coefficient: (none)

Section	Search Type	Analysis Method	Plates	Static Factor of Safety	Seismic Factor of Safety
50' Fill Slope 2H:1V	Circular	Bishop	D-1 & D-2	1.54	1.11
C-C'	Circular	Bishop	D-3 & D-4	1.63	1.24
C-C' Detail	Circular	Bishop	D-5 & D-6	1.81	1.38
D-D'	Circular	Bishop	D-7 & D-8	1.81	1.34
F-F'	Circular	Bishop	D-9 & D-10	1.54	1.26
G-G'	Circular	Bishop	D-11 & D-12	1.51	1.10
G-G' Temp. Cut	Circular	Bishop	D-13	1.25	-

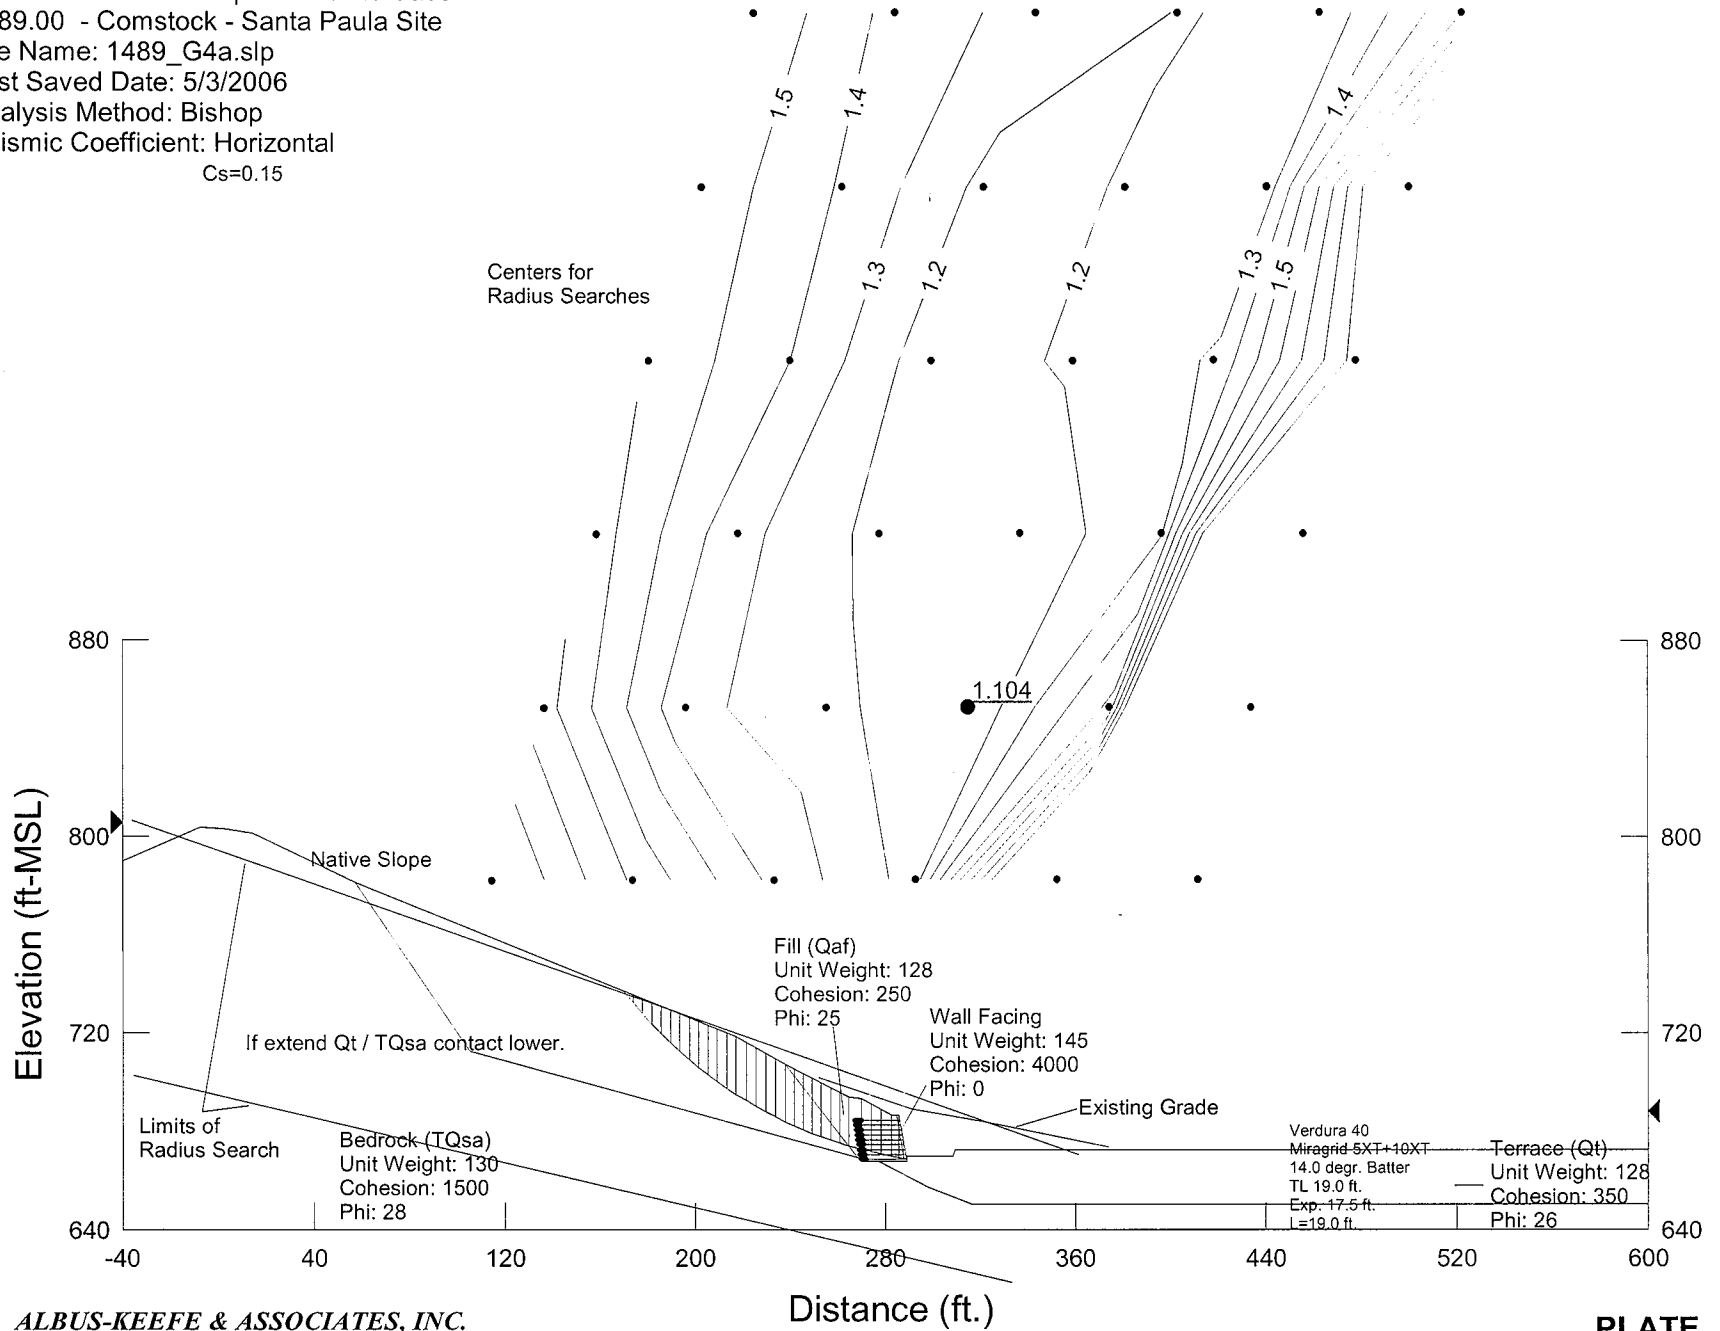
Section G - Native Slope - Seismic Case
 1489.00 - Comstock - Santa Paula Site
 File Name: 1489_G4a.slp
 Last Saved Date: 5/3/2006
 Analysis Method: Bishop
 Seismic Coefficient: Horizontal
 Cs=0.15

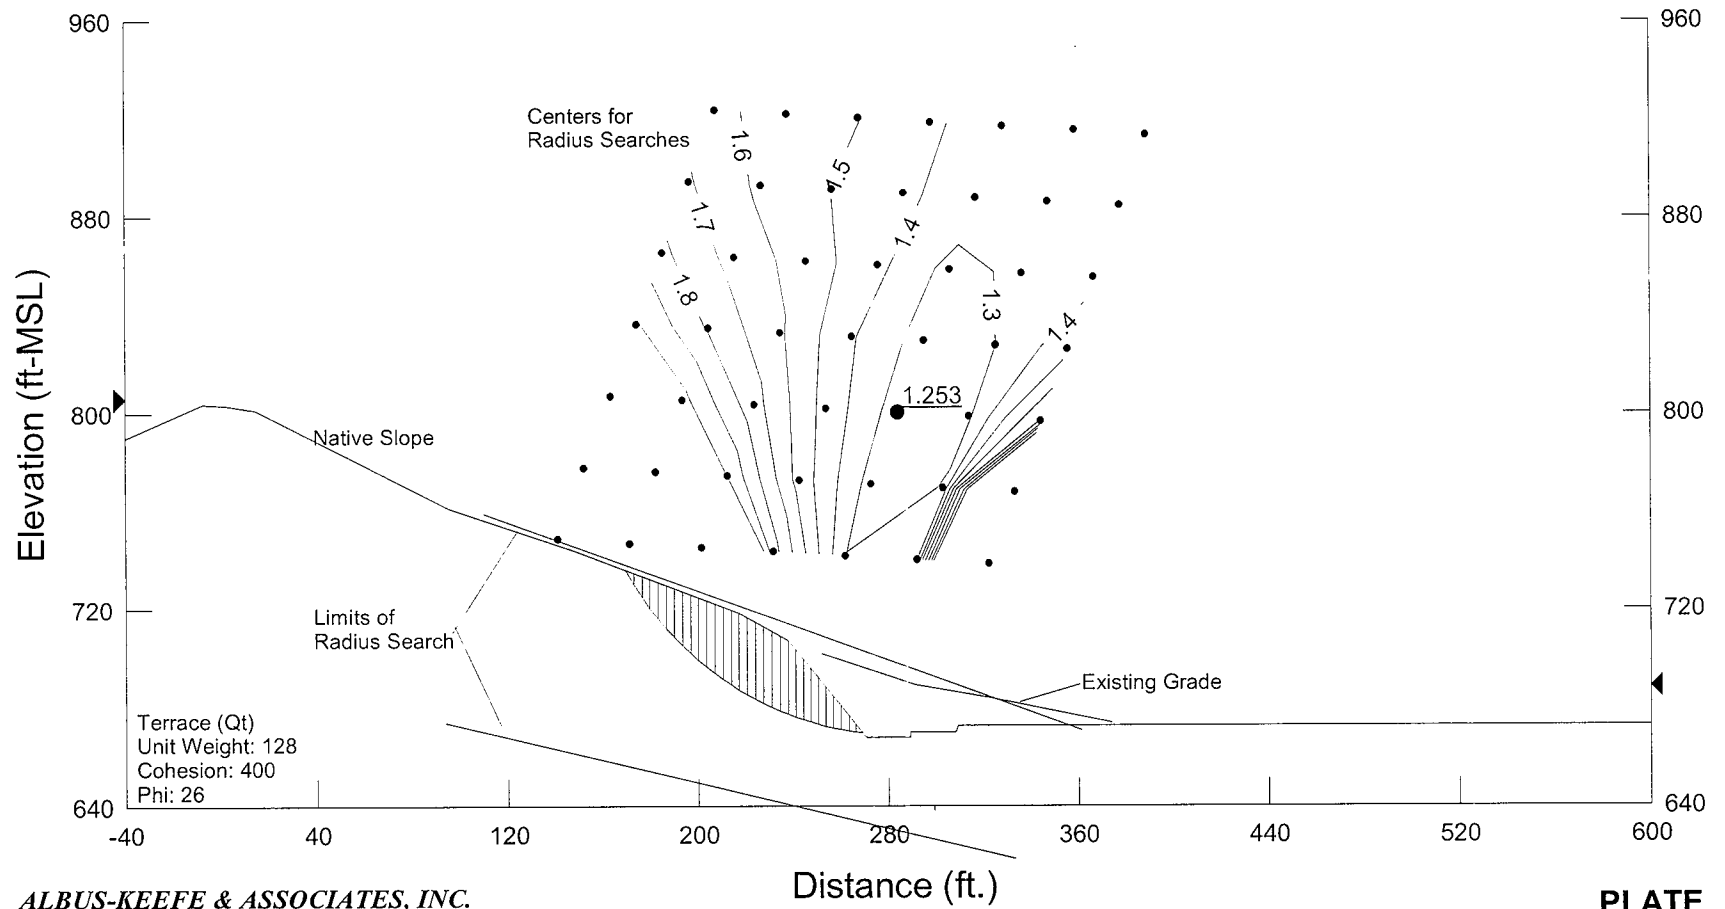
Section G - Native Slope - Temporary Cut
1489.00 - Comstock - Santa Paula Site
File Name: 1489_G3.slp
Last Saved Date: 5/3/2006
Analysis Method: Bishop
Seismic Coefficient: (none)

IF ALL Qt

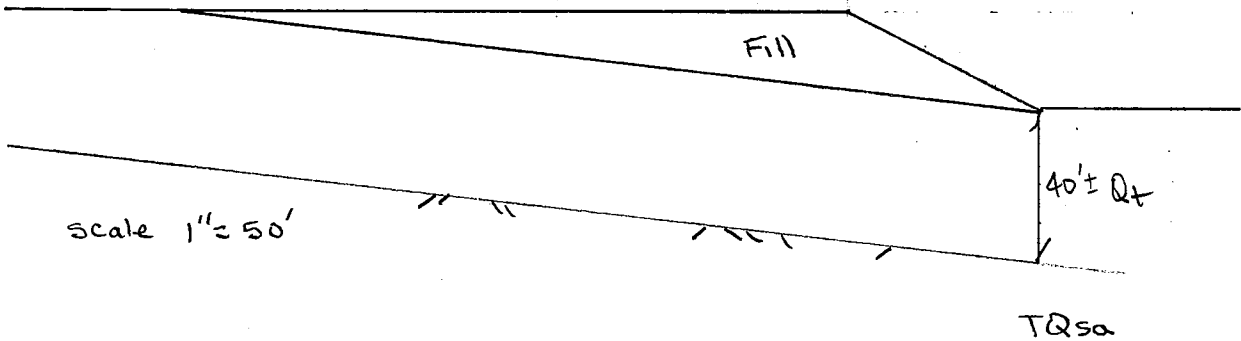
Cross Section at Lot 66

Settlement Analysis @ Deepest Fill

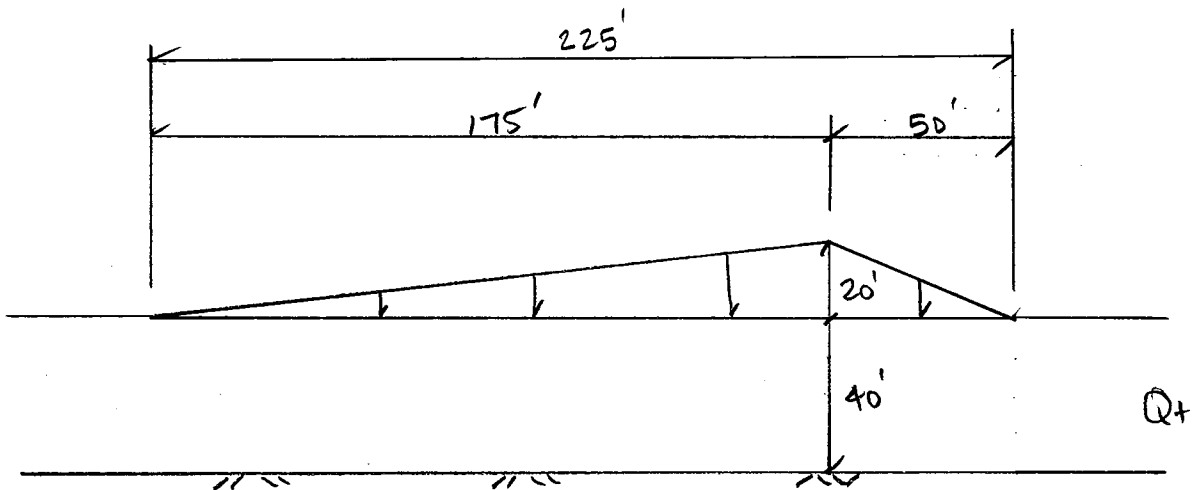
Model at Lot 66

<u>Qt</u>				
0-7'	$c_c = 0.057$	$c_r = 0.007$	OC + 3000 psf	TQsa
7-40	$c_c = 0.057$	$c_r = 0.007$	OC + 1875 psf

TQsa non-compressible

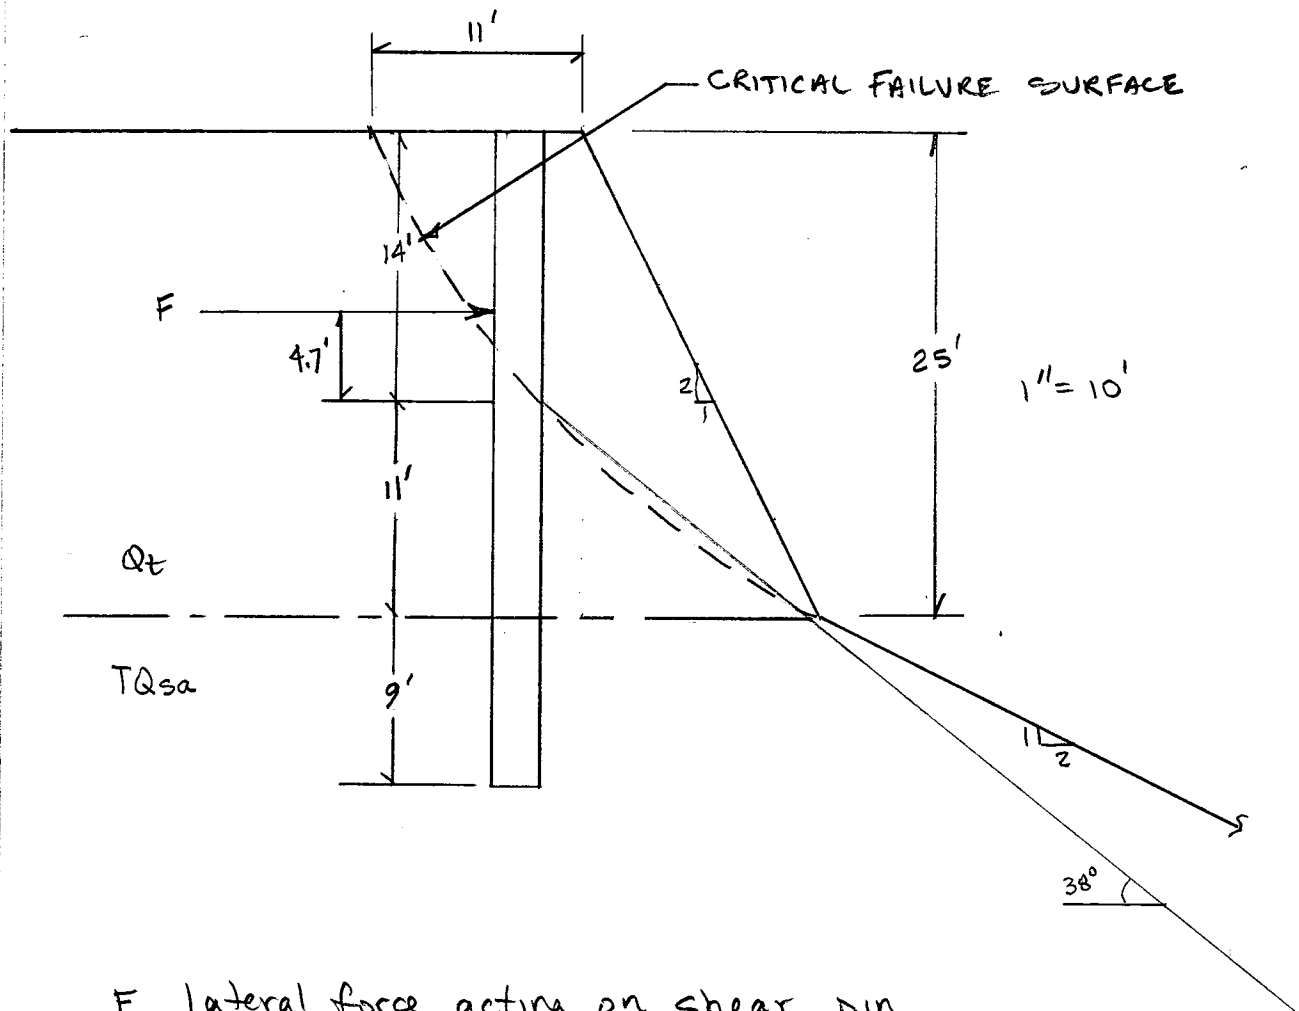
SHEAR PIN DESIGN

F , lateral force acting on shear pin,
 is greater of unbalance lateral force
 to obtain slope stability factor of
 safety ≥ 1.5 or active earth pressure
 from upper 14' if outer wedge slides
 away.

Per stability analysis, $F = 3,850 \text{ lbs/ft}$ for $FS = 1.5$
 (see attached plot, Plates E-7 & E-8)

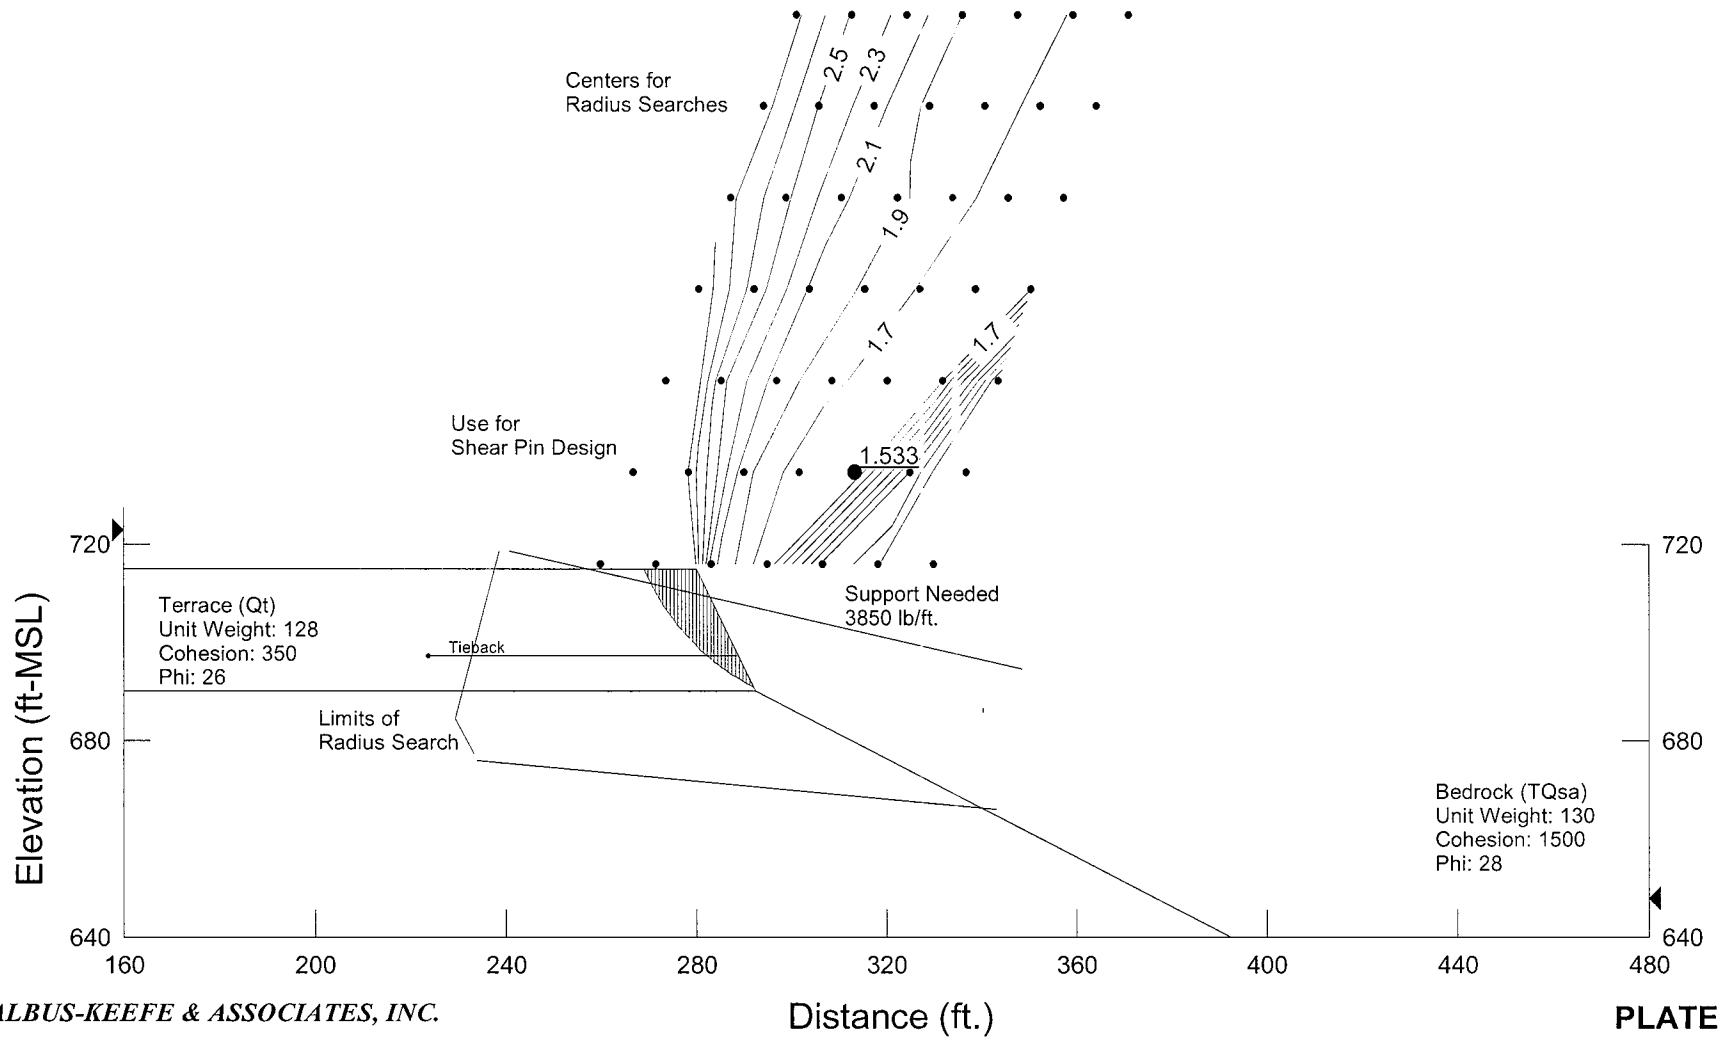
Shear Pin Design - Required Support - Static Case
 1489.00 - Comstock - Santa Paula Site
 File Name: 1489_SP1.slp
 Last Saved Date: 5/3/2006
 Analysis Method: Bishop
 Seismic Coefficient: (none)

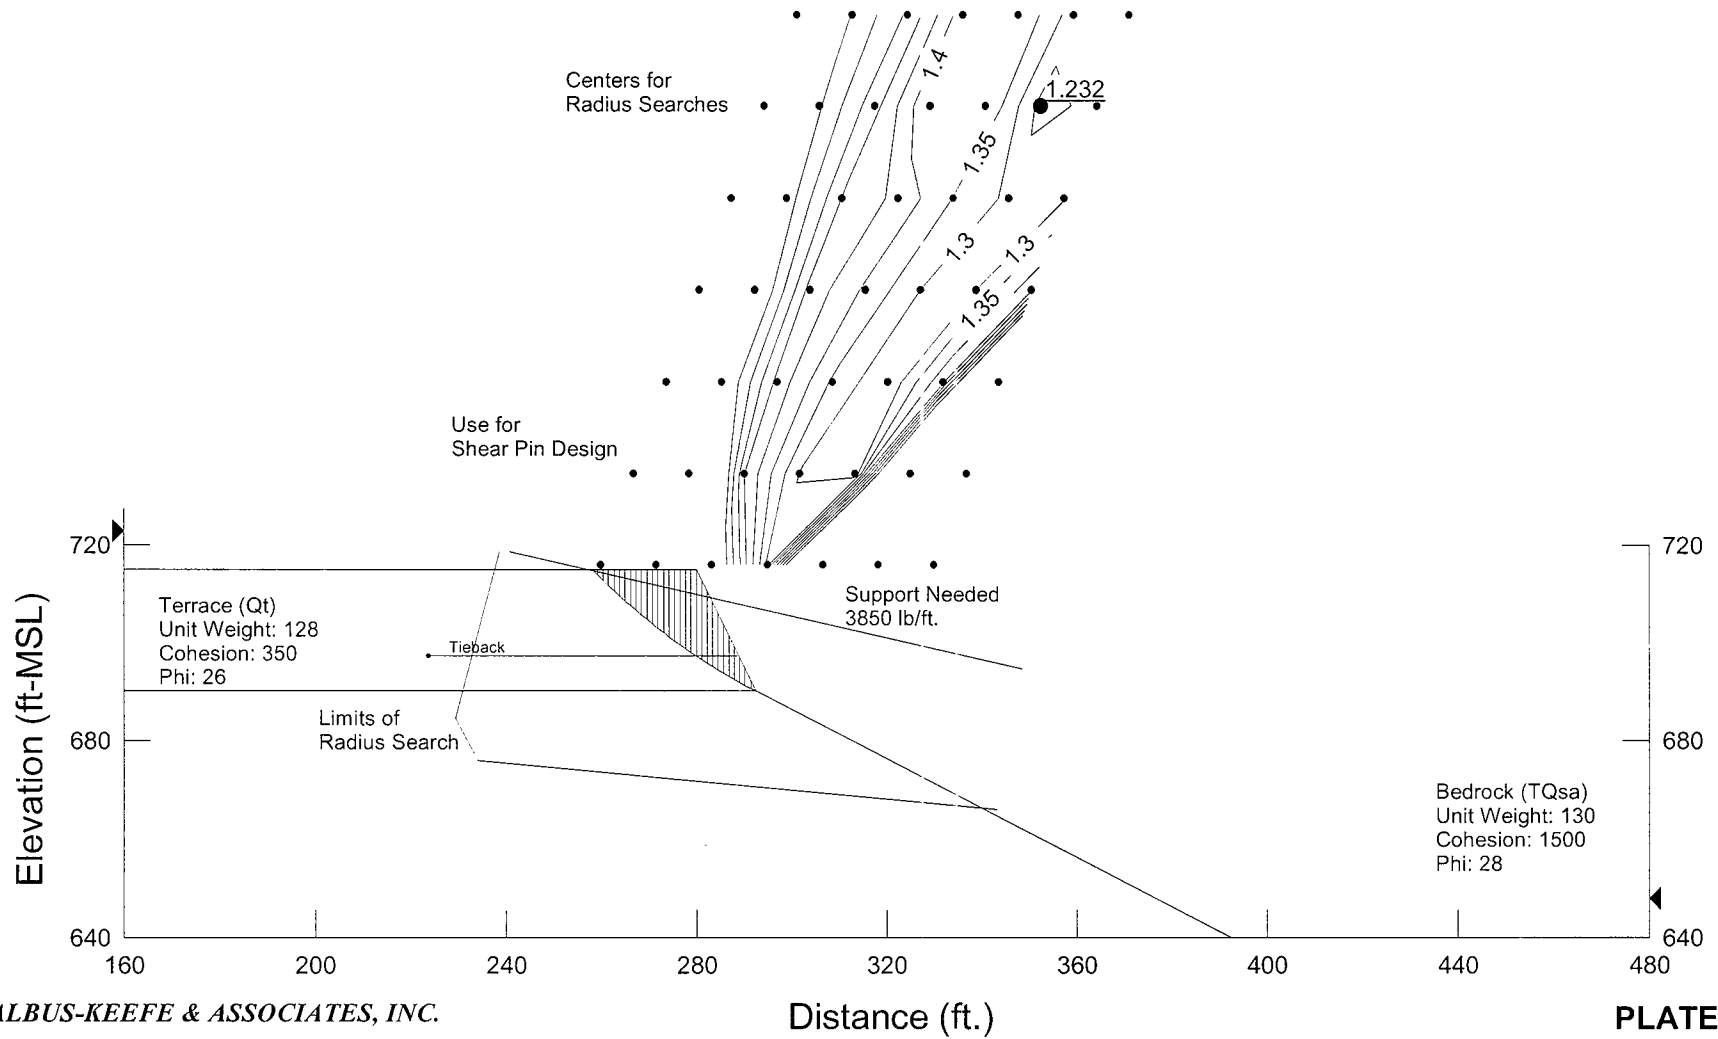
Shear Pin Design - Required Support - Seismic Case
 1489.00 - Comstock - Santa Paula Site
 File Name: 1489_SP1s.slp
 Last Saved Date: 5/3/2006
 Analysis Method: Bishop
 Seismic Coefficient: Horizontal

Cs=0.15

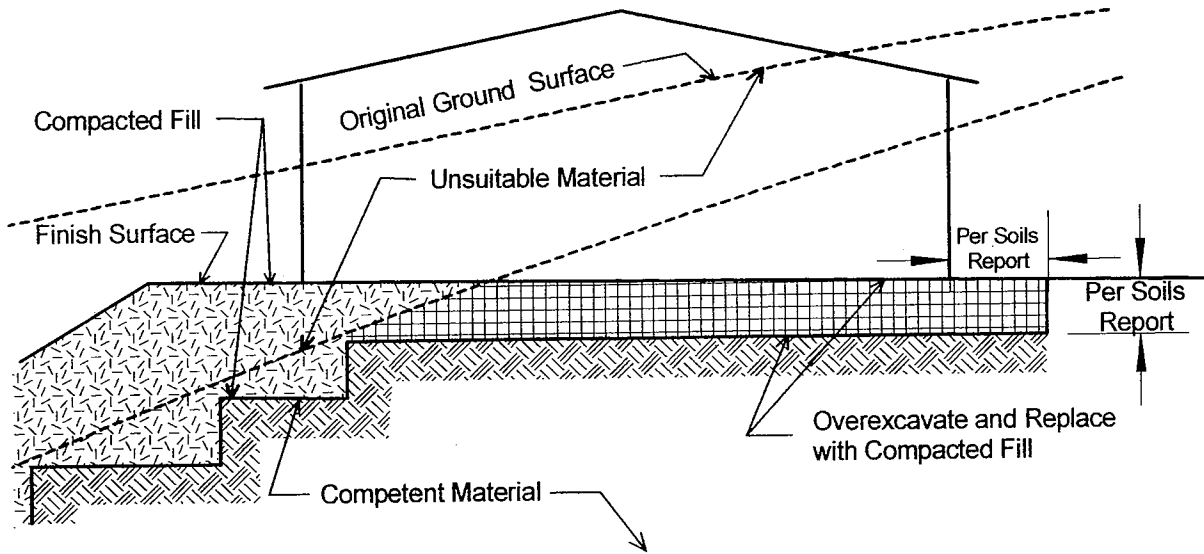
CUT TRANSITION LOT

TRANSITION LOT CAPPING

Not To Scale
See attached soils report for
specific recommendations.

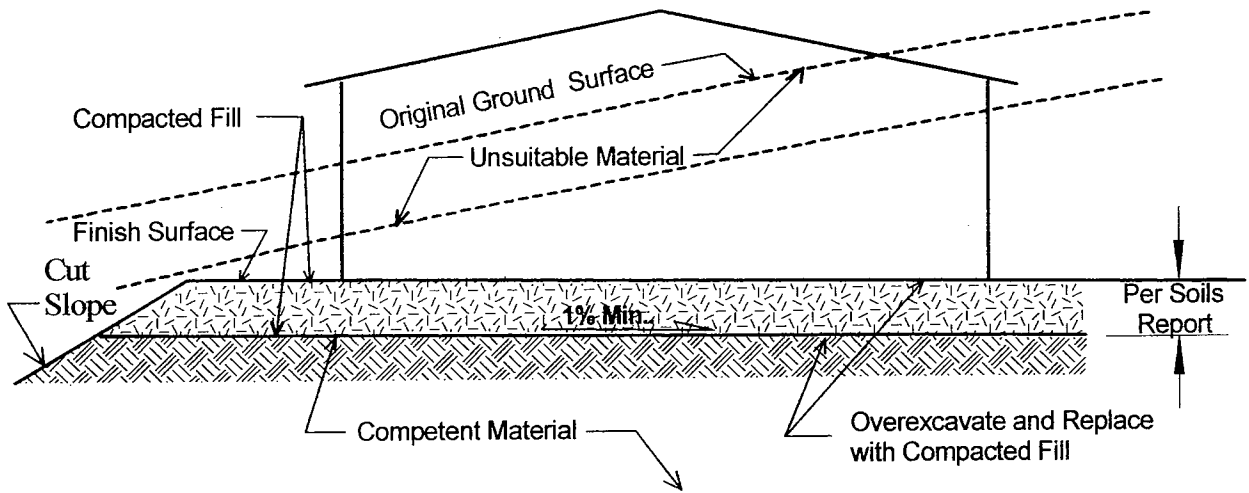
CUT LOT CAPPING

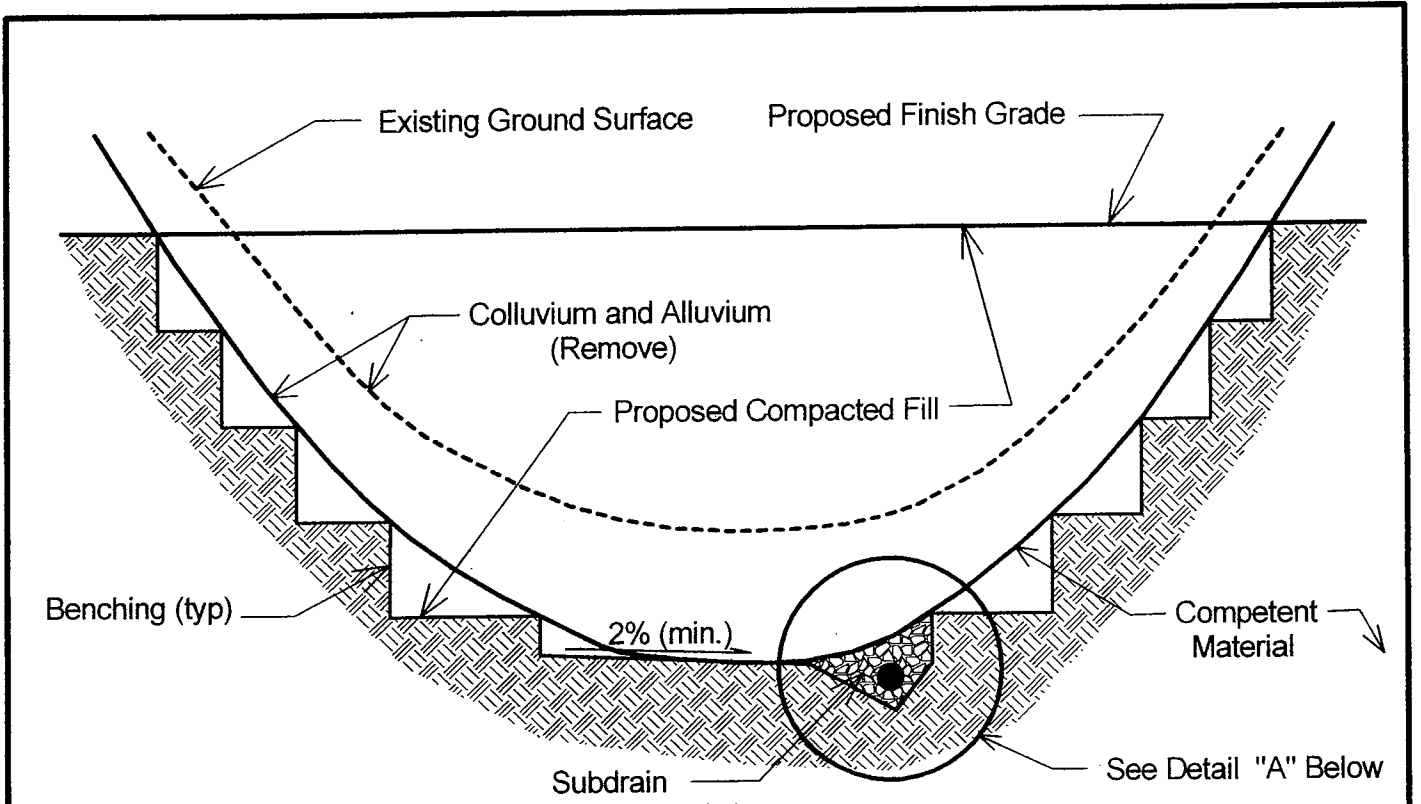
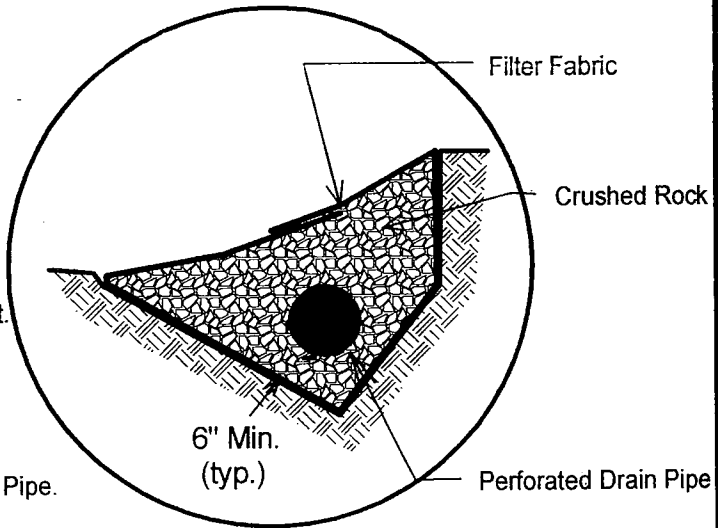
CANYON SUBDRAIN

(location per soils engineer/geologist)

Filter Fabric should consist of Mirifi 140N or equivalent. Ends should overlap at least 12 inches.

CALTRANS Class II Permeable Filter Material can be used in lieu of Crushed Rock encased in Filter Fabric

DETAIL "A"

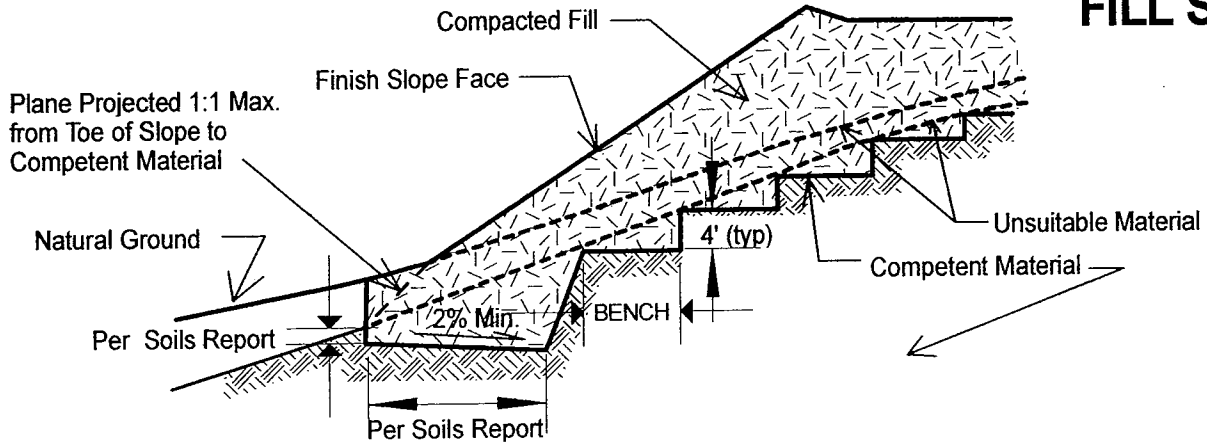
FILL SLOPE

For subdrains see "BACKDRAIN" detail.

Benching shall be done when slope angle is equal to or greater than 5:1. Minimum bench height shall be 4 feet. Minimum fill width shall be 9 feet.

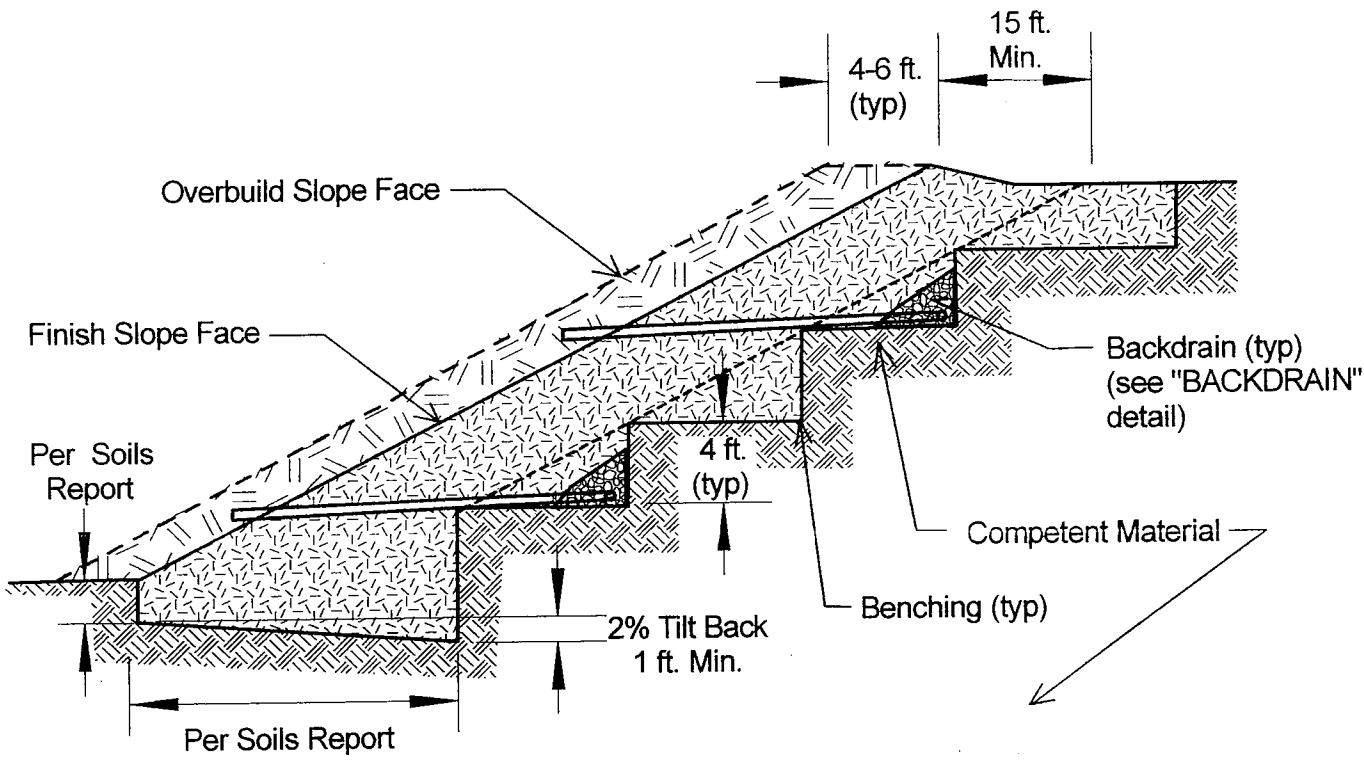
BUTTRESS/STABILIZATION FILL

Not To Scale
See attached soils report for specific recommendations.

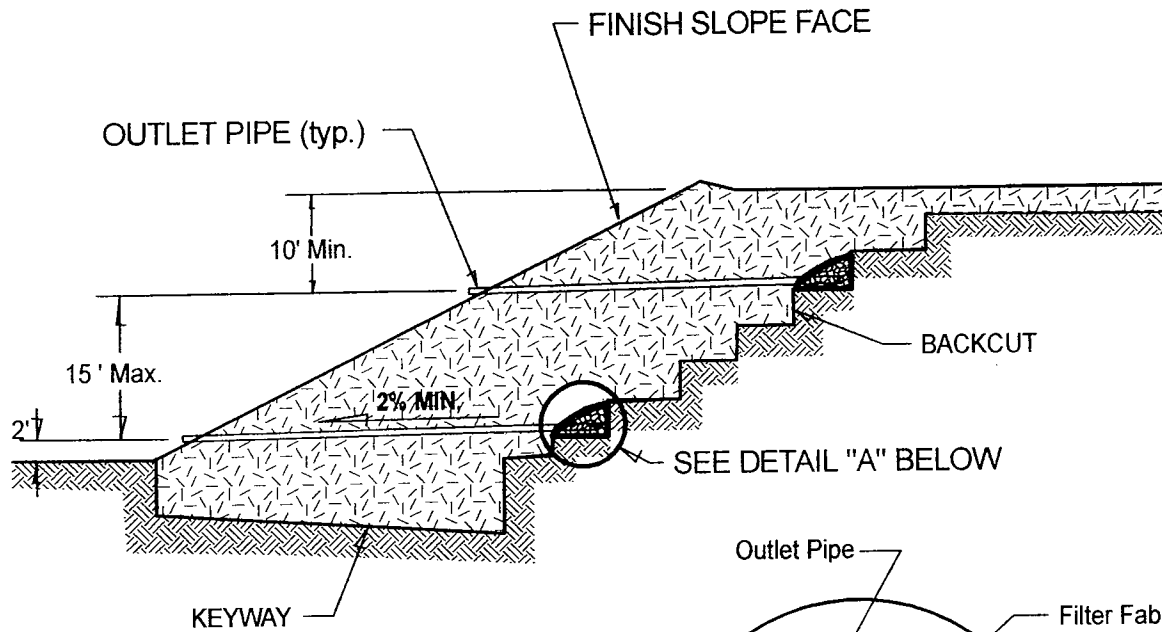
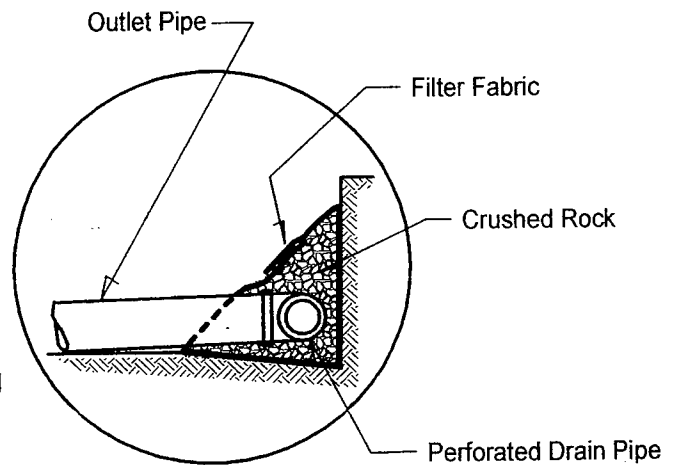
Perforated Drain Pipe should be at least 4 inches in diameter consisting of either Schedule 40 PVC or SDR 35. A min. of 8 perforations per linear foot should be provided along the bottom of pipe. Upstream ends should be provided with a cap. The pipe should slope at a min. 1% gradient toward Outlet Pipes.

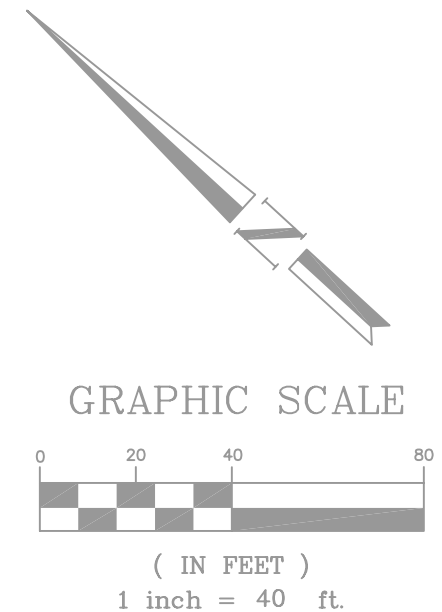
EXPLANATION	
---10---10---	- Miragrid 10XT Geogrid
L = 40'	- Length of Geogrid
J	- Geologic Cross-Section

The grading plans have been revised by DRC to reflect the removal and replacement of the slope down to at least the daylight of the terrace deposits. The plan depicting these revisions has been attached herein as Plate 1. We have performed slope stability analyses of the conditions along the bluff using the computer program Slope/W. Details of the program and methodology were provided in our referenced Supplemental Geotechnical Investigation.

Facing stability will require the installation of additional geogrids. We are recommending the use of Mirifi 2XT geogrids that are embedded into the slope face 8 feet then wrap the outer slope face with a minimum embedment of 3 feet. These geogrids should be provided every 2.5 feet vertically. Our proposed layout is provided on Plate 1 and a schematic of the system is provided on Plate 2.

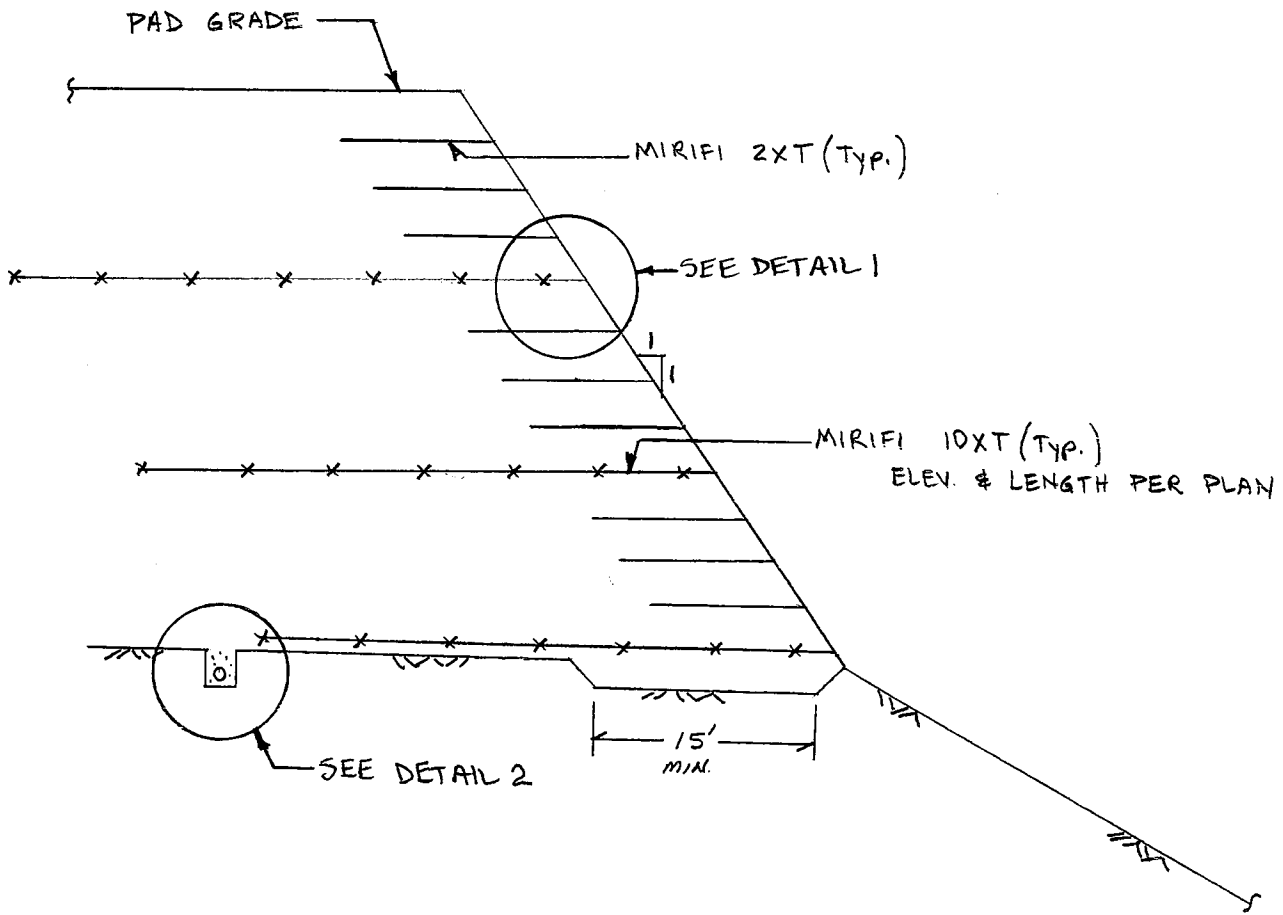
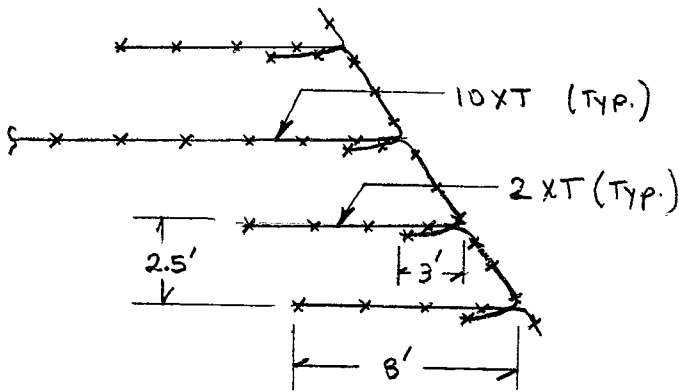
SCHEMATIC LAYOUT OF GEOGRID SLOPE

DETAIL 1

Plate 2- Schematic Layout of Geogrid Slope

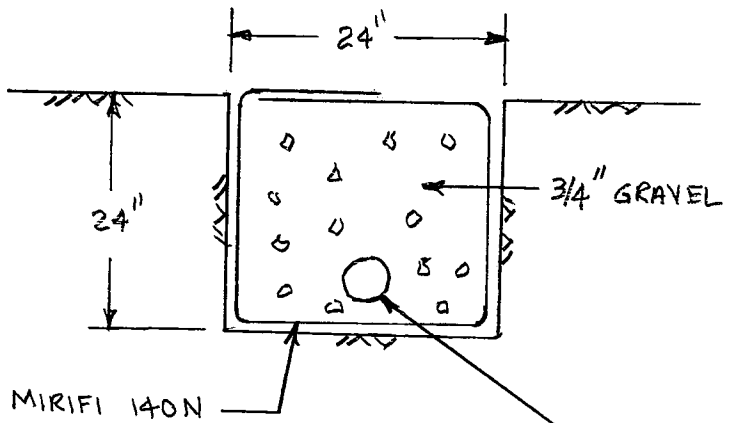
DETAIL 2

4" DIA. PVC PERFORATED PIPE
DRAIN @ 1% MIN., OUTLETS @ 100'

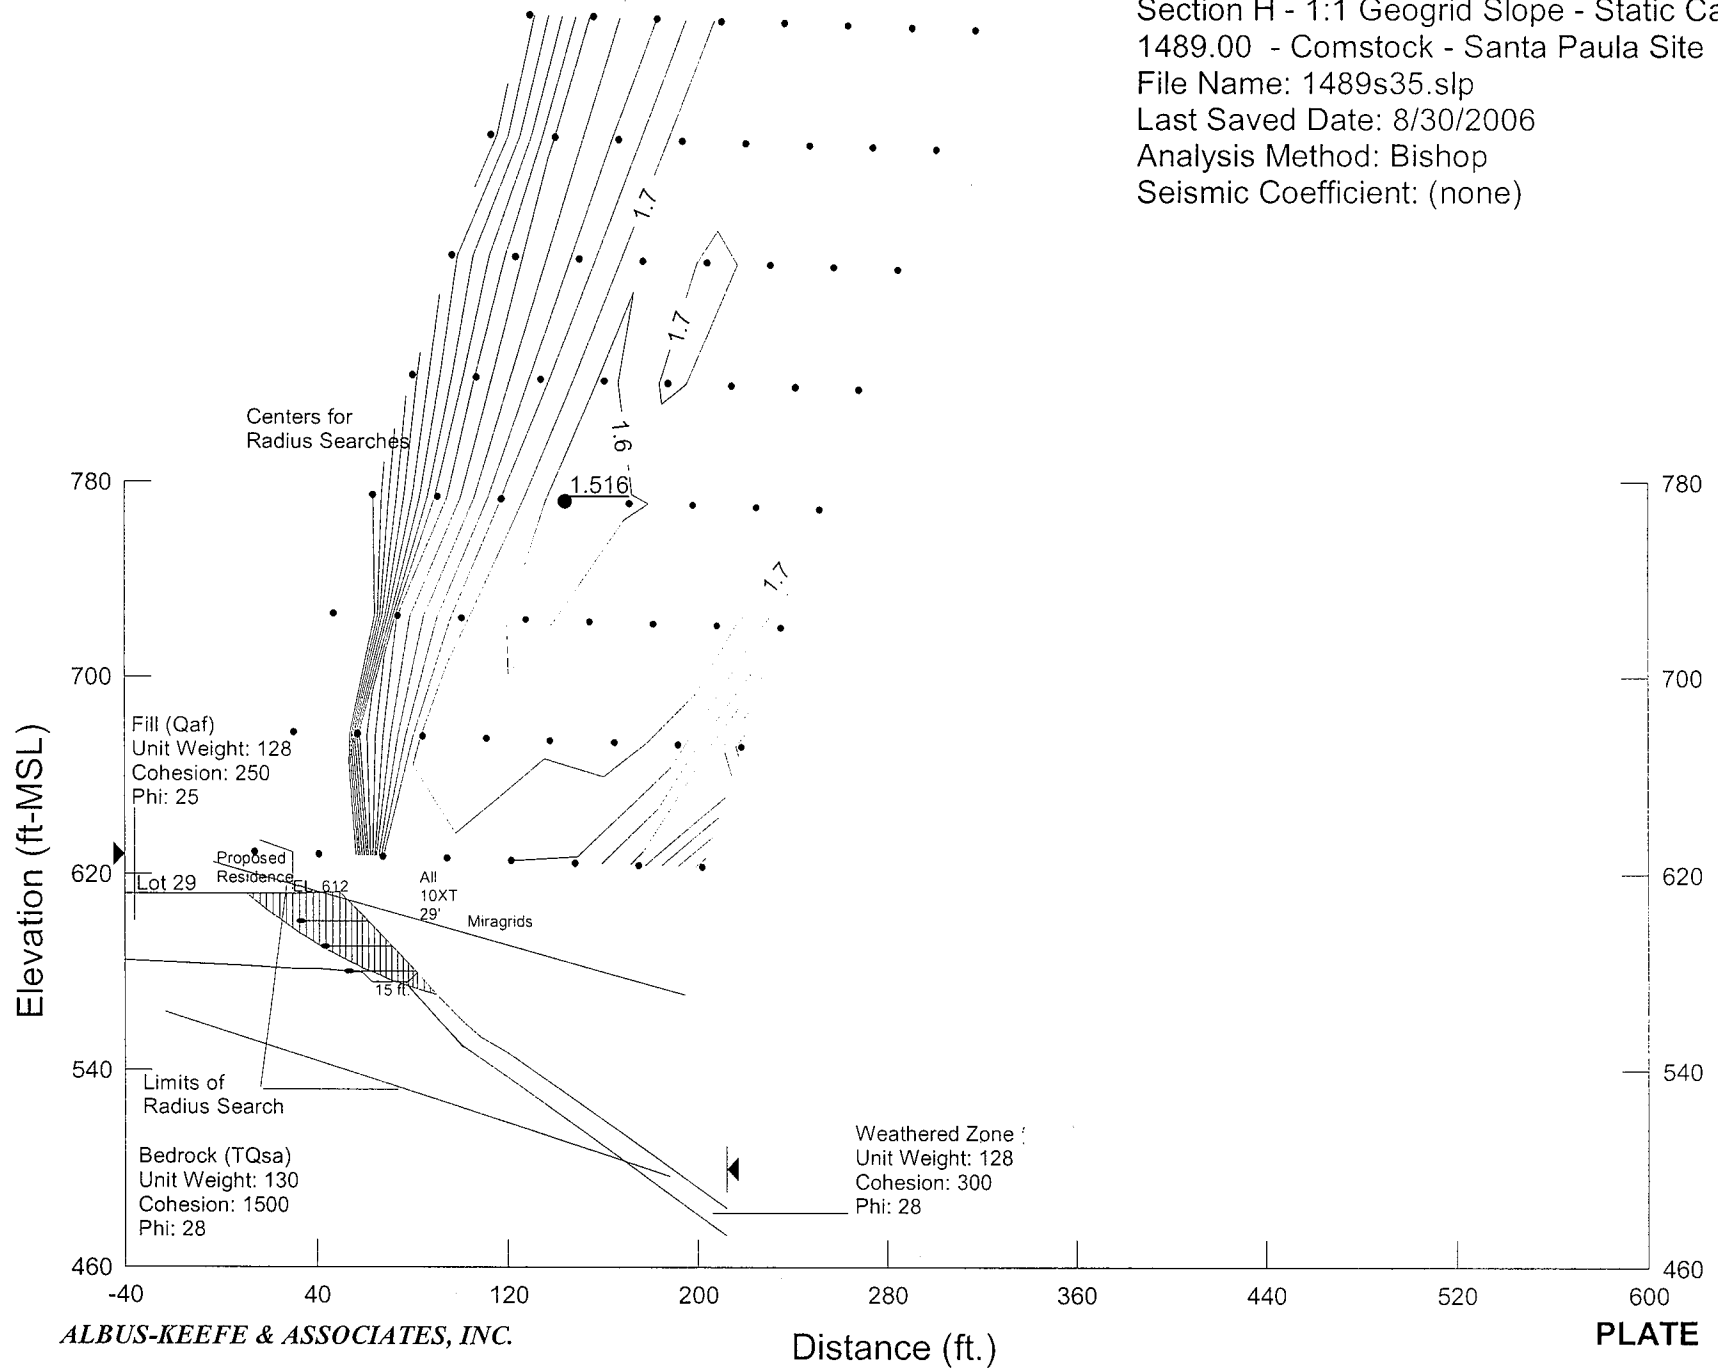
Section H - 1:1 Geogrid Slope - Static Case
 1489.00 - Comstock - Santa Paula Site
 File Name: 1489s35.slp
 Last Saved Date: 8/30/2006
 Analysis Method: Bishop
 Seismic Coefficient: (none)

Plates A-1 through A-6- Stability Analyses for Geogrid Slope
