**SANTA PAULA GEOLOGIC HAZARD
ABATEMENT DISTRICT (GHAD)
PLAN OF CONTROL**

SANTA PAULA, CALIFORNIA

ENGEO INCORPORATED

MARCH 10, 2008

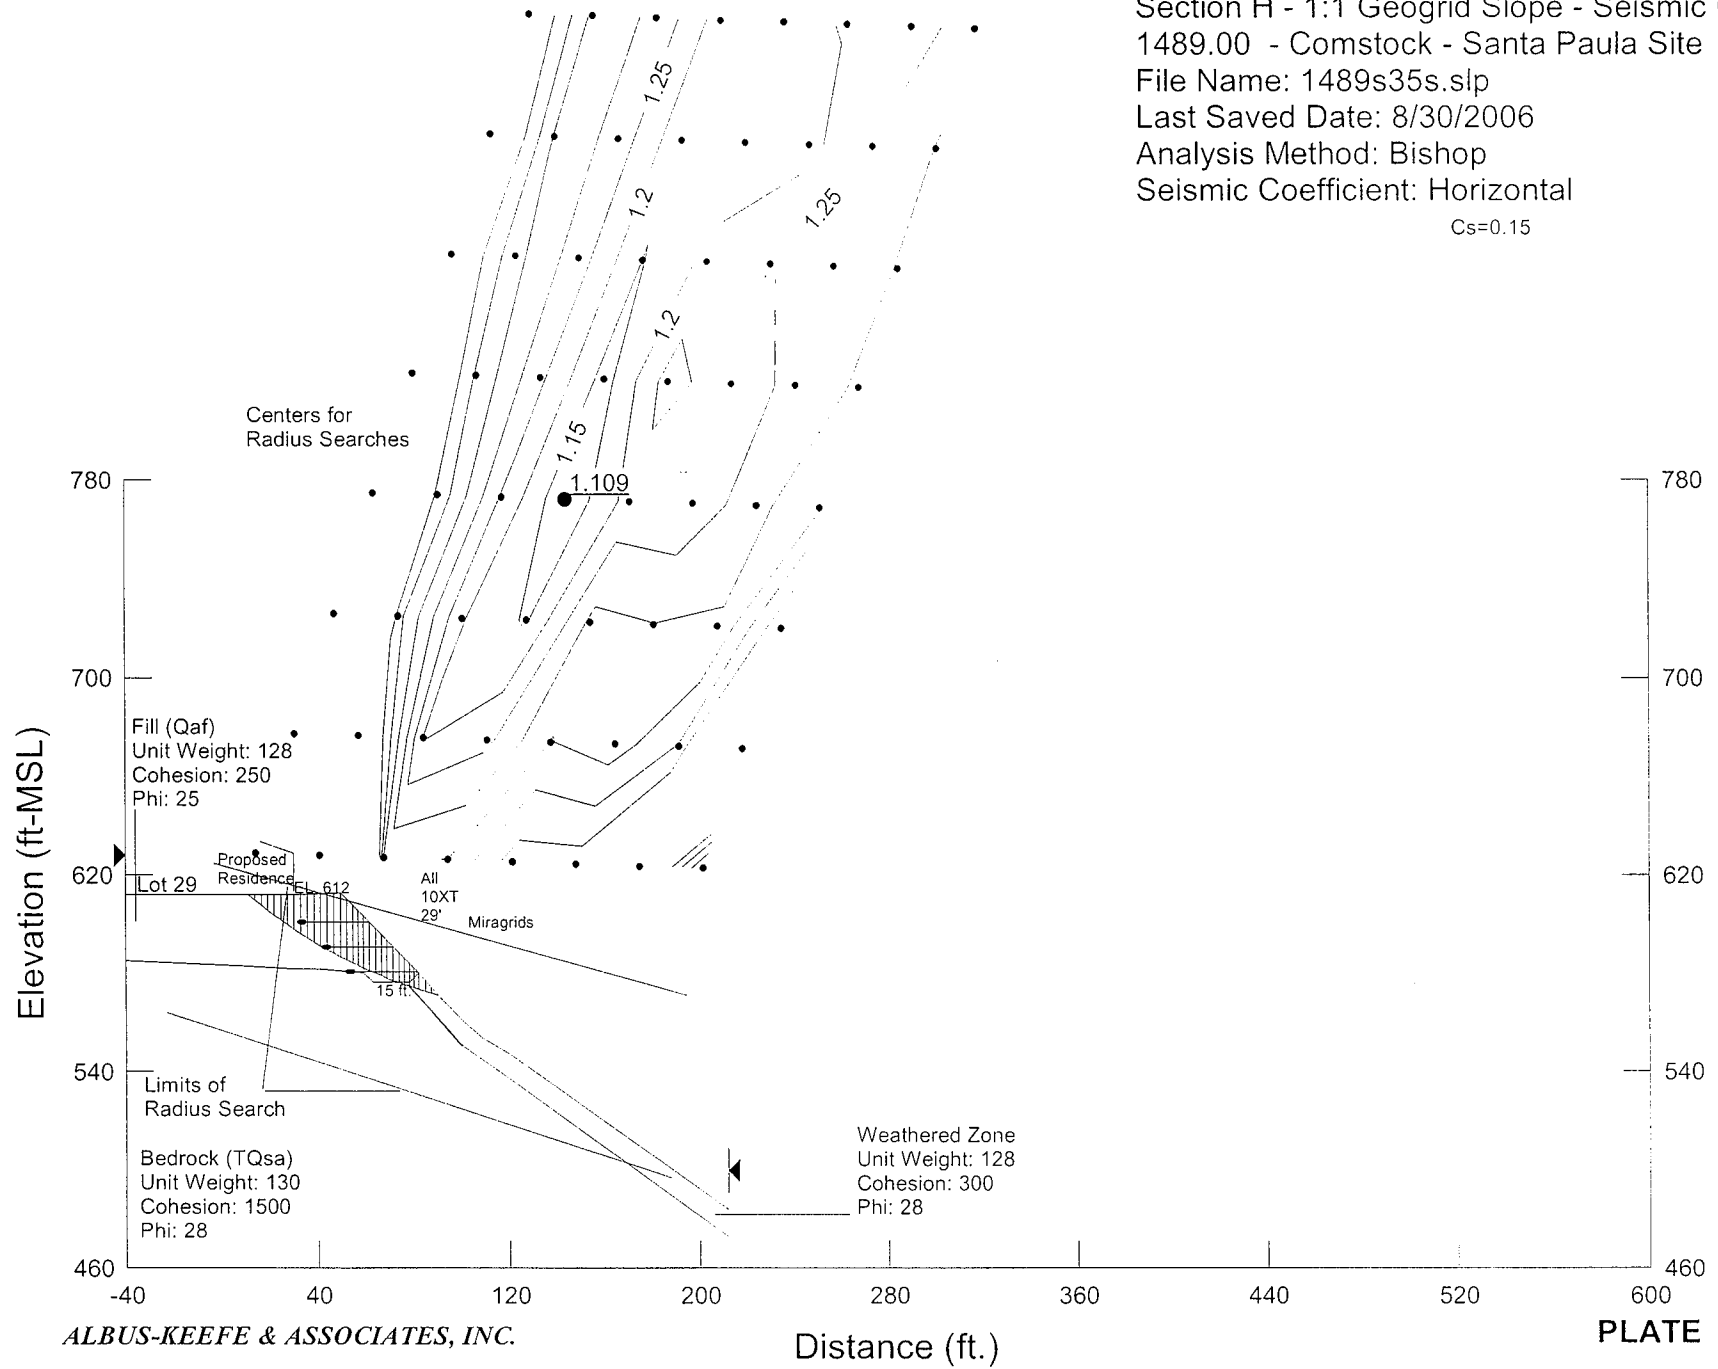
Section H - 1:1 Geogrid Slope - Seismic Case
 1489.00 - Comstock - Santa Paula Site
 File Name: 1489s35s.slp
 Last Saved Date: 8/30/2006
 Analysis Method: Bishop
 Seismic Coefficient: Horizontal
 Cs=0.15

Plates A-1 through A-6- Stability Analyses for Geogrid Slope

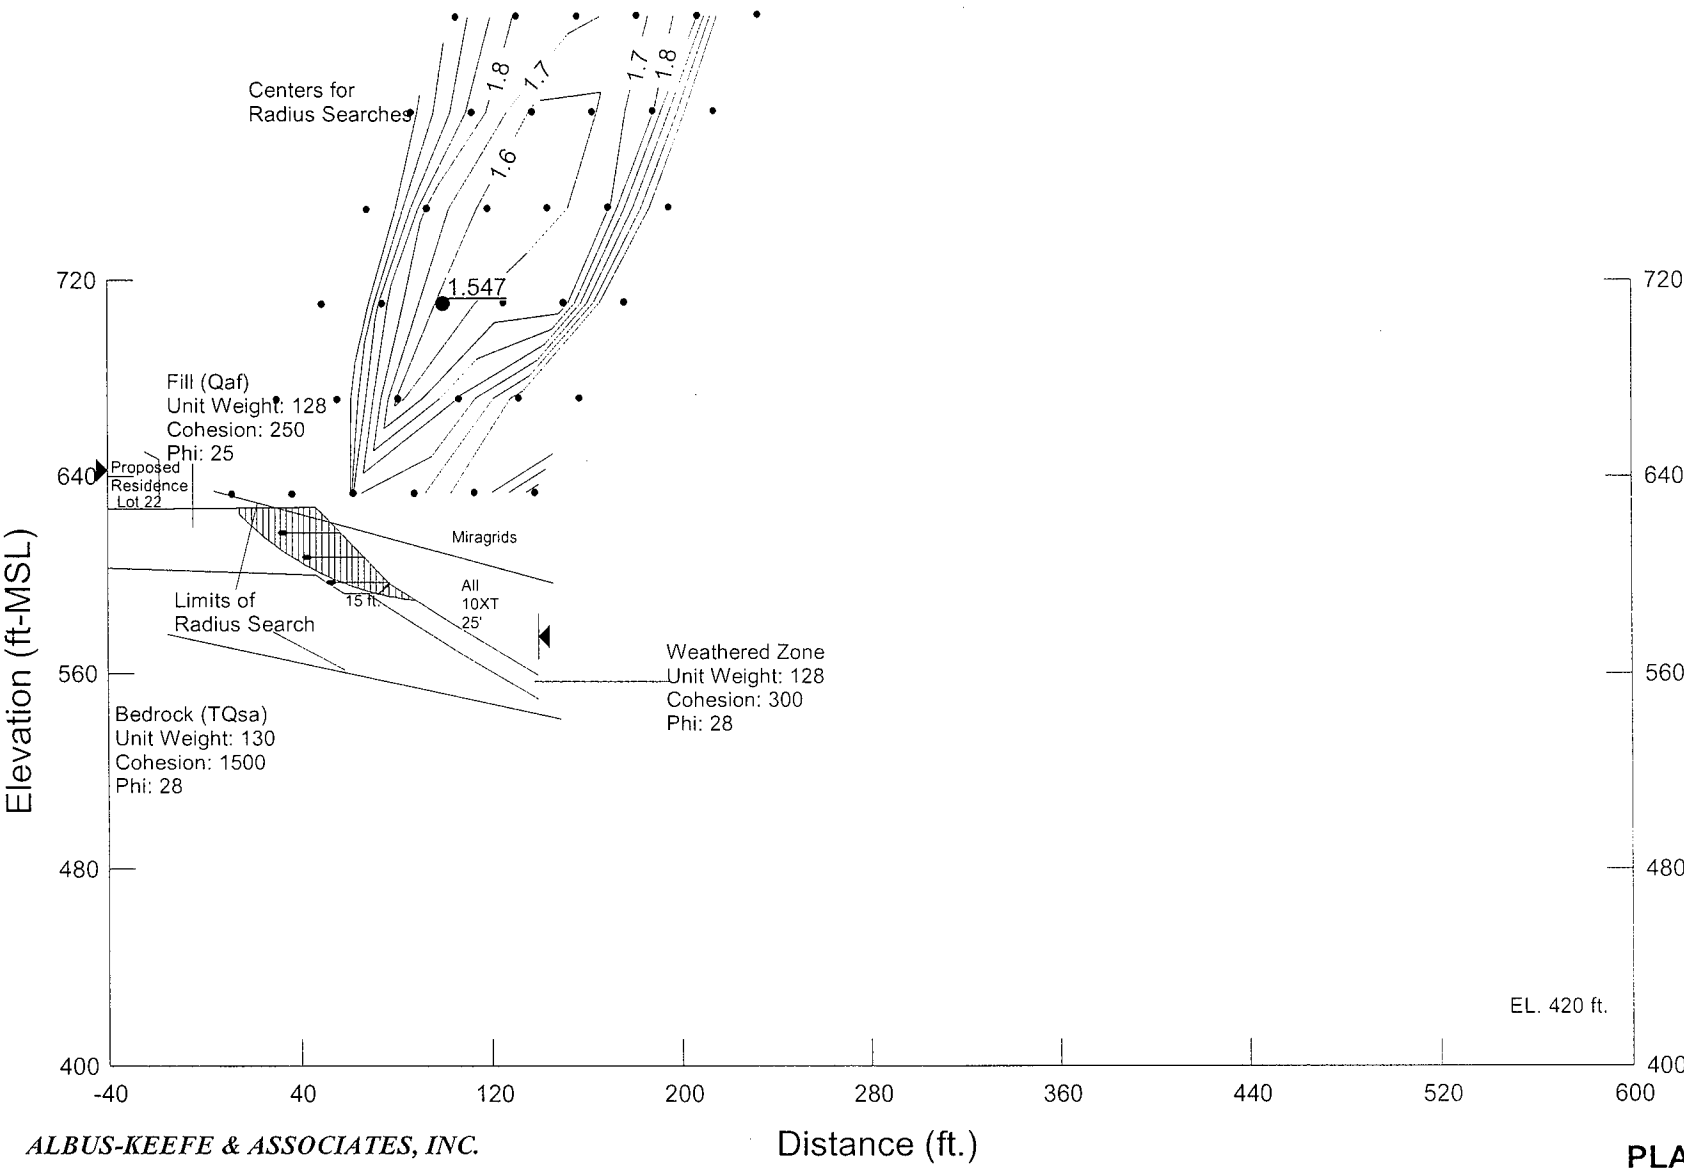
Section I - 1:1 Geogrid Slope - Static Case
 1489.00 - Comstock - Santa Paula Site
 File Name: 1489s36.slp
 Last Saved Date: 8/30/2006
 Analysis Method: Bishop
 Seismic Coefficient: (none)

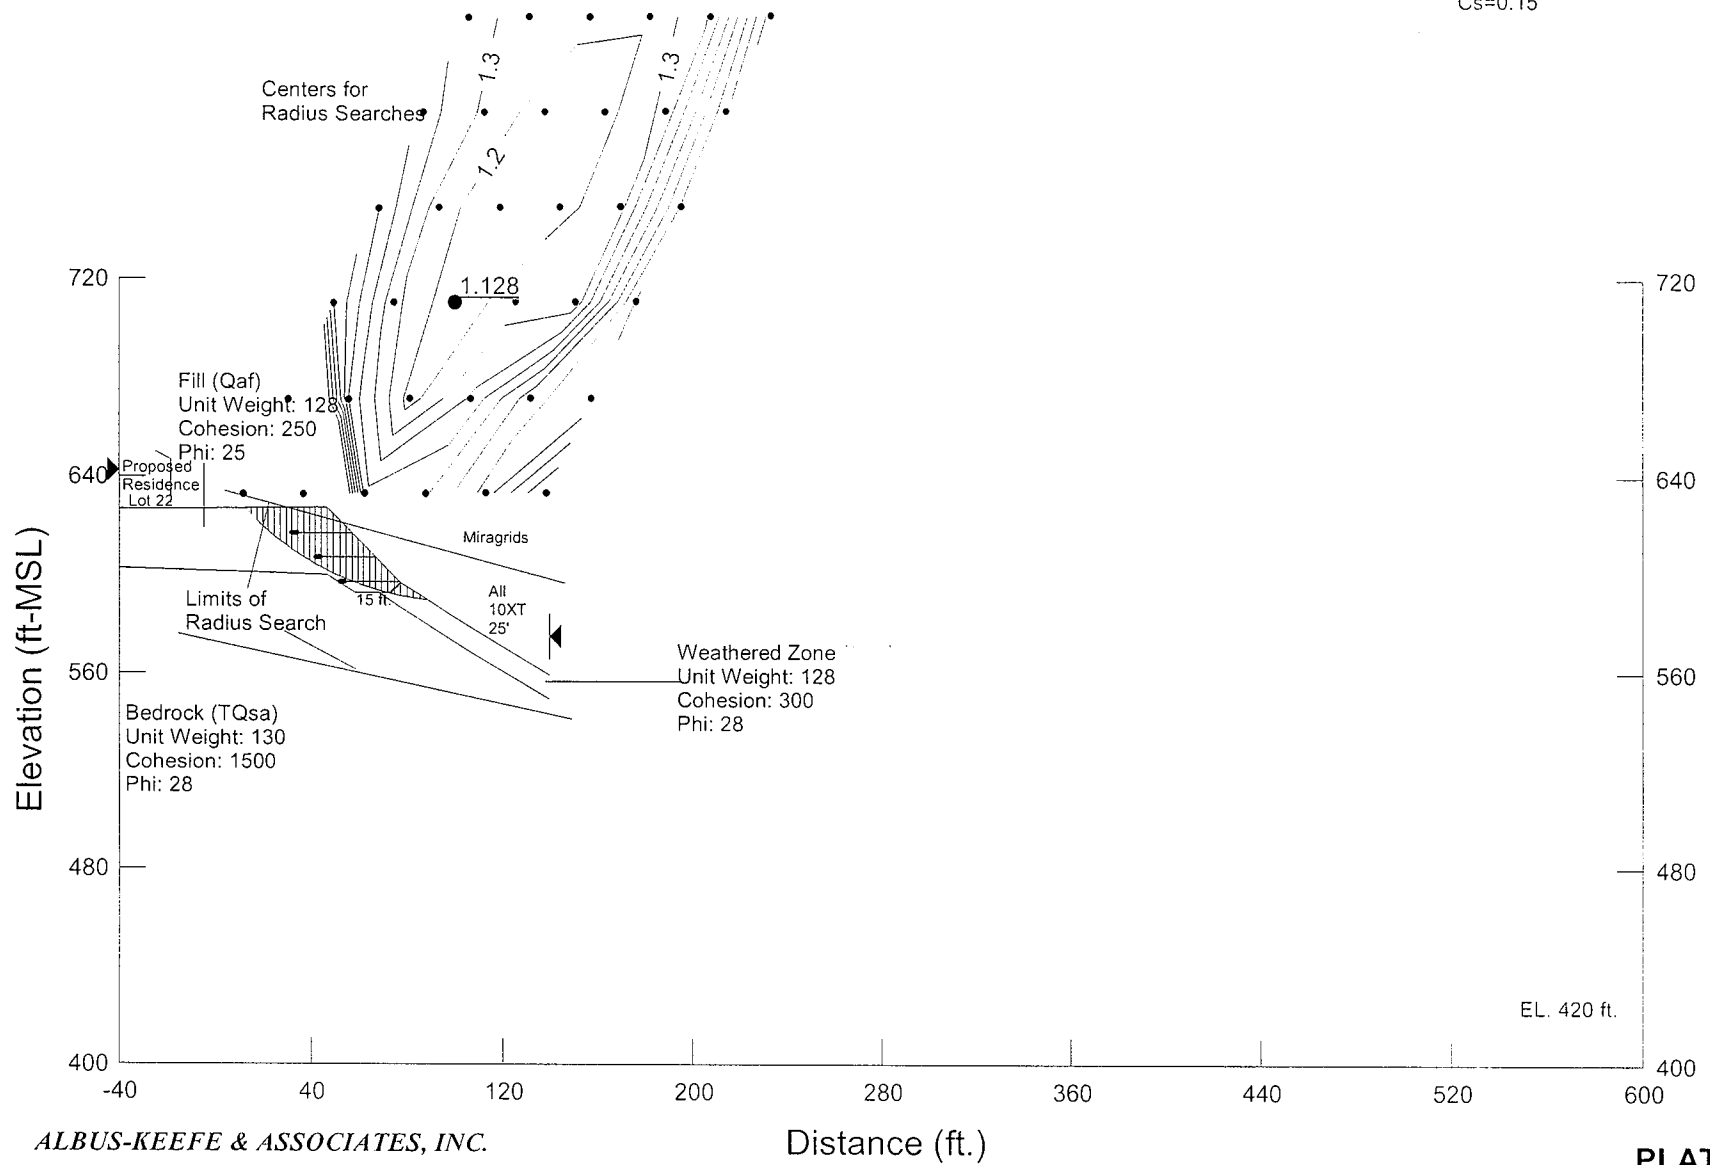
Section I - 1:1 Geogrid Slope - Seismic Cas
 1489.00 - Comstock - Santa Paula Site
 File Name: 1489s36s.slp
 Last Saved Date: 8/30/2006
 Analysis Method: Bishop
 Seismic Coefficient: Horizontal
 Cs=0.15

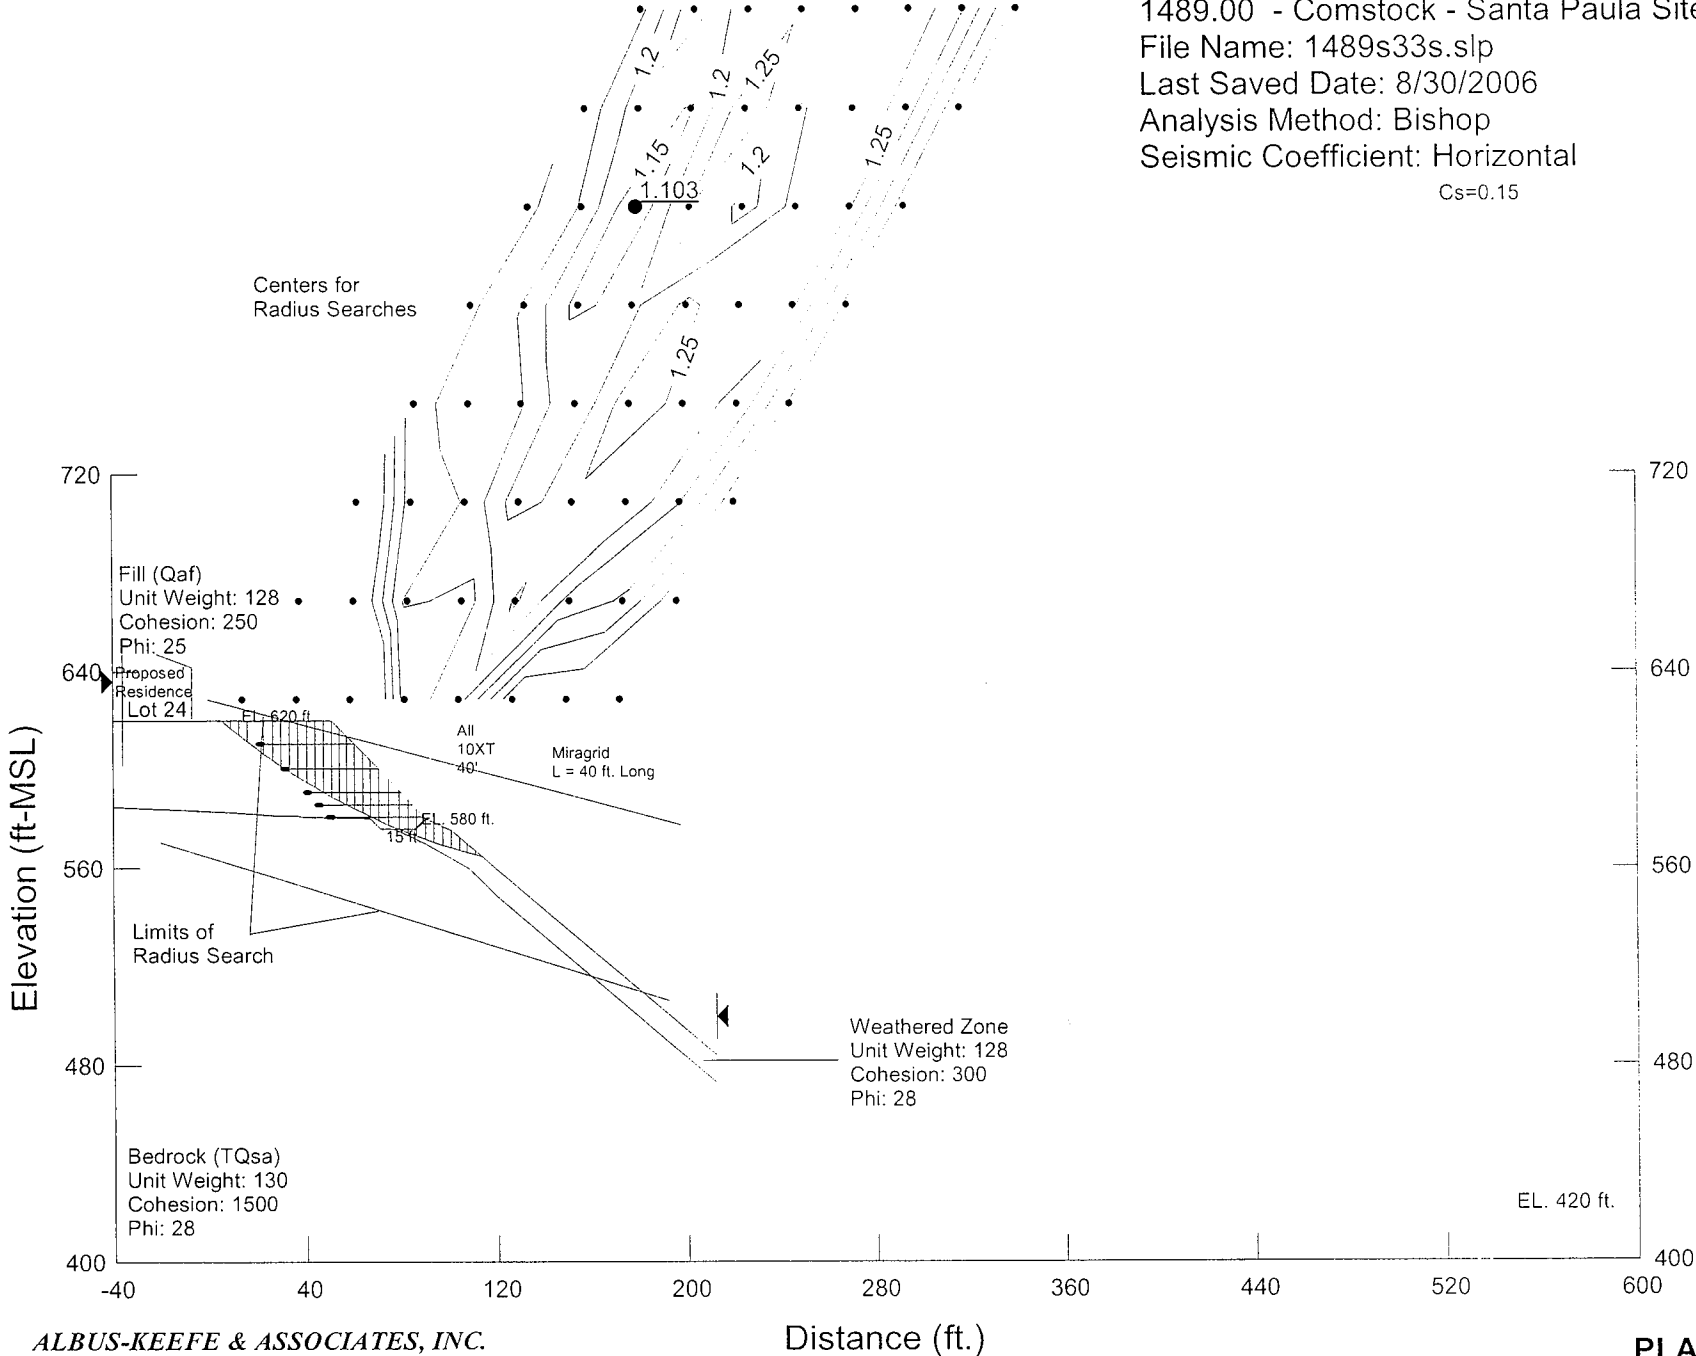
Section J - 1:1 Geogrid Slope - Seismic Cas
 1489.00 - Comstock - Santa Paula Site
 File Name: 1489s33s.slp
 Last Saved Date: 8/30/2006
 Analysis Method: Bishop
 Seismic Coefficient: Horizontal
 Cs=0.15

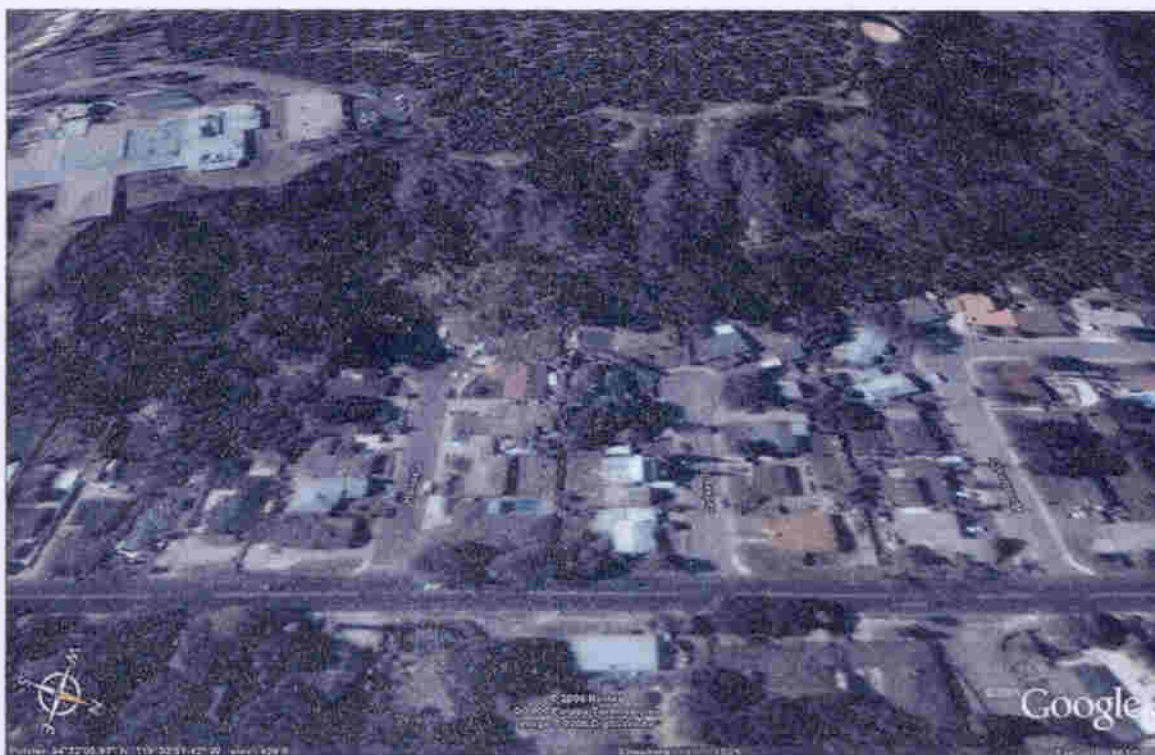
Figure 2. Oblique view of slopes at the site.

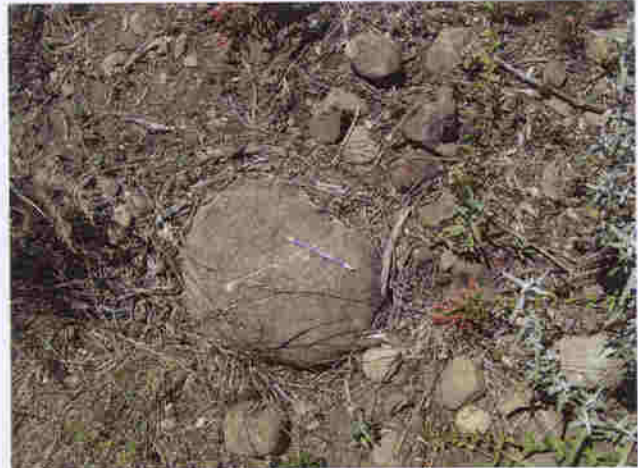
Figure 3. Terrace materials at project site.

The project site is located in the southern Transverse Ranges geologic province. Geologic materials consist of sandstone, siltstone, and claystone of the Saugus Formation capped by terrace deposits. The terrace deposits contain numerous rounded sandstone cobbles up to 1.5-ft in the largest dimension. These cobbles are readily visible in the exposed slopes, Figure 3. Surficial soil is silty sand and soft. The soil is composed of silt, sandy silt, fine-grained

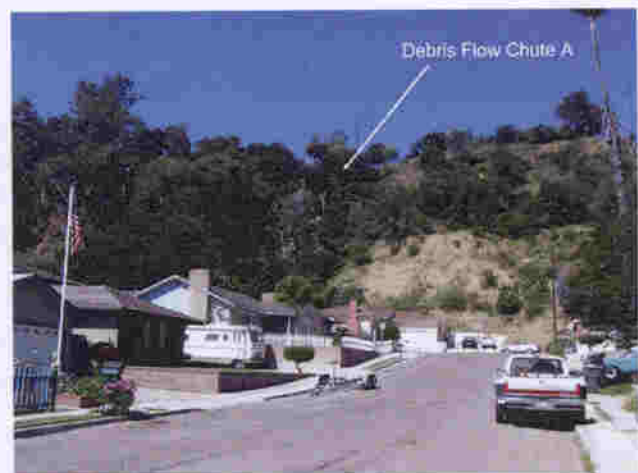
Figure 4. Debris flow Chute A.

All chutes terminated close to the homes located at the base of the terrace. Figures 4 and 5 show the chutes as viewed from below.

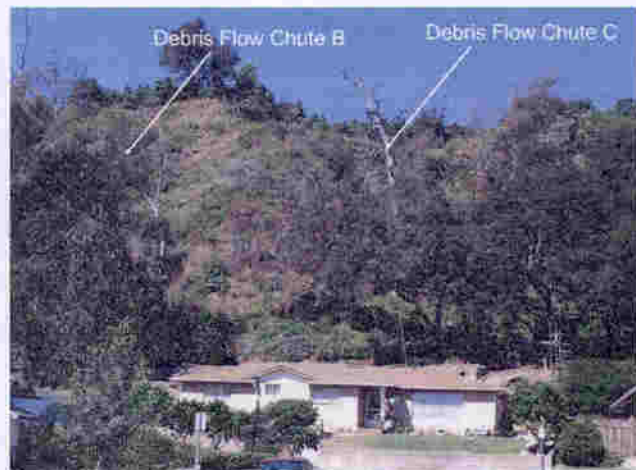
Figure 5. Debris flow Chutes B and C.

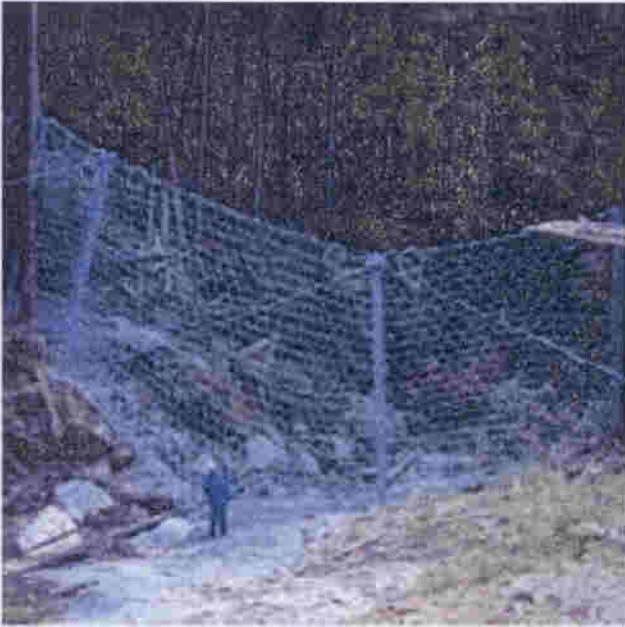
Figure 7. Geobrug UX debris flow barrier (Source: Geobrug Fatzer, AG).

Debris flow analyses, Appendix B, indicated that each of the three debris flow chutes can be mitigated with the installation of a single barrier for a total of three barriers. The analyses indicated that barriers should be placed near the mouth of the chutes just inside the property line, Figure 6. These barriers can be either Geobruigg UX (Figure 7) or VX (Figure 8) barrier depending the shape of the chutes at the finalized barrier locations.

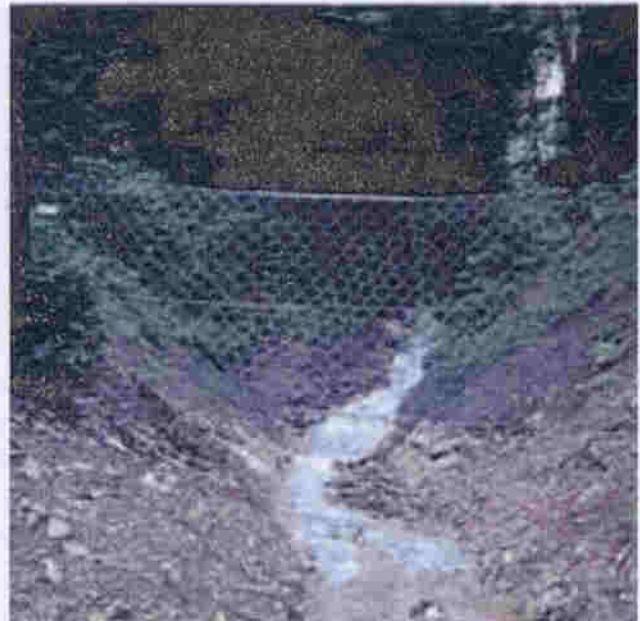
Figure 8. Geobrug VX debris flow barrier (Source: Geobrug Fatzer, AG).

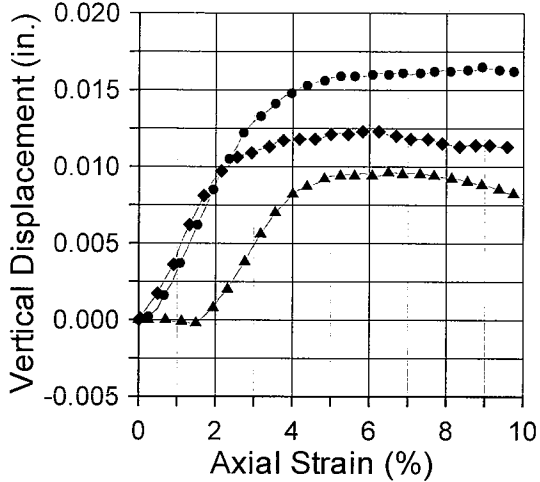
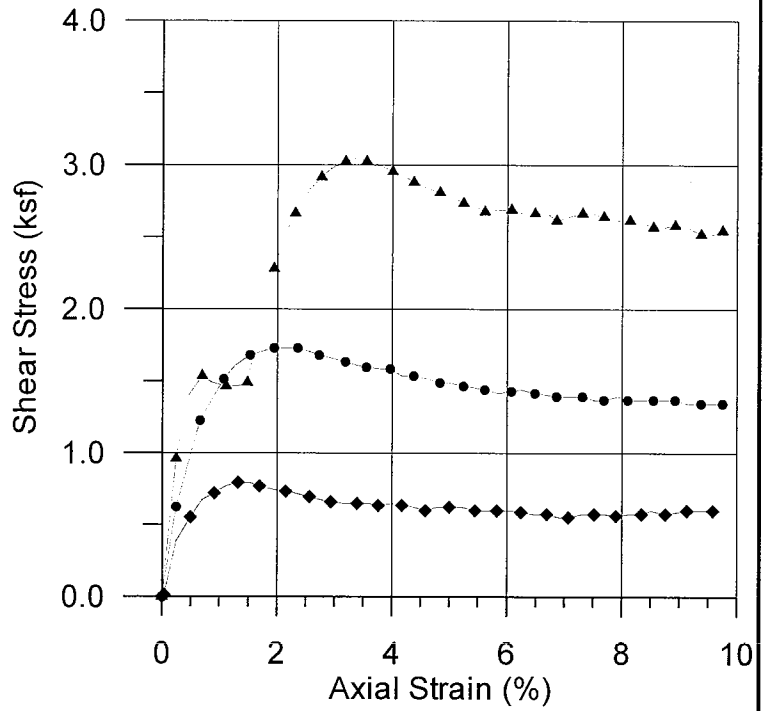
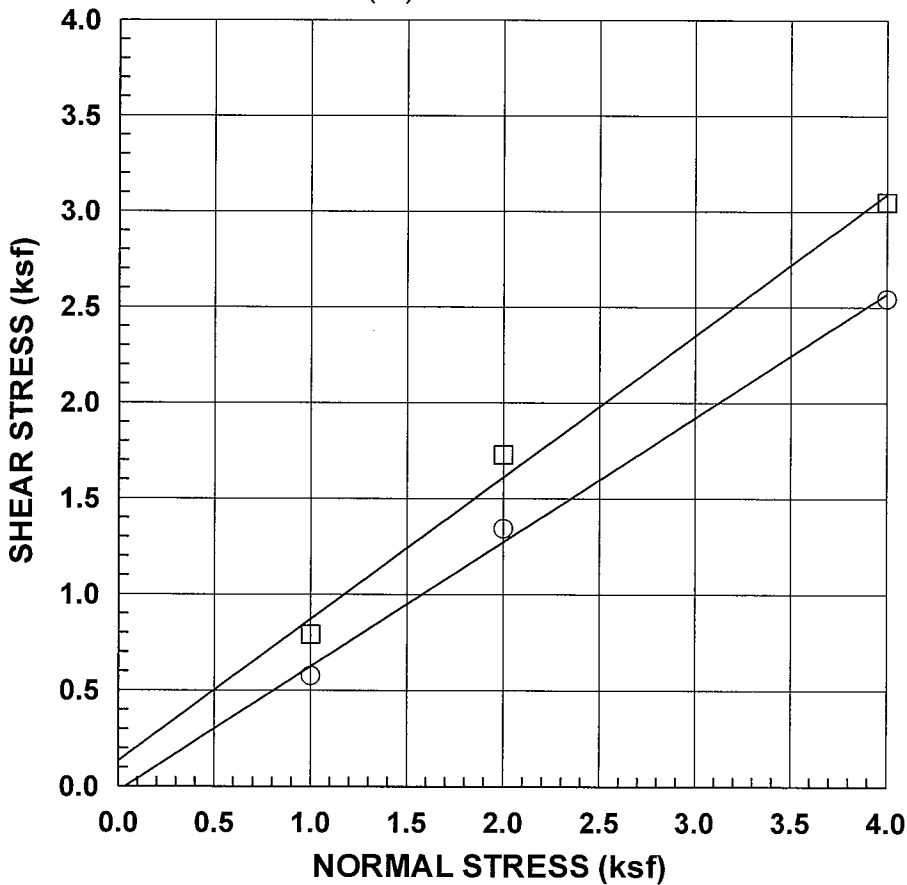
Plate No: B-1

Specimen No.	1	2	3
Normal Stress (ksf)	1	2	4
Peak Stress (ksf)	0.792	1.728	3.048
Peak Displacement (in)	0.032	0.0465	0.0815
Ultimate Stress (ksf)	0.576	1.344	2.544
Ultimate Displacement (in)	0.242	0.247	0.247
Initial Dry Density	117.9	117.9	117.9
Initial Moisture Content (%)	9.007	9.007	9.007
Strain Rate (in/min)	0.050

Strain Legend	
◆	1 Ksf
●	2 Ksf
▲	4 Ksf

Strength Legend	
□	Peak
○	Ultimate

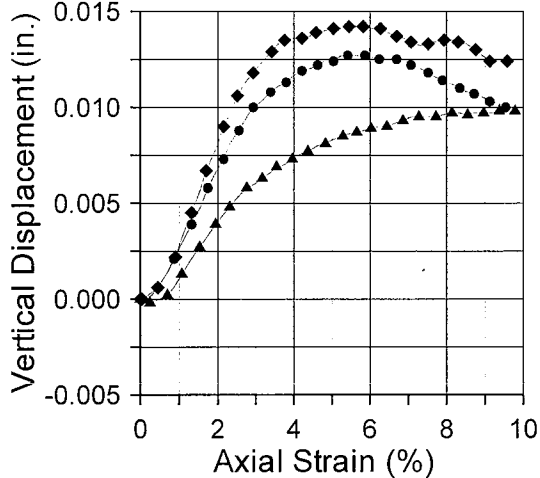
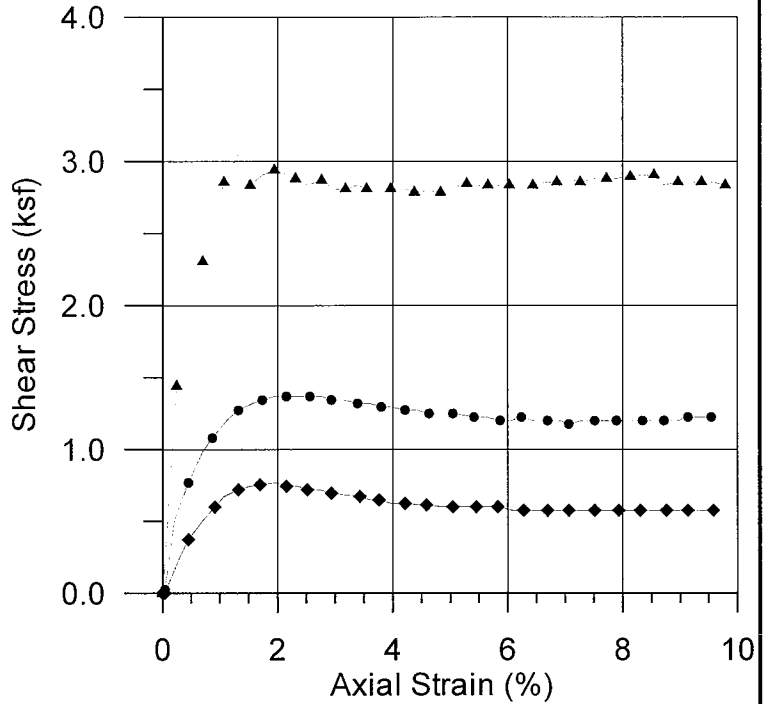
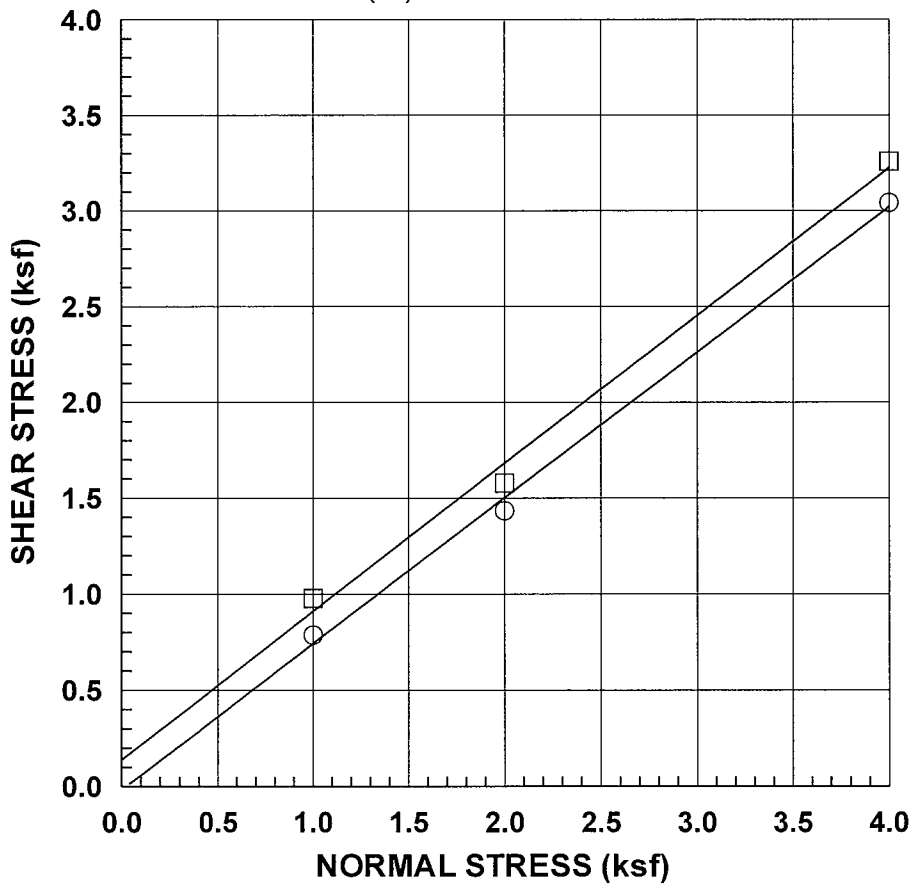
Plate No: B-2

Specimen No.	1	2	3
Normal Stress (ksf)	1	2	4
Peak Stress (ksf)	0.978	1.578	3.258
Peak Displacement (in)	0.0475	0.0465	0.032
Ultimate Stress (ksf)	0.786	1.434	3.042
Ultimate Displacement (in)	0.242	0.241	0.246
Initial Dry Density	117.9	117.9	117.9
Initial Moisture Content (%)	9.024	9.024	9.024
Strain Rate (in/min)	0.050

Strain Legend	
◆	1 Ksf
●	2 Ksf
▲	4 Ksf

Strength Legend	
□	Peak
○	Ultimate

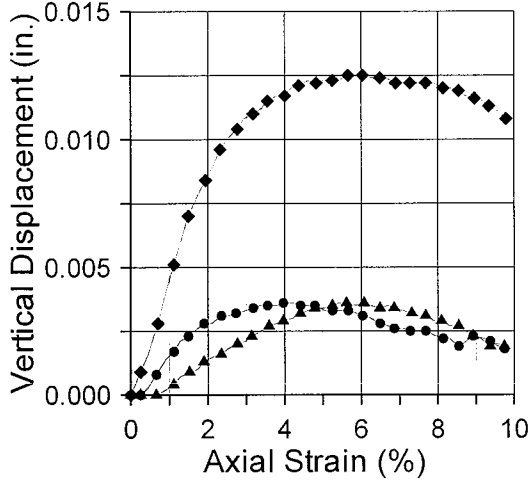
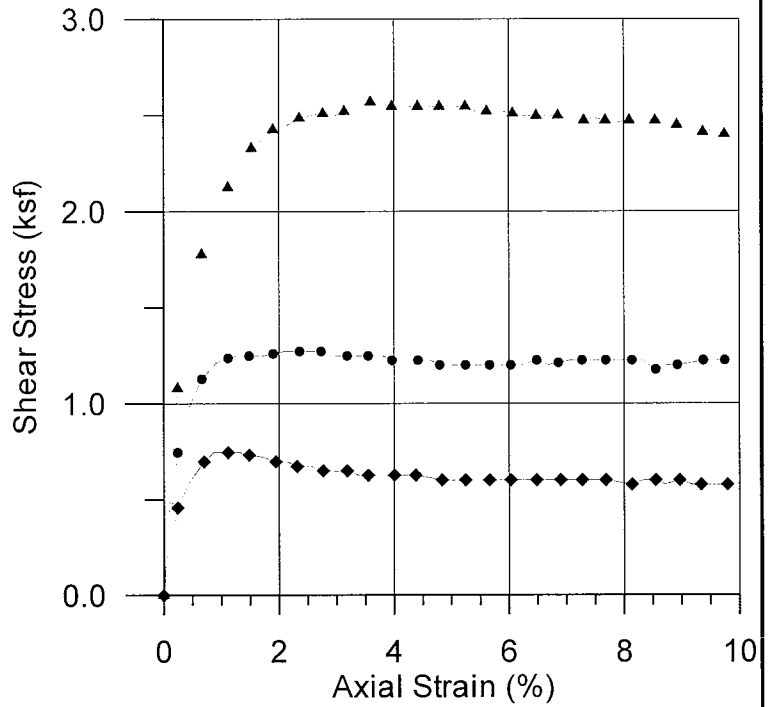
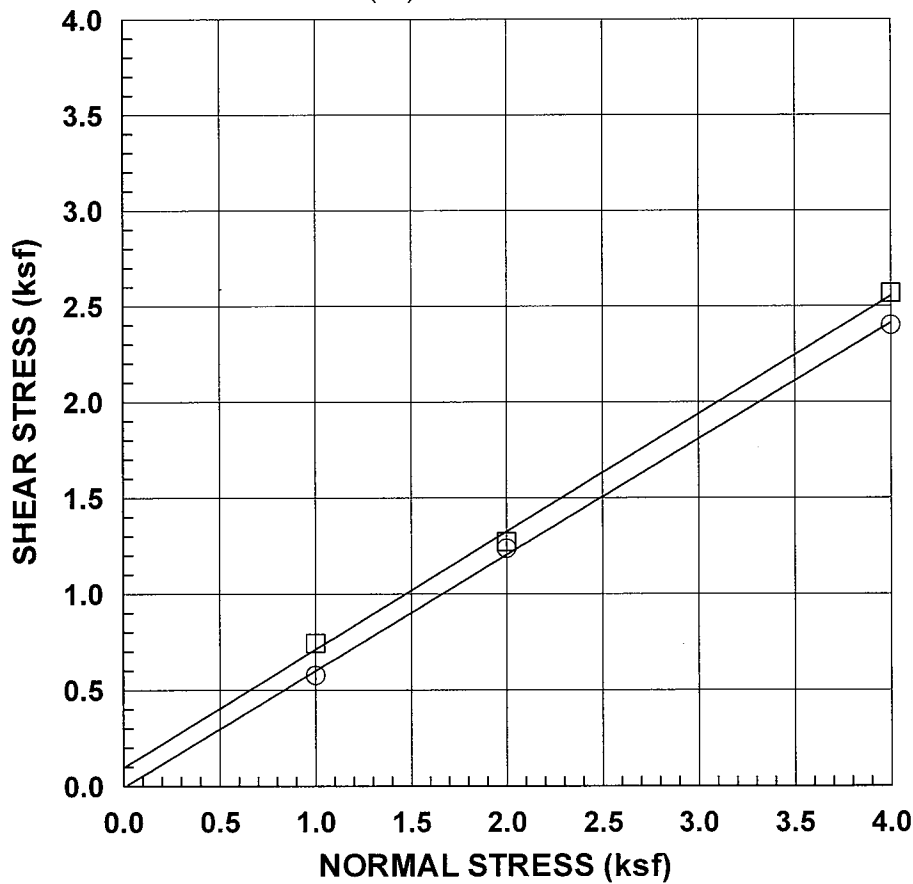
Specimen No.	1	2	3
Normal Stress (ksf)	1	2	4
Peak Stress (ksf)	0.744	1.272	2.568
Peak Displacement (in)	0.021	0.051	0.087
Ultimate Stress (ksf)	0.576	1.236	2.4
Ultimate Displacement (in)	0.246	0.247	0.247
Initial Dry Density	117.4	116.5	116.5
Initial Moisture Content (%)	9.995	10.86	10.86
Strain Rate (in/min)	0.050

Strain Legend	
◆	1 Ksf
●	2 Ksf
▲	4 Ksf

Strength Legend	
□	Peak
○	Ultimate
